Historic Site Preservation Board Staff Report

Date: November 13, 2012
Case No.: 3.1198 – HSPB # 27
Application Type: Certificate of Approval – Building Re-Roof
Location: 800 North Palm Canyon Drive
Applicant: Roofing Standards - El Paseo Building
Zone: C-1 (General Commercial)
General Plan: Neighborhood Community Commercial (NCC)
APN: 505-285-009
From: Glenn Mlaker, AICP, Assistant Planner

SUBJECT: Water Testing and leak investigation

RE: 800 N. Palm Canyon Drive, Palm Springs, CA

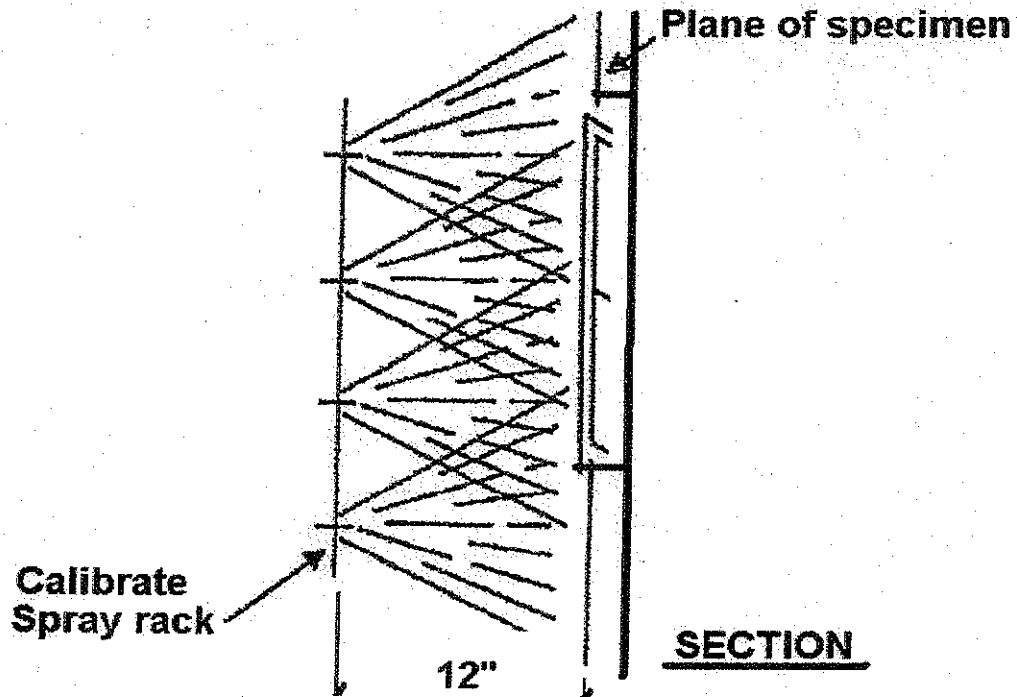
FIGURE 1 – ASTM 1105 CALIBRATED SPRAY RACK SYSTEM

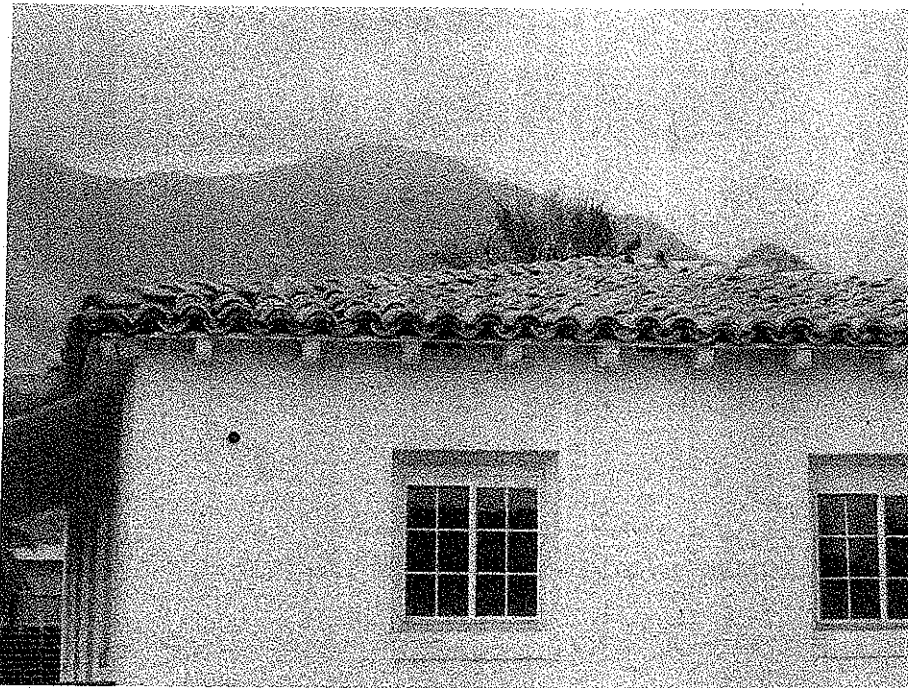
- 1) Water leaked in the south wall of the office
- 2) Water leaked in the entry stairway on the north side of the office.
- 3) Water leaked at the north wall and roof facing Palm Canyon Drive through the balcony door

PHOTO 1 - South exterior elevation Suite B

- The entire upper roof requires re-roofing.
- Remove existing underlayment and replace with a double layer of 40-lb roofing felt.
- Replace the hip and ridge board with new wood boards
- Provide new roof edge metal in compliance with the City of Palm Spring City Ordinance to meet the local historical building designation.
- Re-install existing clay tile roof to include new wire-tie system by Newport Tile Tie system
- Install a new sill pan at the west door to the west balcony

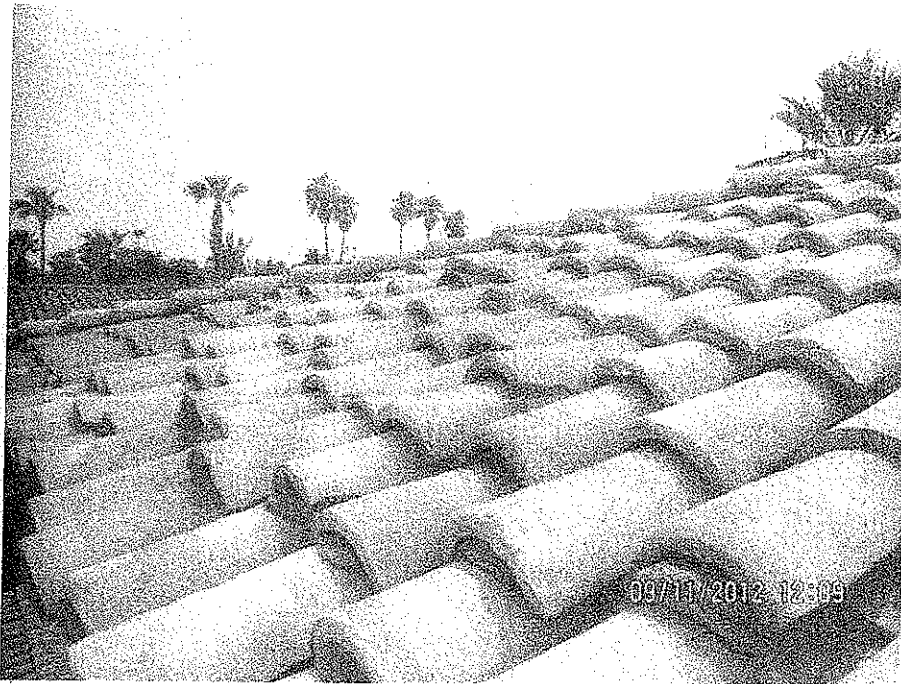
PHOTO 2 - Roof Suite B. historical designation of existing roof tiles by the City of Palm Springs.

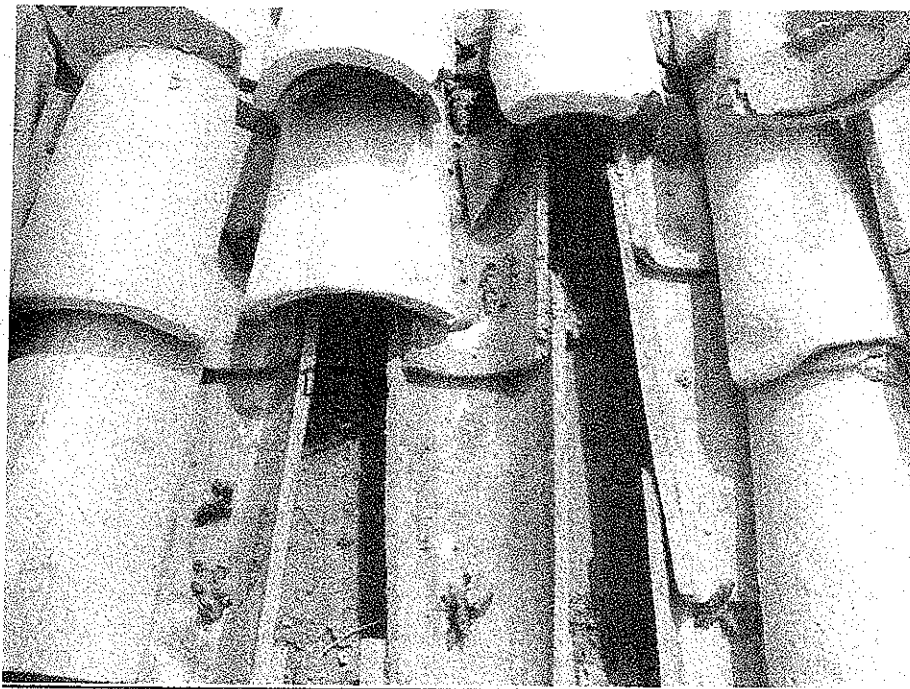
PHOTO 3 - Roof Suite B, tile have no fasteners, the underlayment has fully deteriorated and not effective to keep rain water out.

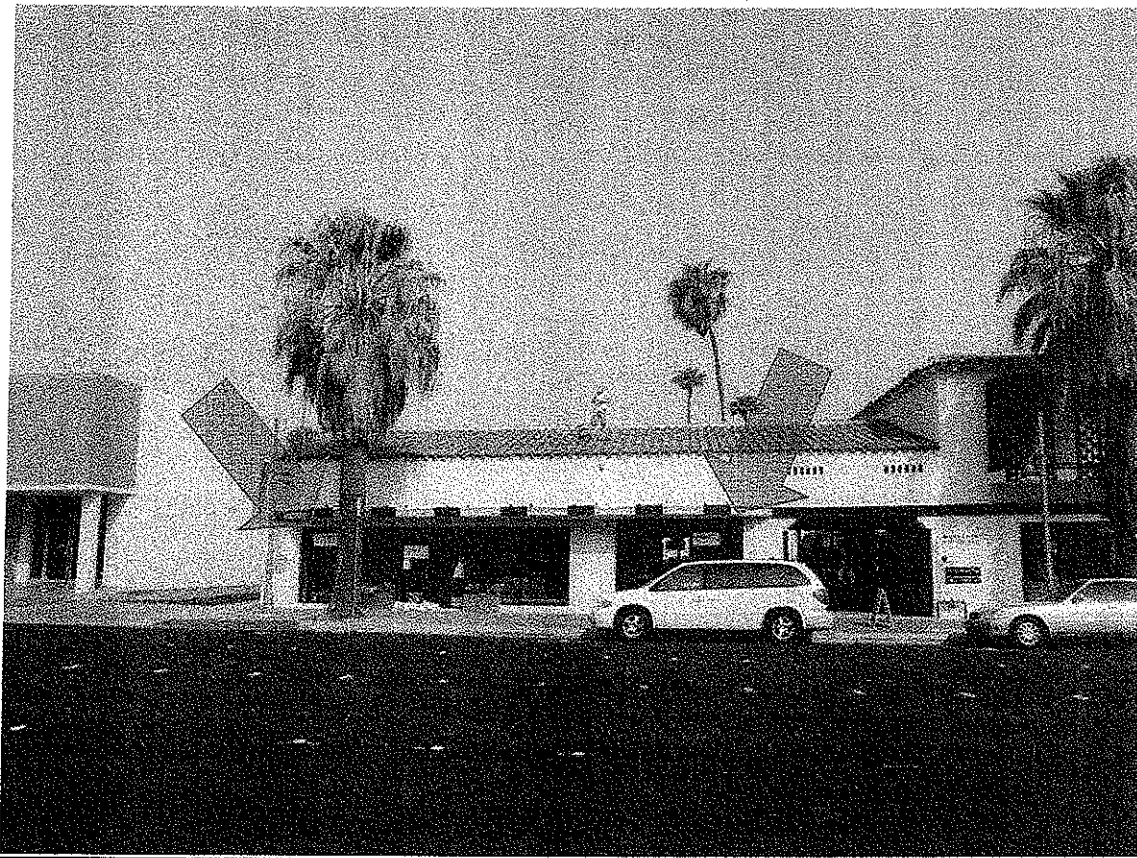
PHOTO 4- West exterior Elevation of Suite F

***Blue arrow notes location of water leaks at black painted column tie to block wall.
Main roof of Suite F requires repair by complete removal and reinstallation.
Reinstallation must meet the City of Palm Spring building departments.***

- Re-roof the entire retail gallery. Remove existing underlayment and replace with a double layer of 40-lb roofing felt.
- Replace the ridge board with new wood boards
- Provide new roof edge metal
- Re-install existing clay tile roof to include new wire-tie system by Newport Tile Tie system
- Repair west wall at black column wall tie with pressure injection sealant by SealBoss.
- Replace the existing sheet metal flashing continuously above the fabric canopy. Provide a new 24-GA bonderized metal flashing and painted white to match the wall color. Fully seal to wall with a 3/8" wide sealant joint.

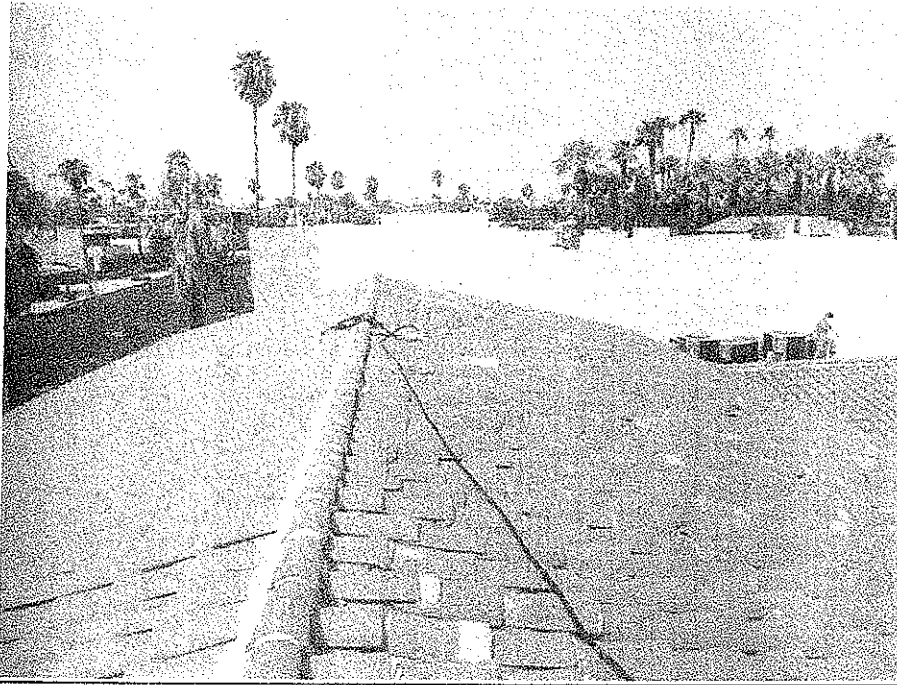
PHOTO 5 – Main roof over Suite F has no fasteners used in the roof tile.

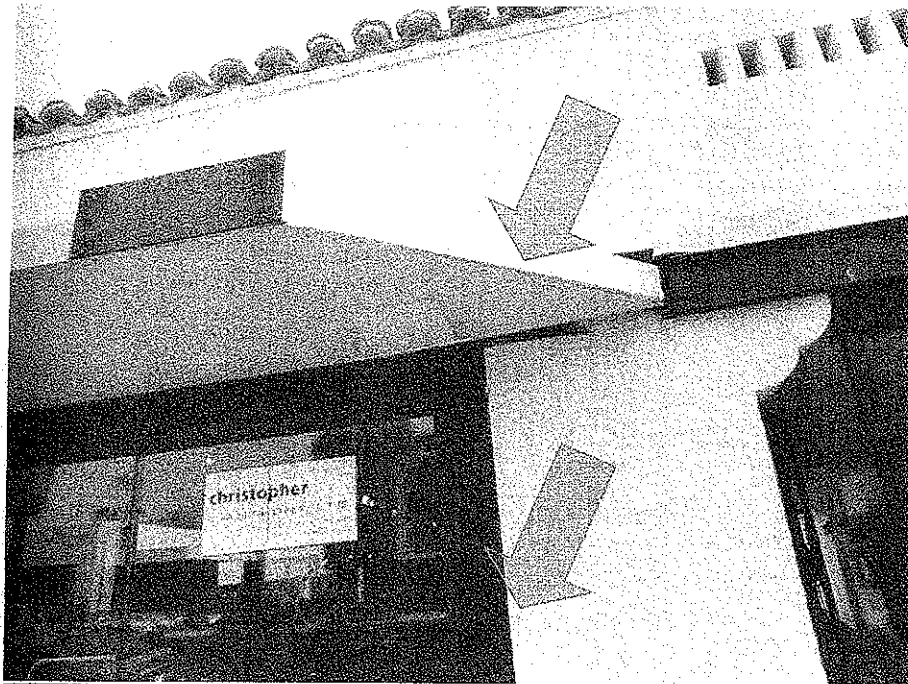
- 2) Hand spray wand at the column tie
 - Water leaked at the west wall located at the south steel column tie using the hand wand spray.
- 3) Water test the canopy flashing at the west wall of the storefront.

PHOTO 6 - West exterior Elevation. Water leak occurred at the top of the window wall and at the side of black steel column joint at the masonry wall.

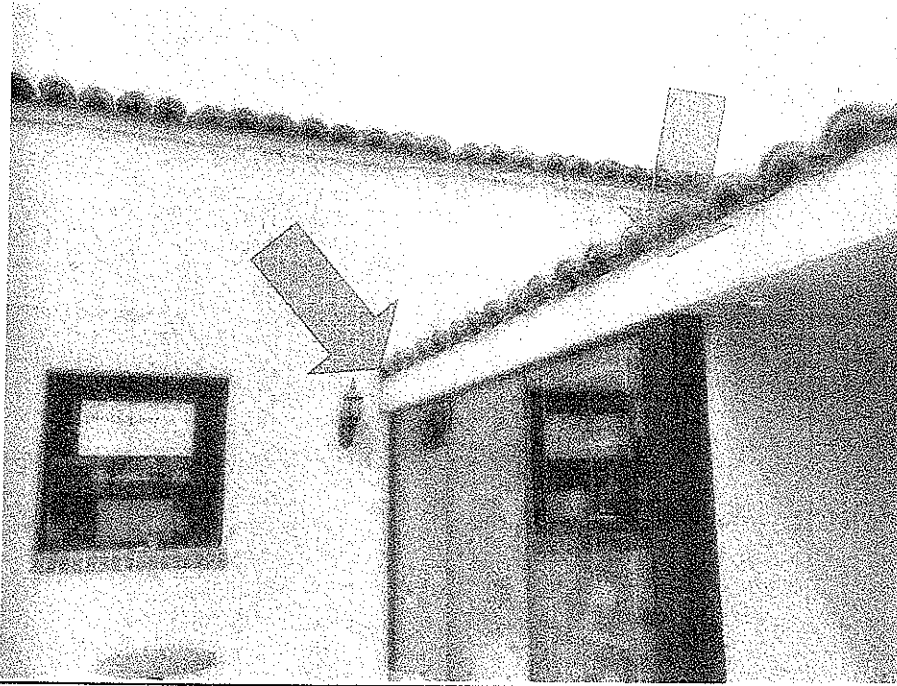
- Water leaked at the south courtyard window from the reverse lap installation of a new stucco band above the window
- 5) Visual inspection of the lower roof at the courtyard

PHOTO 7 – Courtyard south window leaked due to reverse lap installation of the stucco band. Install a new drip flashing over the roof edge.

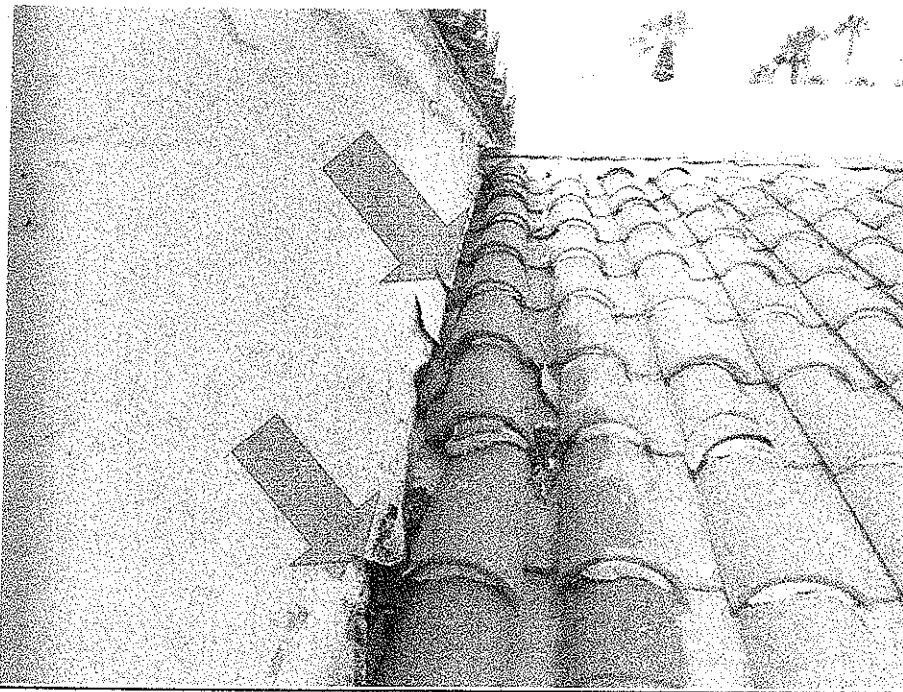
- Visible inspection of the roof flashing found reverse lap and open seam of the roof wall tie flashing. Lower roof of Suite F requires complete repair by complete removal and reinstallation. Reinstallation must meet the City of Palm Spring building departments.

PHOTO 8 – East lower roof has incomplete wall flashing installation. A water leak was reported at roof to wall transition.

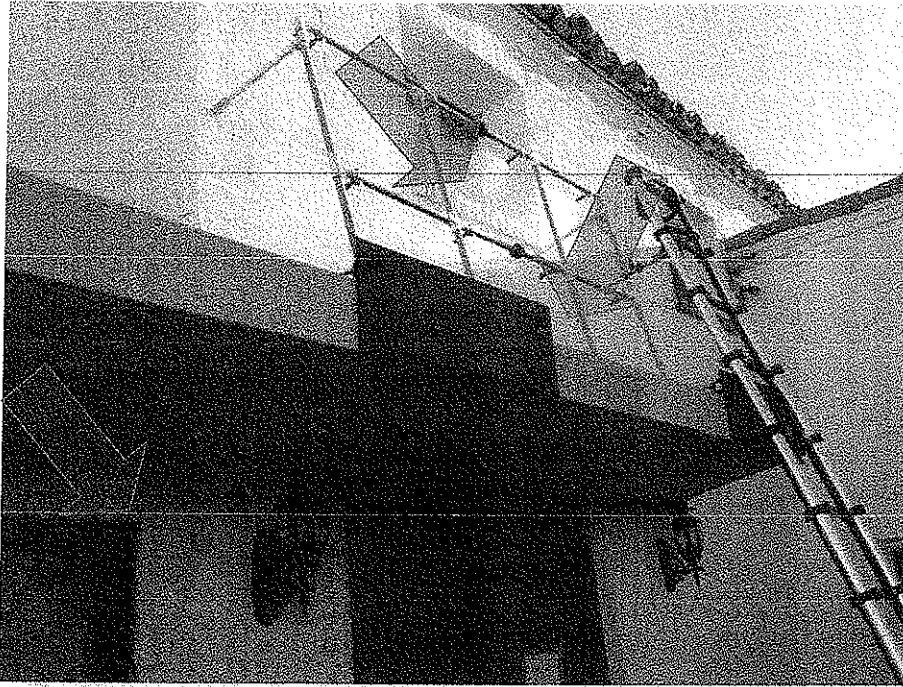
- 1) Water test the south wall above the new restaurant entry door
 - Water leaked at the masonry wall cracks
 - Water leaked at the lower roof to wall connection

PHOTO 9 – Water test above the entry door of the restaurant produced a leak into the dining room below. The window above the entry door also leak at the window frame. The wall above the entry door also leaked – see blue arrows.

- The masonry wall has wall crack at the south wall requiring pressure injection system using SealBoss or equal.

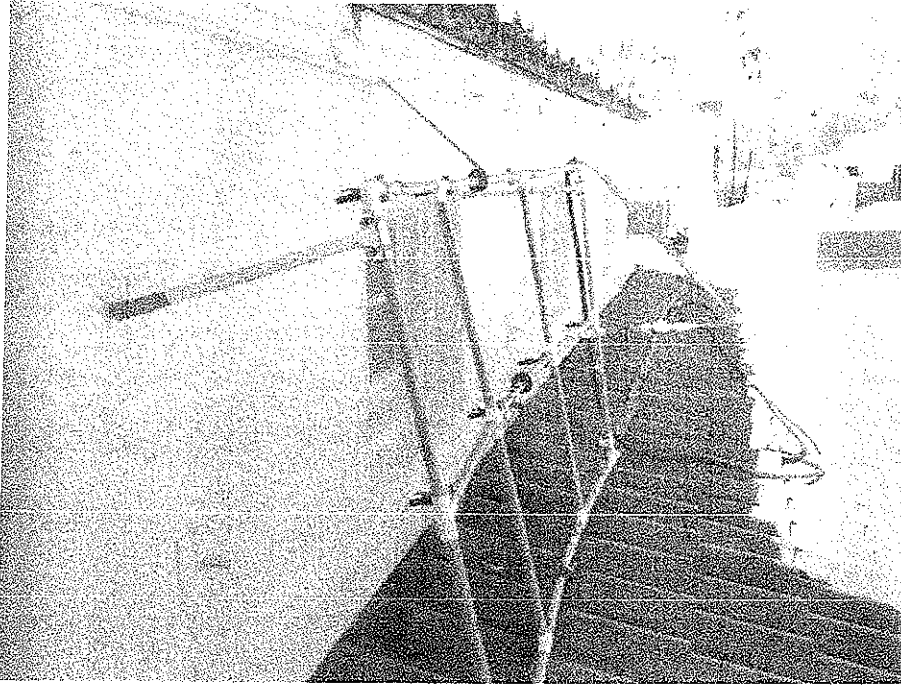
- 4) Water test the one (4) clerestory windows above the main restaurant north side
 - Water leaked into the main eating area of the restaurant through the masonry wall

PHOTO 10 – North roof and wall with the clerestory windows leaked into the main dining area.

- Water leaked into the main dining area of restaurant interior masonry wall.
- Re-roof the upper side roof with new double alyer of 40# roof felt. Re-attached at tiles using Newport Tilt tie system or equal. Install anew edge drip metal.
- Reseal all cracks in the masonry wall with SealBoss injection system or equal
- Repair wood-framed windows and re-seal, re-paint all wood splits and cracks.

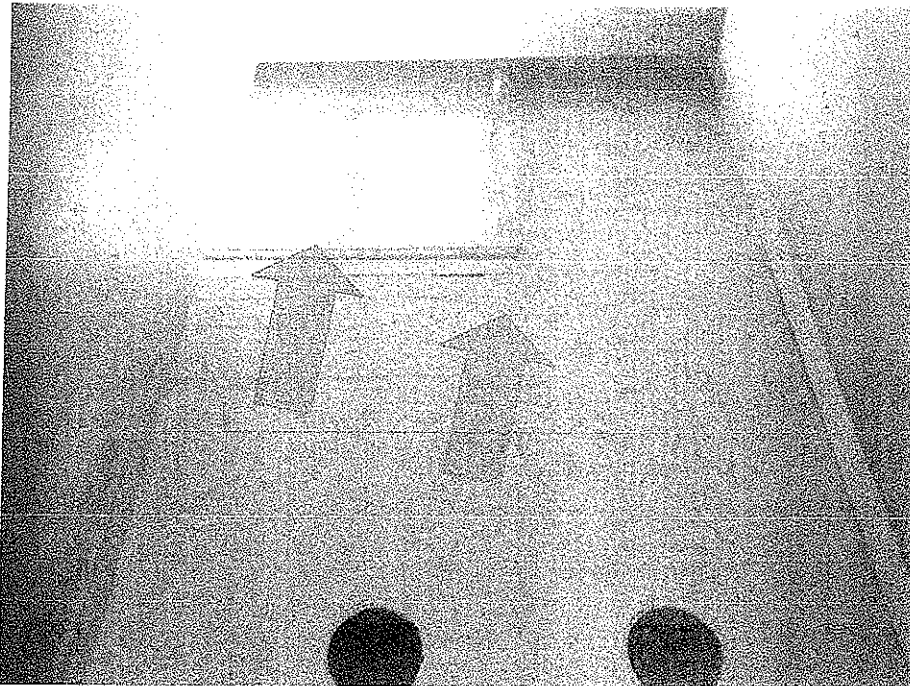
PHOTO 11 – Interior water leak in the main dining area.

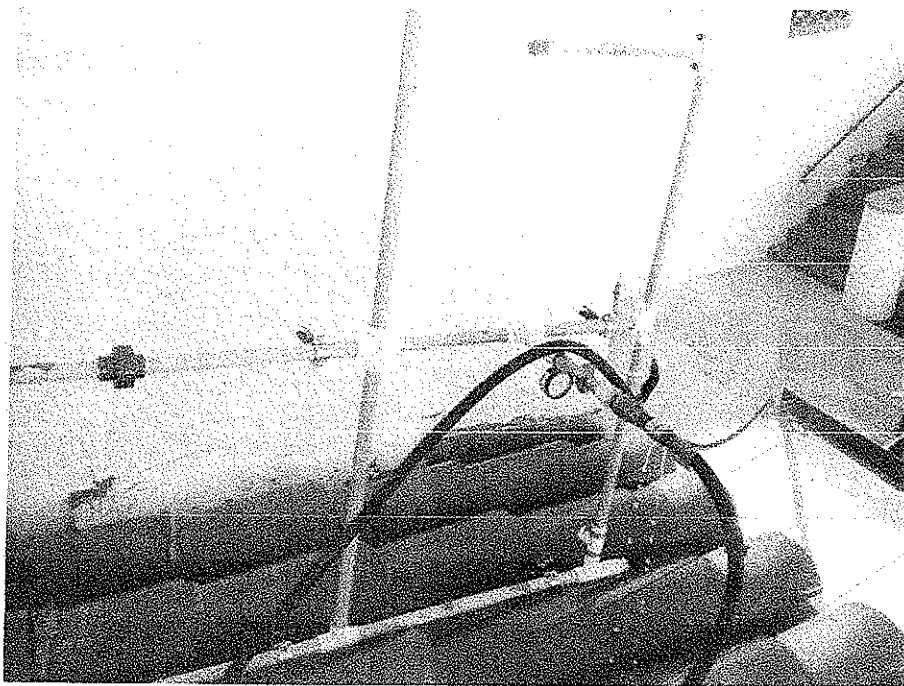
PHOTO 12 – Lower roof at the courtyard for the restaurant had an interior water leak in the smaller dining area.

- Entire lower re-roof is required at the courtyard.
- Remove existing underlayment and replace with a double layer of 40-lb roofing felt.
- Replace the ridge board with new wood boards
- Provide new roof edge metal in compliance with the City of Palm Spring City Ordinance.
- Re-install existing clay tile roof to include new wire-tie system by Newport Tile Tie system
- Replace the roof to wall flashing.

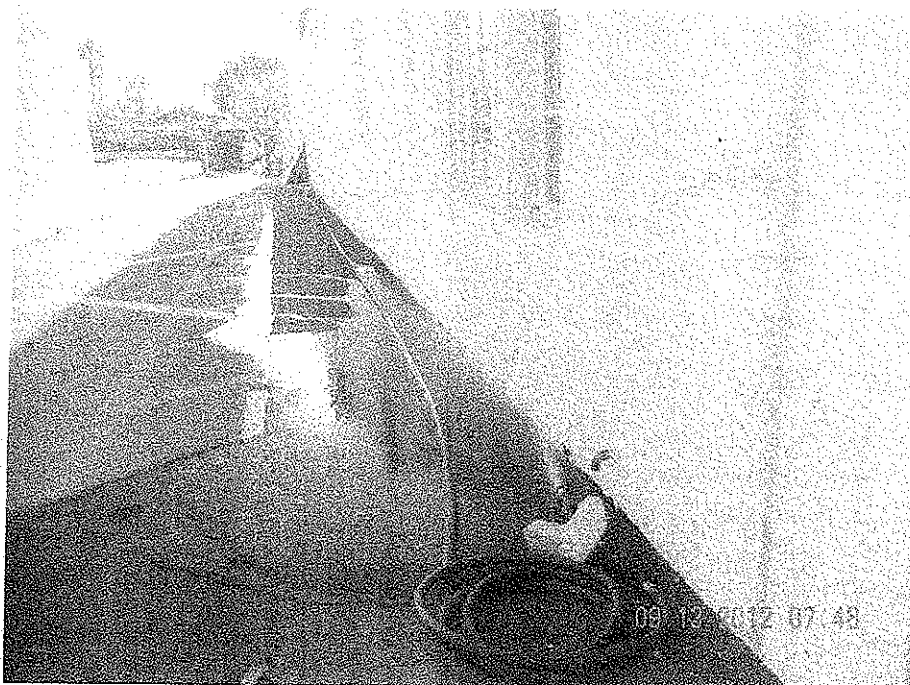
PHOTO 13 – North wall water test along the alley produced a leak through the masonry wall.

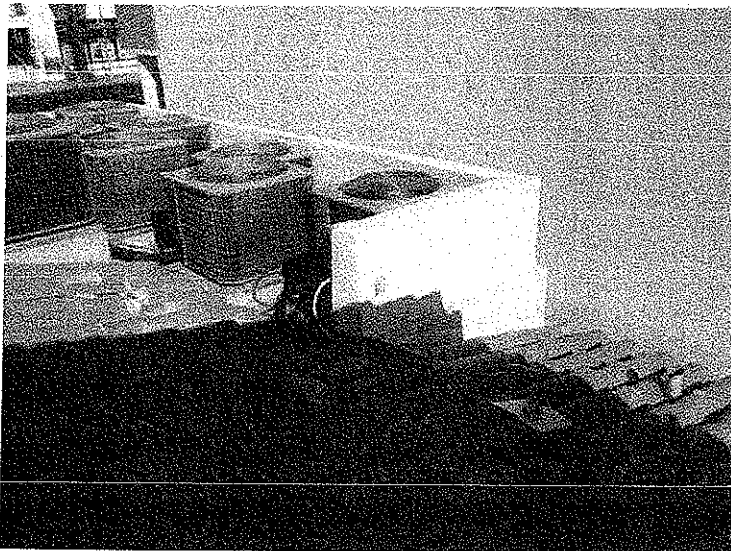
A mechanical roof well is located at the north side of the lower roof between the Gallery store and restaurant. The mechanical well has 6 existing condenser units. The sheet metal curb was found to be sitting directly on top of the roofing ply with tie-in to the roofing system for a watertight installation. While no reported active water leak has been reported, water stain patterned at the roofing and interior ceiling cracks indicate an active water leak.

The mechanical curb did not have any roofing under the sheet metal covering the mechanical curb.

PHOTO 14 – North mechanical well.

Our office recommends the entire mechanical well be repaired by installin g a new roofing system and install curb metal to tie-in to the new roofing.
