## City Council Staff Report

SUBJECT: APPROVAL OF AMENDMENT NO. 2 IN THE AMOUNT OF \$70,000 TO THE PROFESSIONAL SERVICES AGREEMENT WITH ARCHITECTURAL RESOURCES GROUP, INC., (A6791) FOR THE CORNELIA WHITE HOUSE EXTERIOR REPAIRS, CITY PROJECT NO. 15-16

## Existing Conditions Assessment

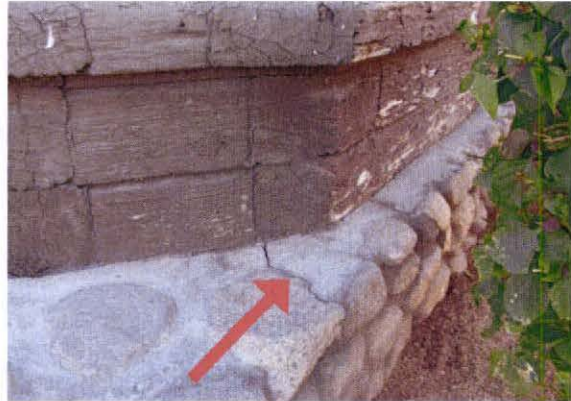
The wood-framed superstructure of the house is raised on a perimeter foundation wall. The foundation wall is composed of reinforced concrete with field stone at the exterior faces. The stone is fully mortared to the wall, and there is a mortar wash generally present at the top surface of the wall. However, the top surface is relatively flat throughout, with little to no positive slope away from the building for surface drainage. There was no flashing or waterproofing was observed. Sealant has been used to seal the horizontal joint between the foundation wall and wood walls. This has trapped moisture within the woodwork, and exacerbated the decay. Cracks were observed at the northwest corner and southwest corner of the Dining Room foundation walls. At the northwest corner, the building has an angled wall (chamfered corner) whereas the foundation wall has a full 90-degree turn. The stones at the southeast corner are oddly laid, with some overlap with landscape curbing. It is unclear how this form affects the concrete foundation wall, or if it is a weak detail and could potentially be a problem in the future. Landscaping includes a small tree, grass lawn, and some flower beds. There is an underground sprinkler system surrounding the building, but the watering schedule is unknown at this time. Reportedly, some sprinklers have sprayed the building walls in the past.

Concrete and stone foundation wall at northwest chamfered corner. Note crack in wall.

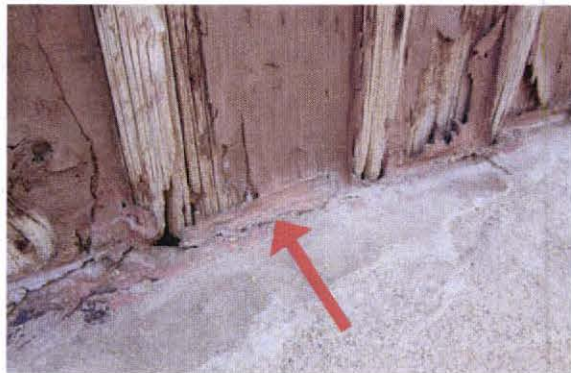
Typical sealant joint at horizontal joint between wood and foundation walls.

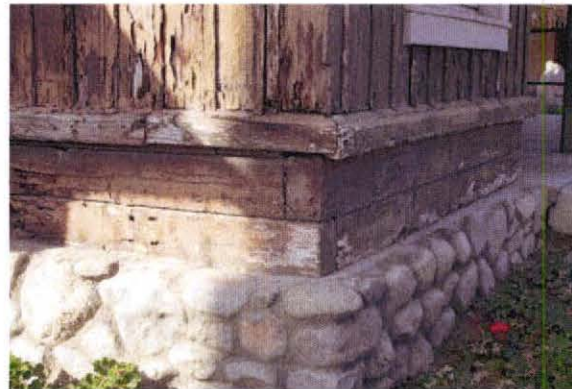
Heavy decay at cross ties at northeast corner.

The cross ties have moderate to advanced decay throughout. The decay is more advanced at building corners, end-to-end joints and at the base of members in contact with the foundation wall. Several areas of full thickness voids were observed at east, west, and north elevations. At the west elevation, there appears to be a replacement piece; the piece is short in length, with straight cut end-to-end joints rather than angled. There is also a rectangular dutchman repair directly above this replacement piece. Previous epoxy repairs were also noted at the base of the walls. This appears to be an injectable-type epoxy and no longer serves its purpose. The epoxy is aged and yellowed, and is no longer bonded to the wood substrate. It also traps moisture within the wood, promoting further decay.

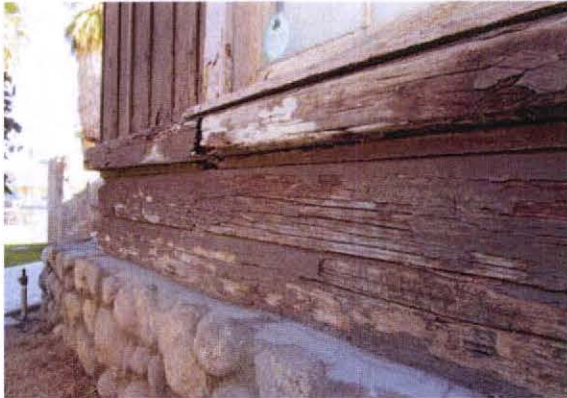
Heavy decay at cross ties at west elevation.

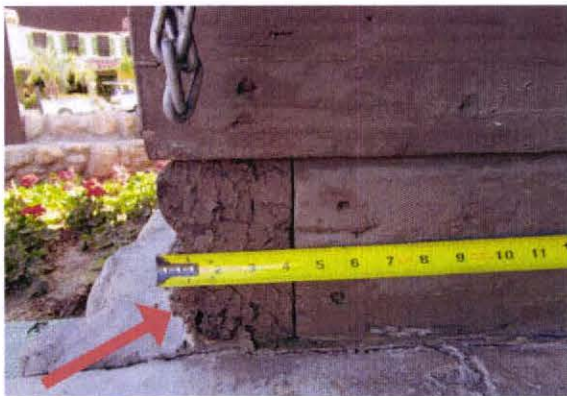
Decay and section loss at cross tie at northwest corner of Bathroom.

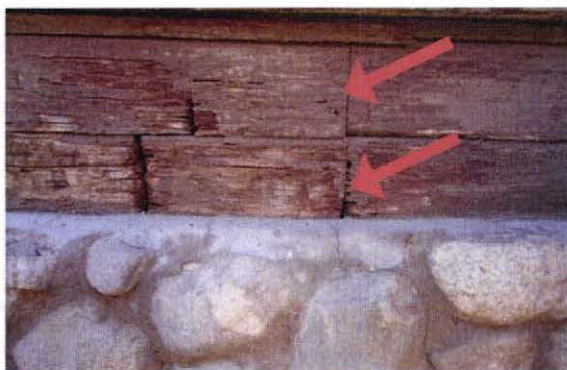
Prior cross tie replacement and dutchman repair above, west elevation.

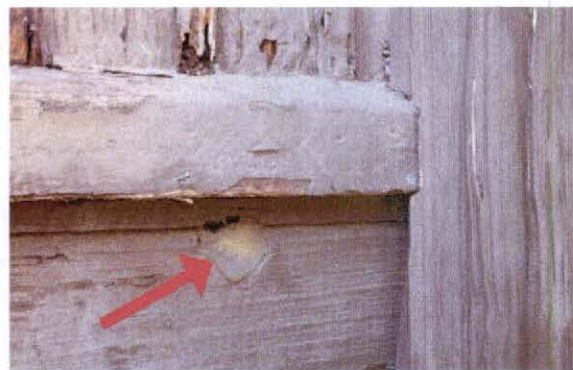
Prior epoxy repair at west elevation.

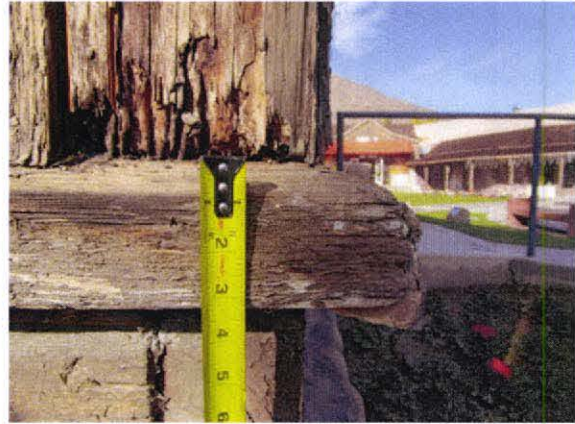
*Belt course at northeast corner. Note bottom 1/2-inch removed.*

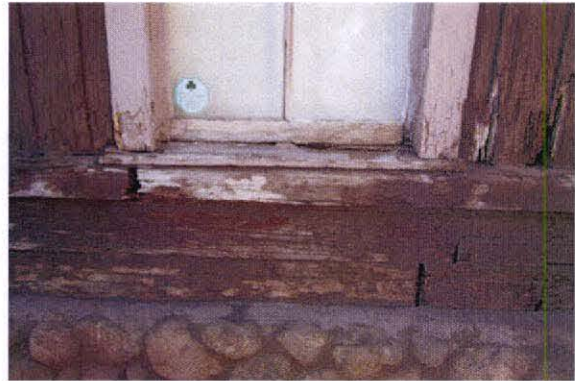
*Heavy decay at belt course at west elevation.*

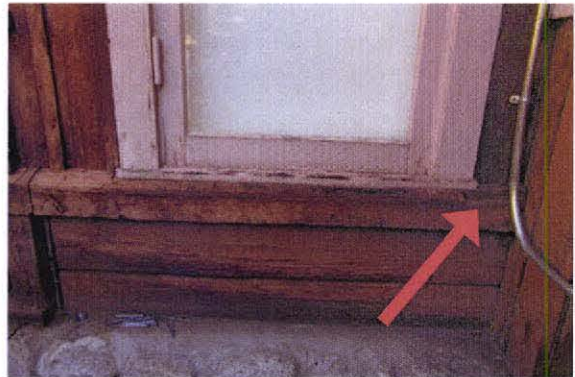
*Belt course at south elevation of Dining Room. Note notch at right side.*

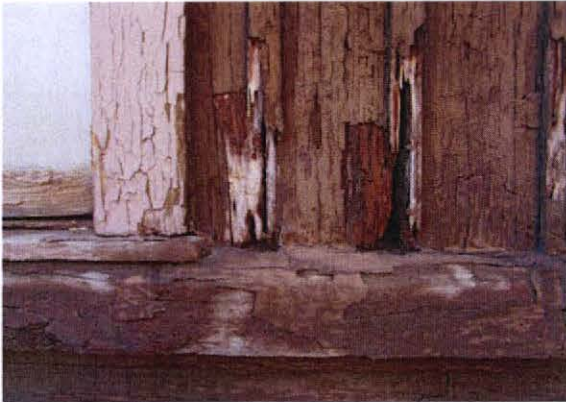
Heavy decay at base of cross ties above belt course at west elevation.

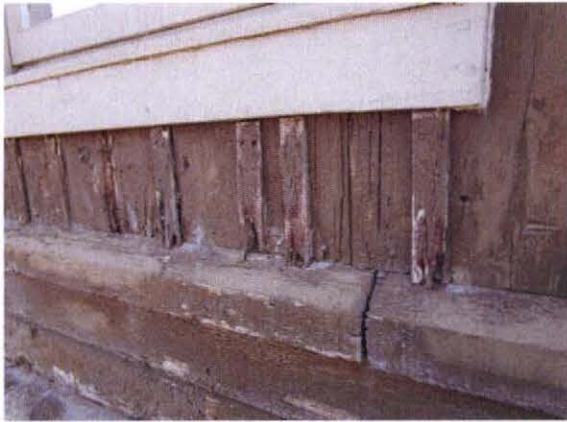
*Decayed, missing and added battens at north elevation.*

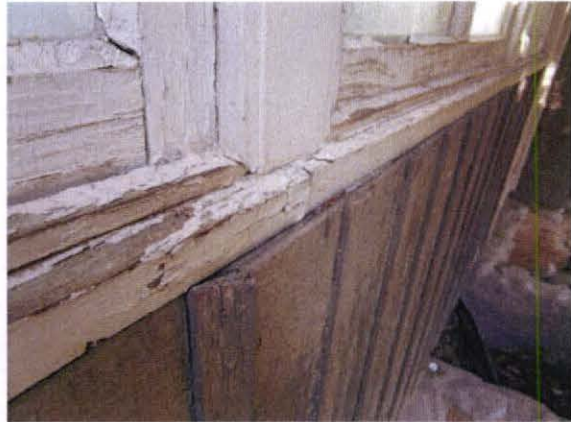
*Displaced siding at east elevation of Second Room.*

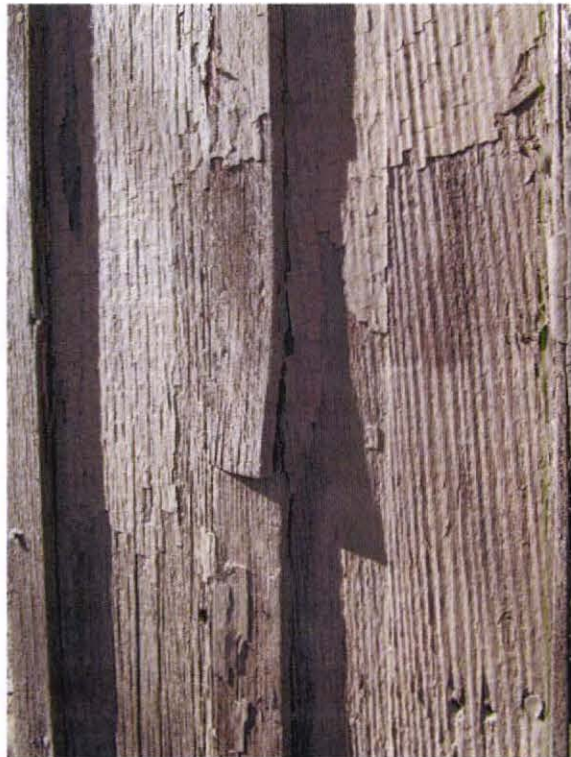
*Warped batten at east elevation.*

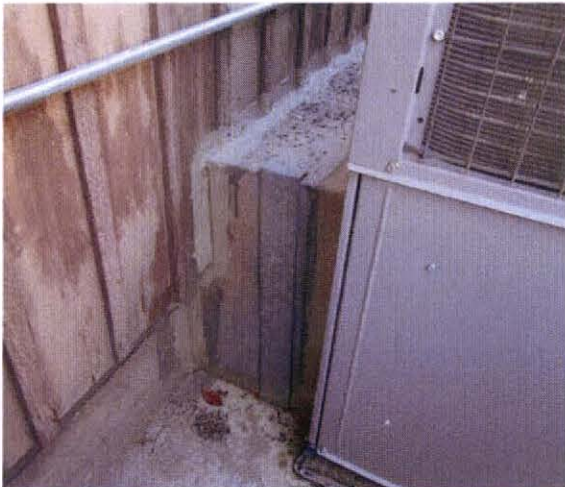
The board-and-batten siding has had numerous repairs and modifications over the years. At the southwest corner, the siding has been partially overlaid with an additional 1/4-inch layer of board and batten siding. This is at locations for surface-mounted boxes and other equipment. At the base of the west wall, near the center, a large opening has been cut into the siding to install heating and ventilating ductwork. The ductwork is poorly sealed to the siding with lots of sealant. Other modifications at this area include surface-mounted boxes, conduits, switches, etc. and a cleanout for the kitchen sink. Surface-mounted conduits, electrical boxes and lights have been added at the other elevations. Also, just to the east of the kitchen door, the foundation wall rises in height slightly. The base of the siding was most likely cut to accommodate for this construction imperfection.

*Modified siding at west elevation for HVAC equipment.*

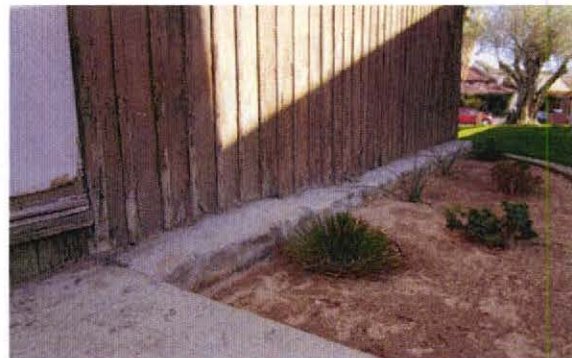
*Rise at foundation wall, south elevation.*

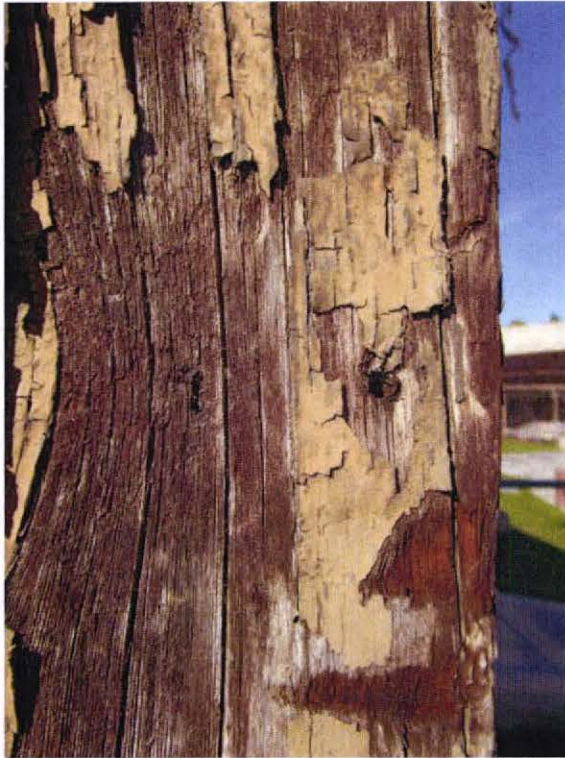
Detail view of heavily deteriorated paint. Note white residue which could be old primer or paint layer.

Exterior surfaces of cross ties, siding and trim are generally painted a flat brown color with windows, doors and trim painted a pale pink. It is unclear whether these are the original paint colors, or if the house has always been painted or if the railroad ties had a natural or stained finish at one time. Additional finish sampling is needed for confirmation. The photo from 1960 indicates painted surfaces, with the window sash painted a light color and the casing trim matching the building walls. In the 1979 photos, the windows and casing trim are painted pink. In general, paint coatings may have been preferred since they would provide a uniform finish for the various wood species, light and dark, used throughout the house. However, any creosote preservative treatment originally used on the cross ties would have made painting difficult, most likely requiring repainting more often.

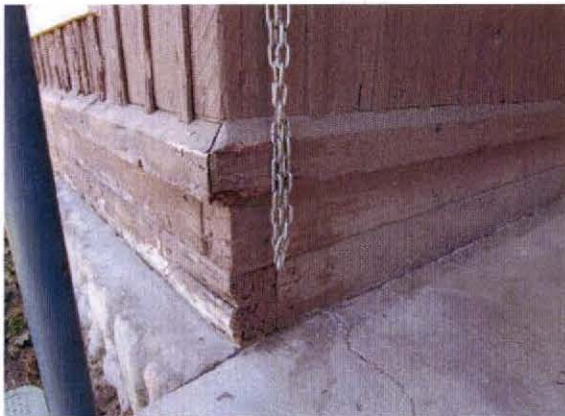
Typical view of paint coatings. Note relatively intact paint layer at protected porch (right) side and deteriorated layer at exterior (left) side.

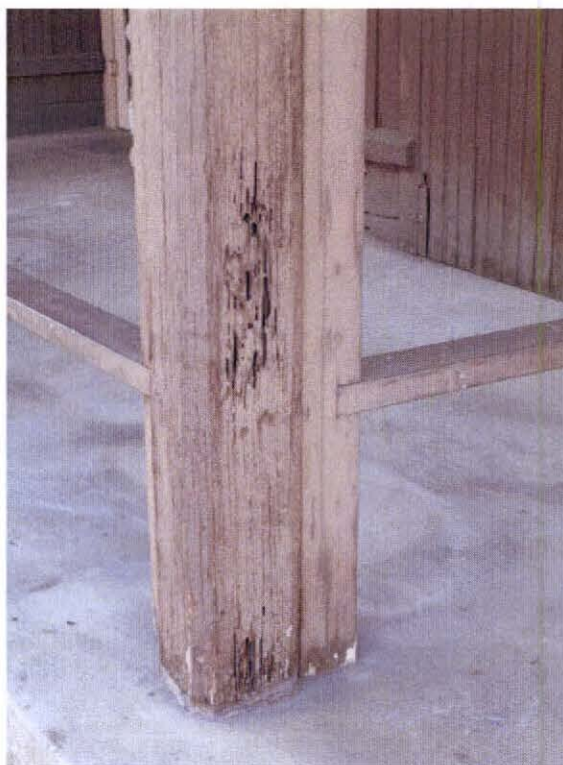
The porch concrete floor slab was most likely installed when the building was moved to this location. The slab has positive slope for drainage to the north. There is some wood decay and staining at the base of the building walls, in particular at the northeast corner of the porch, possibly from splashing of roof water. No gutters or downspouts were observed. Porch columns have been raised from the floor on metal column bases. There was some decay observed at the base of the columns. The balustrade railing was reportedly added at a later date. It consists of an upper and intermediate rail and vertical posts. The posts sit flush with the concrete slab and are decayed at the bottom.

*View of decay at porch column and base of balustrade post.*

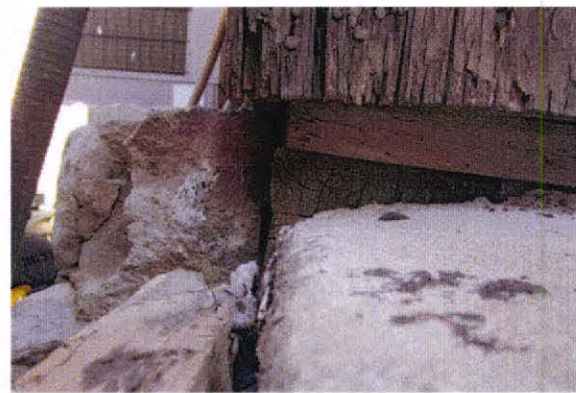
There is a concrete sidewalk leading up to the rear Kitchen door. Just to the west of the door, it appears that a small section of concrete slab has been added between the walk and the mechanical area gate. This slab is sloped toward the mechanical area, but has been poured directly up against the wood structural framing of the house. The stone from the foundation wall also appears to be directly in front of the structural framing. There was no visible flashing or waterproofing membrane observed. An oversized hole has also been cast into the small slab section for electrical conduit, leaving an easy access point for water penetration into the foundation of the building.

*Detail view of concrete slab. Note proximity of concrete and stone to wood framing.*

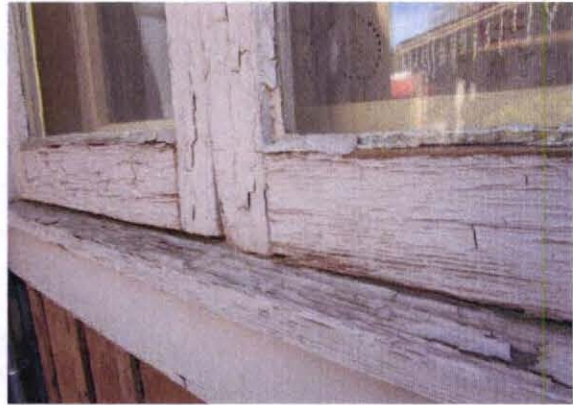
Windows are painted wood sash in wood frames. The types include casement and double-hung sash, some with divided lites. In general, window sills and base of frames, sash and trim are moderately to heavily deteriorated, with wood decay, and cracked and peeling paint observed. Glazing putty is also deteriorated, cracked and separating from the sash. The bedroom window at the north elevation appears to have been modified. The bottom of the east casement sash has been cut, and no longer fits properly to the sill. It also has a broken glass pane. The bathroom window at the north elevation was reportedly replaced by an area craftsman. No information was provided regarding the extent or detailing of the work. Windows have been painted various colors over time, including an earlier mint green. Further investigation is needed to determine original finish colors.

*Typical condition at base of windows.*

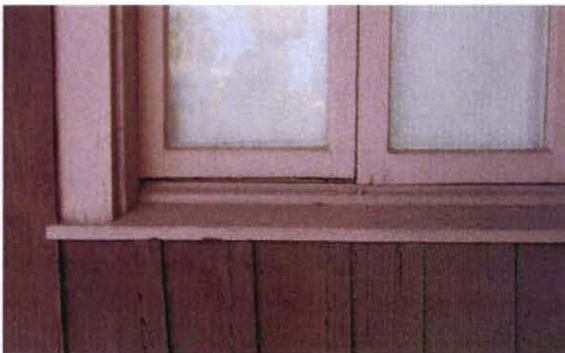
*Modified sash at Bedroom window, north elevation*

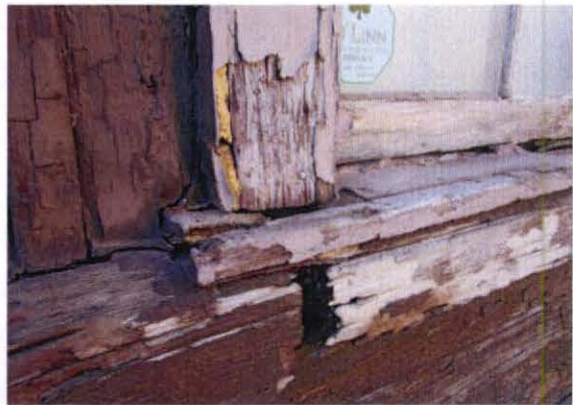
*Advanced decay at Dining Room window at west elevation.*

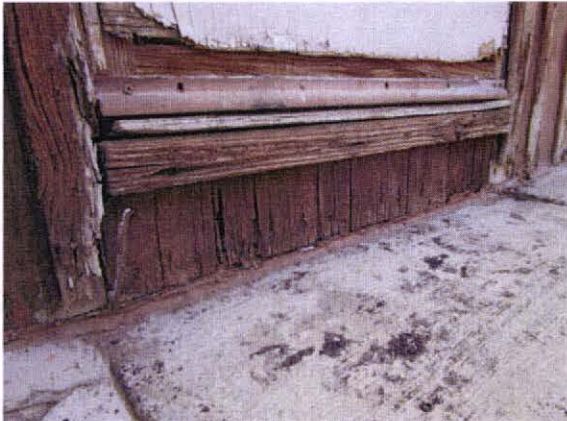
*Decay at base of Kitchen door.*
