PALMS SPRINGS RACQUET CLUB

HISTORIC REPORT

2743 N. INDIAN CANYON DRIVE

J A G ARCHITECTS

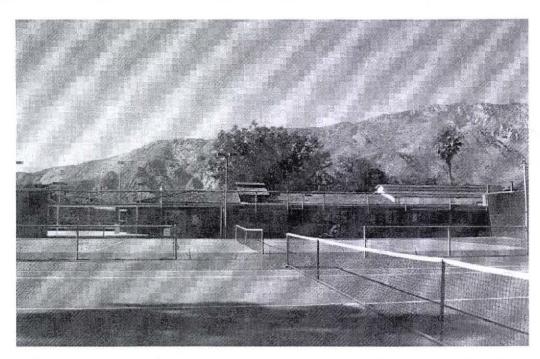
Figure B.1 Building "B"- Bamboo Lounge/ Pro Shop

The south elevation faces the main swimming pool (Fig. B.1). From the pool, the many steps in the roof that show the remaining evidence of the buildings construction history are visible. Aside from the varying roofline, the elevation is also dominated by a wood porch extension on wood posts extending almost to the edge of the pool (Fig. B.8). Picture and steel casement windows run most of the length of this elevation in much the same fashion as the north with stained wood and glass doors located at both ends of the bar. The pro shop portion has an aluminum window wrapping from the front side, but is

View of South Elevation

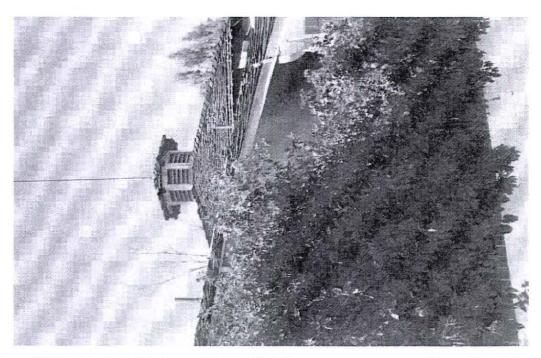
Figure C.1 Building "C"- Kitchen and Dining Building

The kitchen additions are covered with flat roofs with parapets at various heights, similar to the original building. The dining room extension also has a flat, built-up roof that supports air conditioning units with a wood-shake pitched roof surrounding all of the southern edges (Fig. C.3). There is also a wood-framed porch covering extending from the dining room addition towards the Center Courts. The original octagonal roof and cupola is still visible beyond this perimeter roof (Fig. C.1).

View of Bogart Room Roof

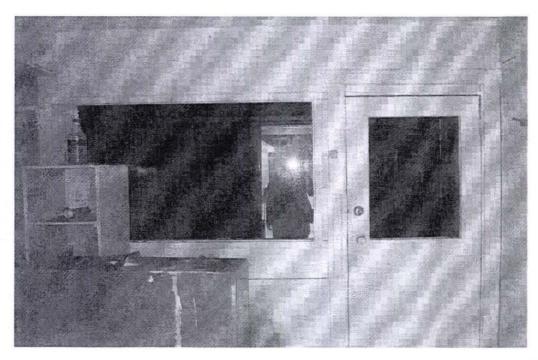
Figure E.7 Building 'E'- Cottage Building

The south side elevation was significantly altered when an infill connection was constructed to connect the Housekeeping Building and the Cottage Building (Fig. E.7, F.2). Although some of the siding still remains on that side, much of it has been removed or damaged. The lower portion of the south roof was framed over by the connecting roof and most of the eave rafters and roof overhang was cut off.

View of West Elevation

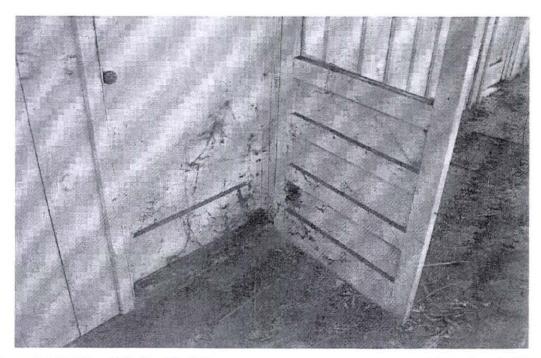
Figure G.4 Building "G"- Shed Building

The building is one-story, wood-framed construction on concrete slab. The building is vernacular in design and is clad with wood board and batten siding punctuated periodically with wood casement windows and wood panel doors. The porch was replaced at some point with metal panels (Fig. G.3). The roof was also replaced with an asphalt composition roof over a new plywood diaphragm. Many original doors still remain, although some door openings have been framed in and most of the screen doors have been removed (Fig. G.4).

View of Typical Door

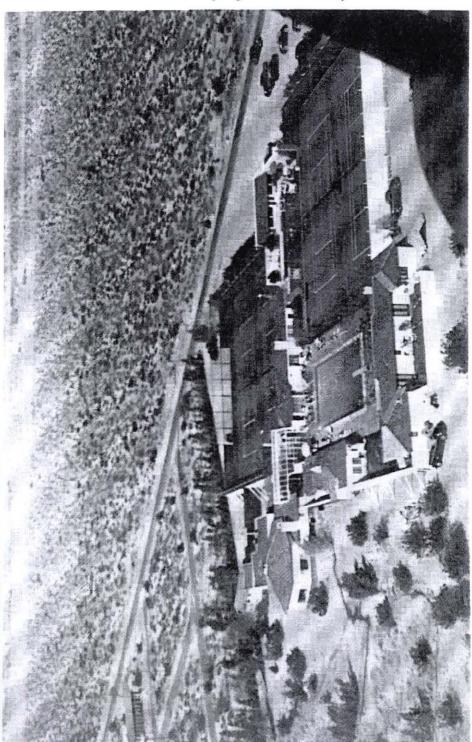
HISTORIC PHOTO (HIST-1) Credit: Palm Spring Historical Society

No records were found to determine the progression of the current parking and driveway configuration although from the very earliest photographs, a parking area was always maintained at the front of the property and cars drove along the north side of Netcher's Creek further into the property, roughly where the current central driveway is located (Fig. Hist-1).
