ARCHITECTURAL ADVISORY COMMITTEE STAFF REPORT

SUBJECT: A MINOR ARCHITECTURAL REVIEW REQUEST BY BANK OF AMERICA FOR ADA UPGRADES AND EXTERIOR REHABILITATION AT THE CITY NATIONAL BANK BUILDING, A CLASS 1 HISTORIC SITE LOCATED AT 588 SOUTH PALM CANYON DRIVE, ZONE C-1 (HSPB #52) (CASE 3.0899 MAA)

Case 3.0899 MAA / HSPB 52 City National Bank ADA Ramp & Repairs.

Palm Springs Main - Exterior Repairs Schematic Design Documents

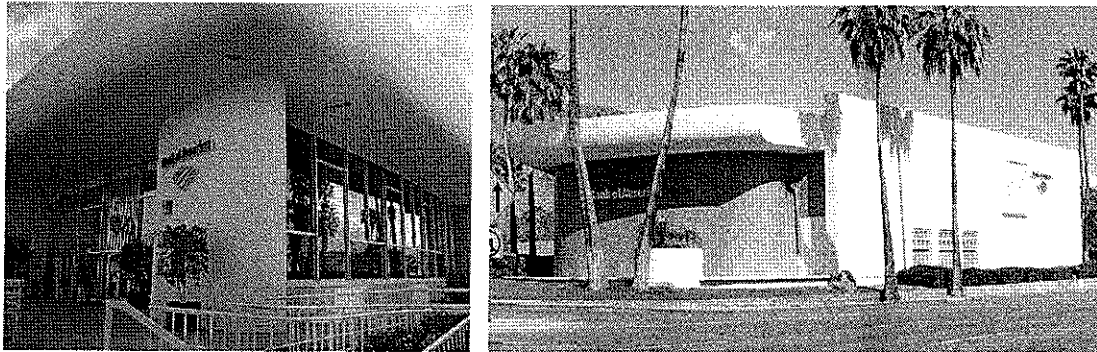
Details of the City National Bank Building – 1959

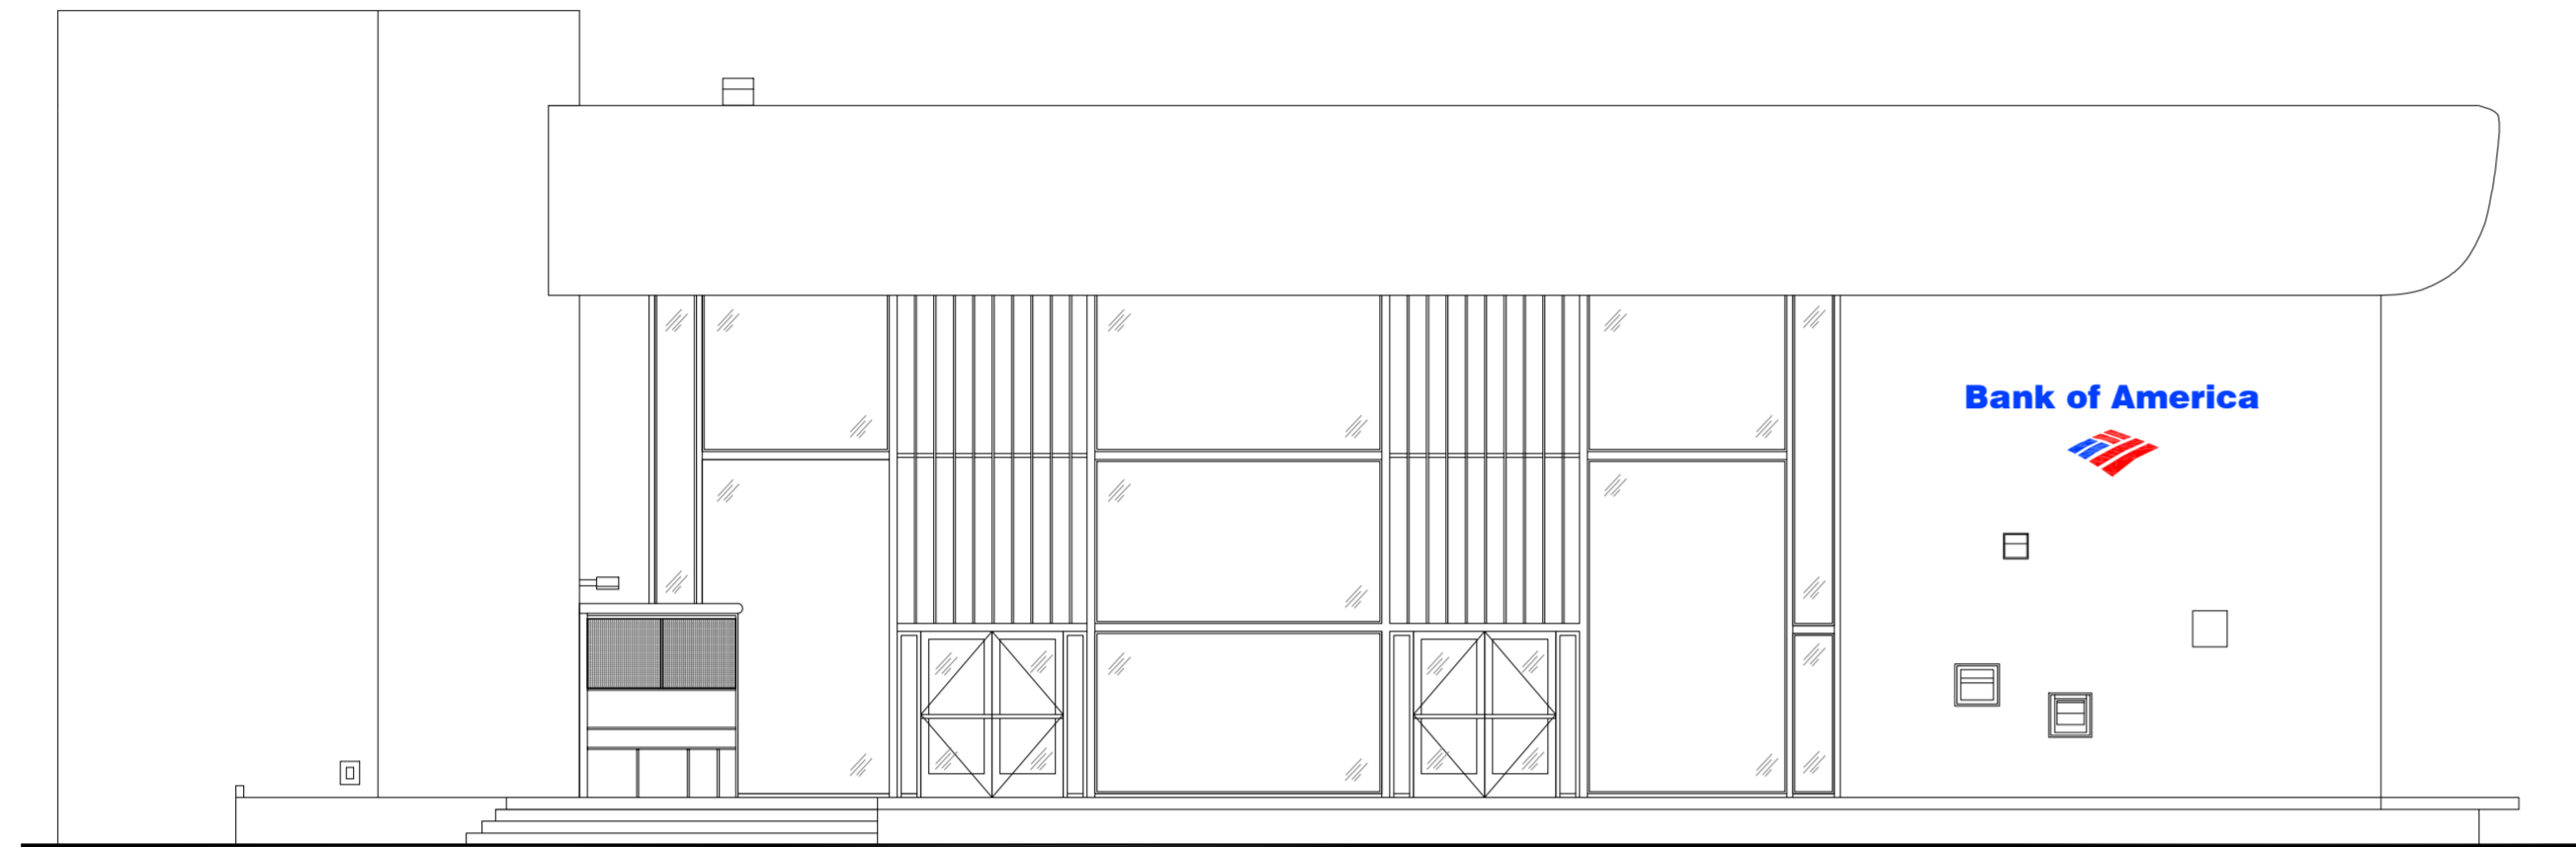
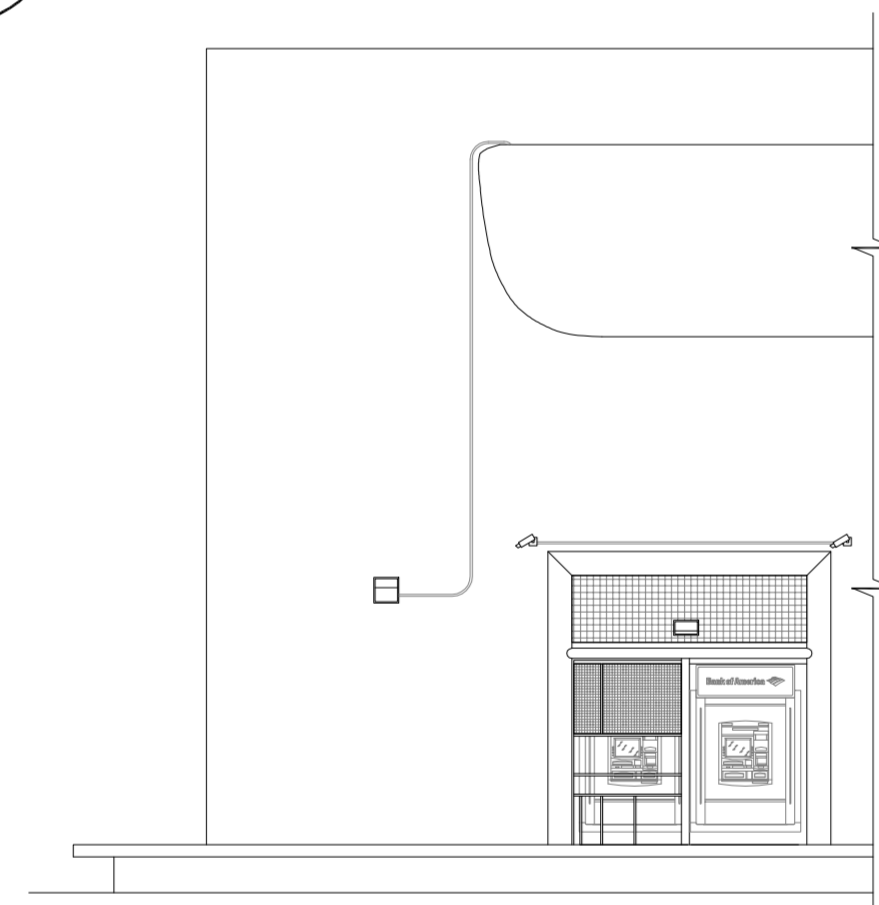
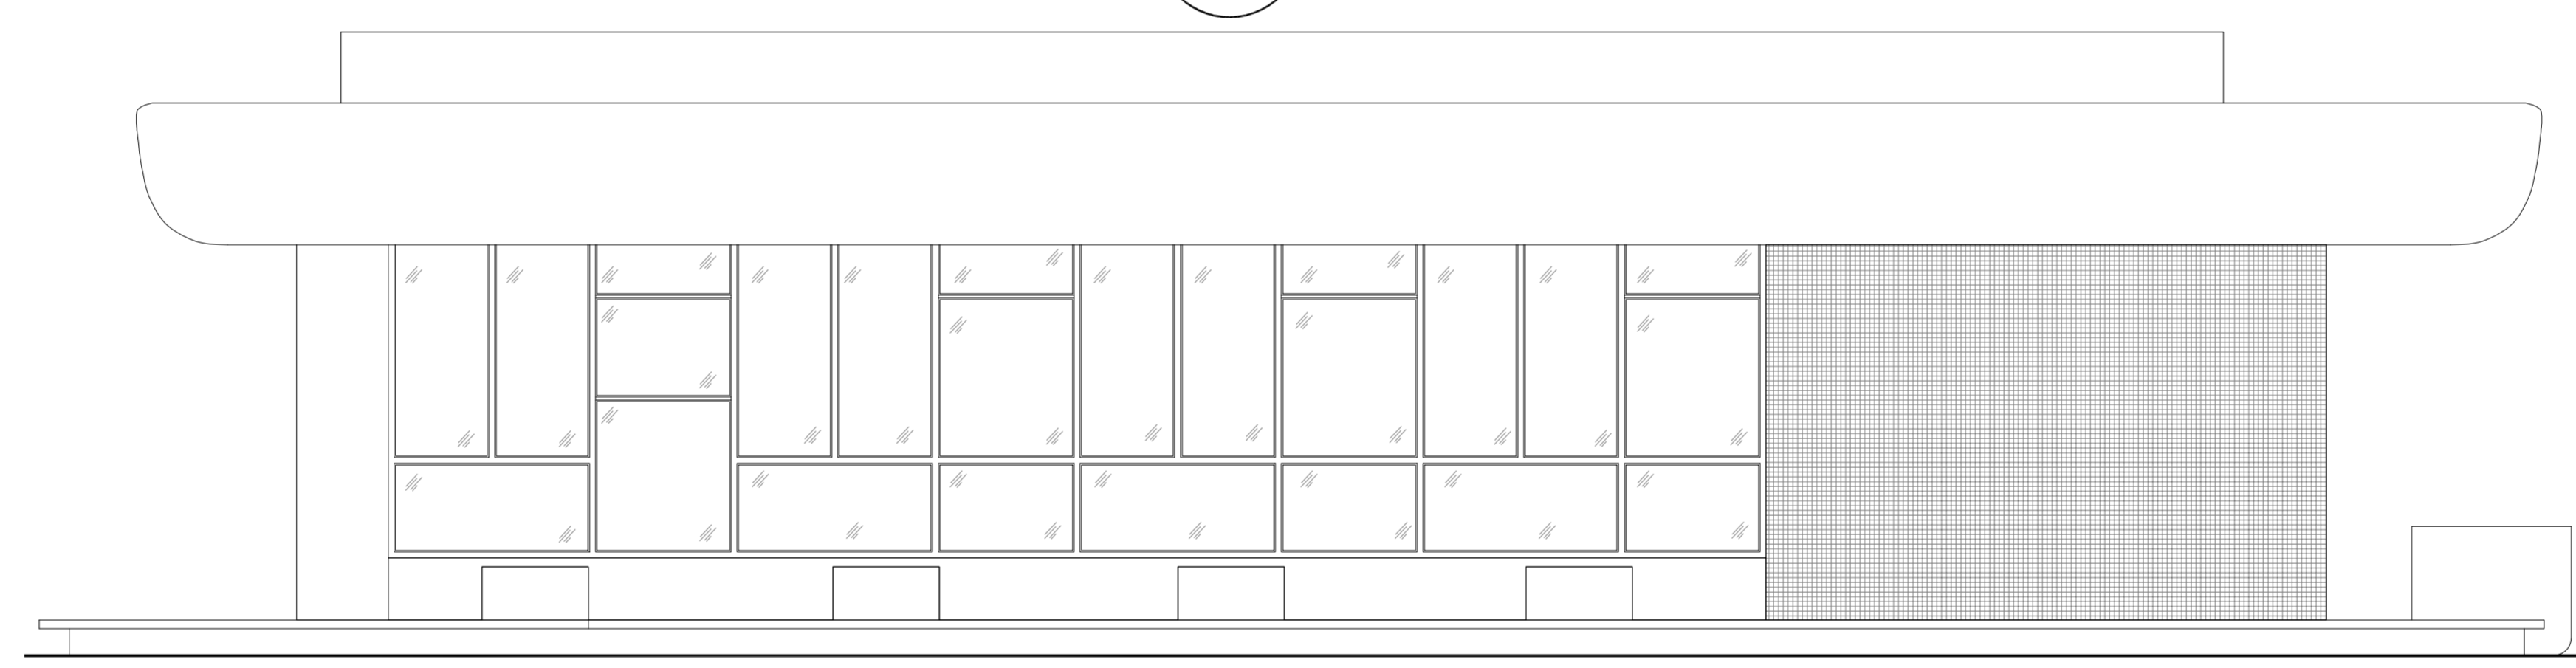
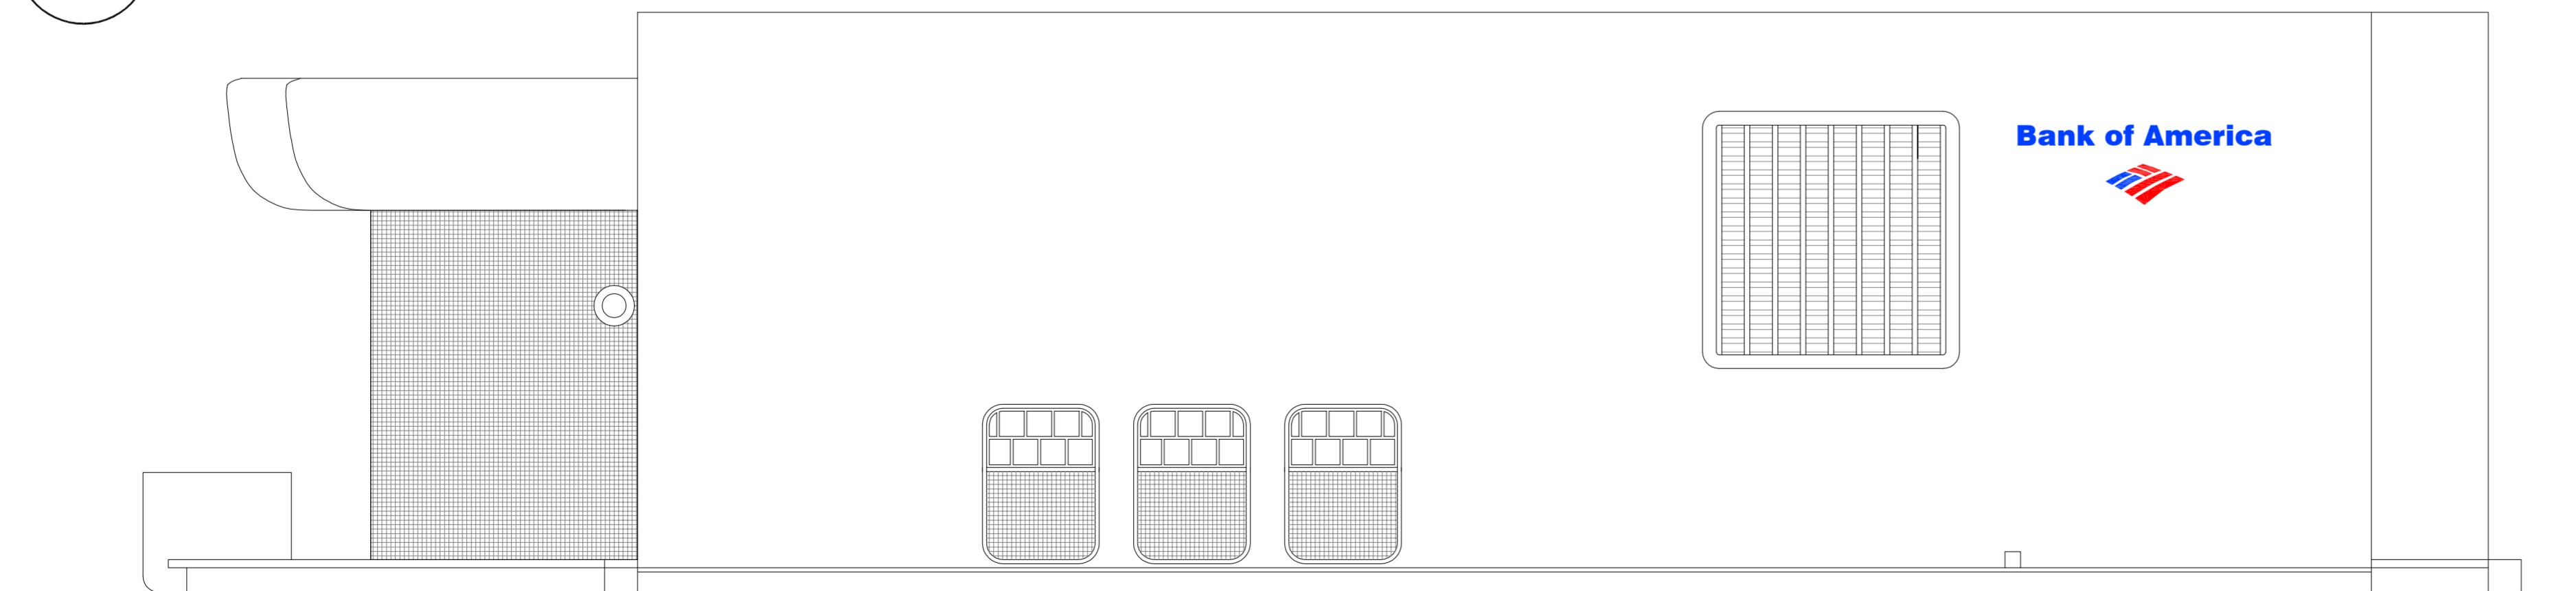
1 NORTH ELEVATION: EXSTNG - FOR REFERENCE
 EL(E)-1 SCALE: 1" = 8'-0"

2 SOUTH ELEVATION: EXSTNG - FOR REFERENCE
 EL(E)-1 SCALE: 1" = 8'-0"

3 WEST ELEVATION: EXSTNG - FOR REFERENCE
 EL(E)-1 SCALE: 1" = 8'-0"

4 EAST ELEVATION: EXSTNG - FOR REFERENCE
 EL(E)-1 SCALE: 1" = 8'-0"

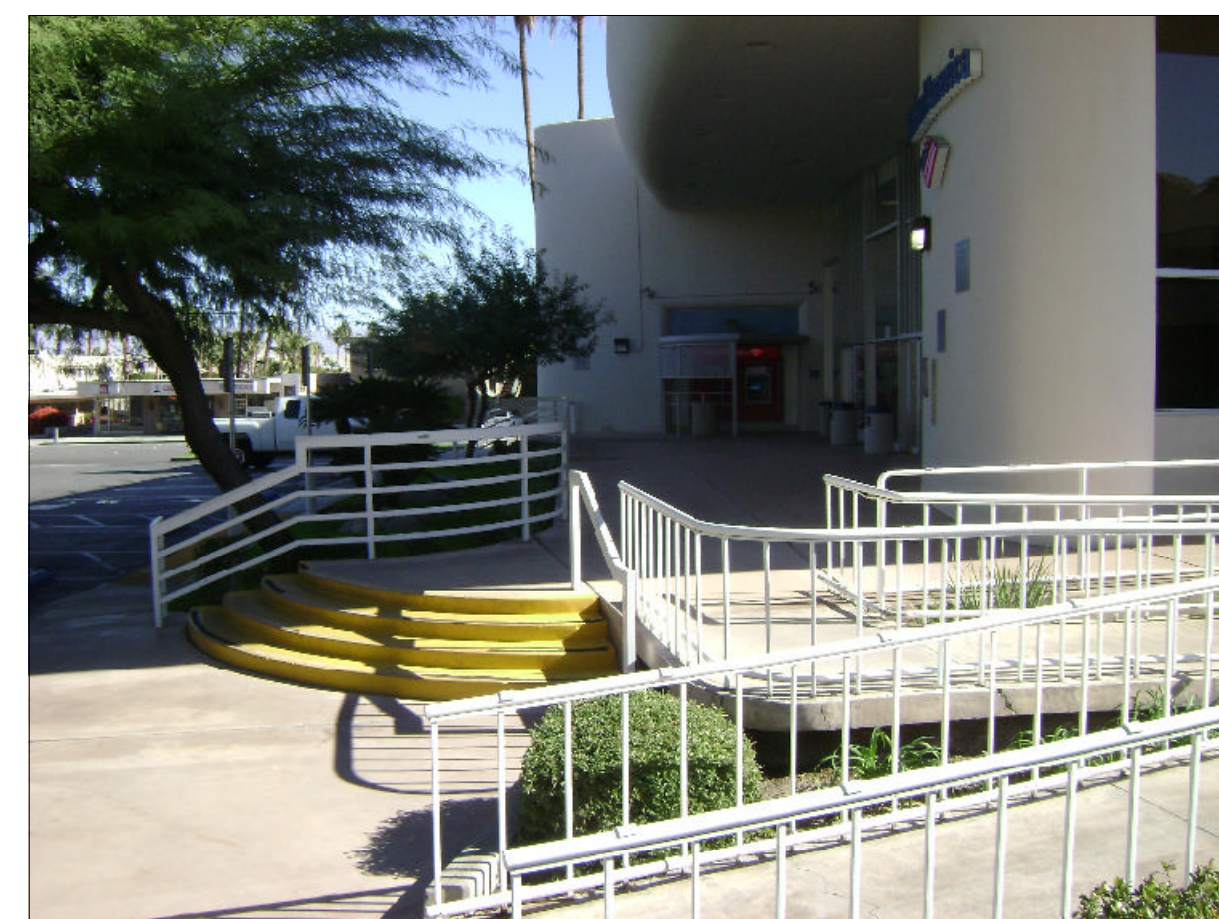
VIEW OF EXISTING RAMP

10. **Exterior Disabled Pedestrian Ramp:** Replacement existing pedestrian ramp and railing with conforming construction. Ramp concrete finish to match existing colored concrete finish, and new railing color to be white. Note: Replacement Ramp and Railing under separate building permit.

- 10. EXTERIOR DISABLED PEDESTRIAN RAMP: REPLACEMENT EXISTING PEDESTRIAN RAMP AND RAILING WITH CONFORMING CONSTRUCTION. RAMP CONCRETE FINISH TO MATCH EXISTING COLORED CONCRETE FINISH, AND RAILING COLOR TO BE WHITE. NOTE: REPLACEMENT RAMP AND RAILING UNDER SEPARATE BUILDING PERMIT.

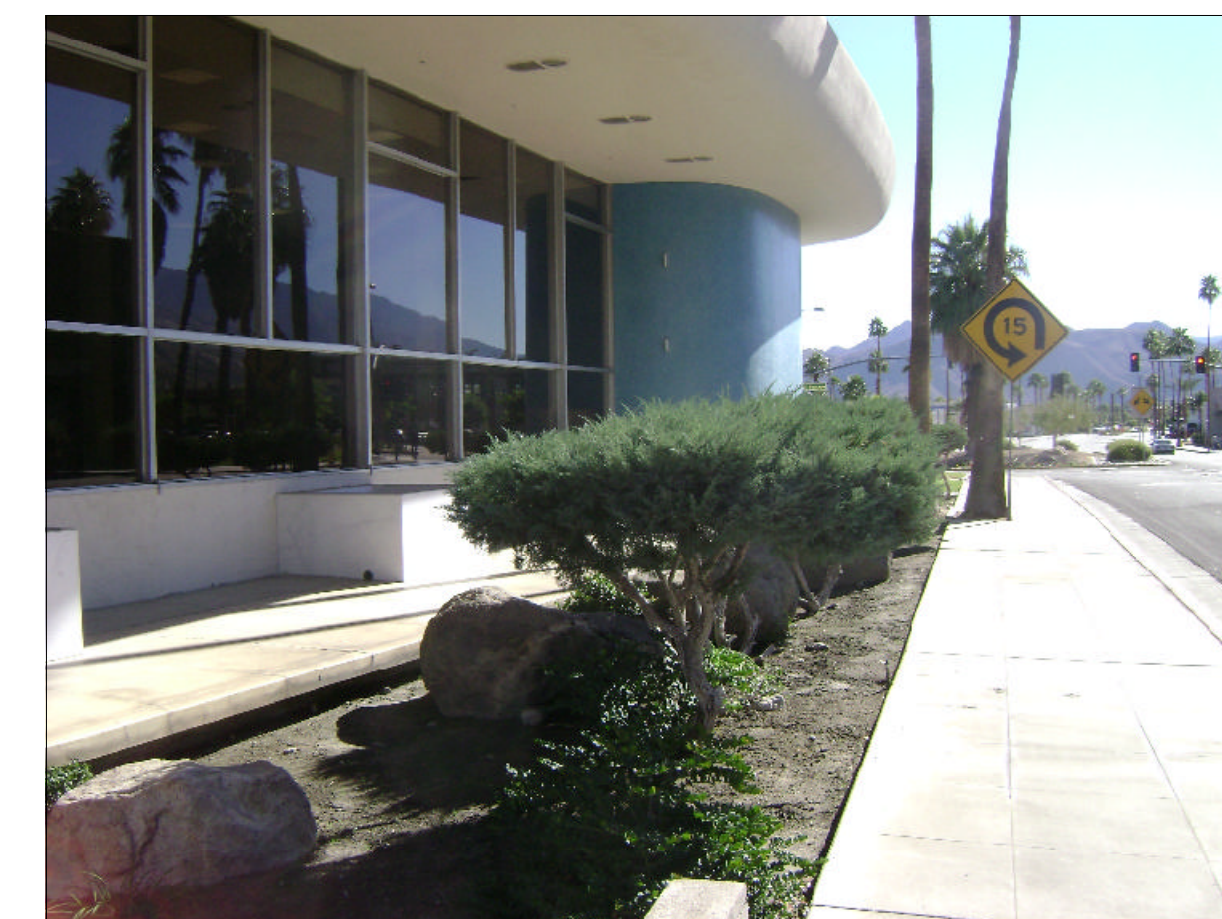
3. *Deteriorated planters along the west façade; missing marble veneer, etc.)*

VIEW OF PLANTER BOXES

Replace missing marble veneer on planter box and re-landscape / replant.

4. **Existing Exterior Planter Box:** Provide marble fascia at planter box that is missing marble fascia.
5. **Existing Exterior Blue Wall Tile:** Clean existing blue tile.

- 4. EXISTING EXTERIOR PLANTER BOX: PROVIDE MARBLE FASCIA AT PLANTER BOX THAT IS MISSING MARBLE FASCIA.
- 5. EXISTING EXTERIOR BLUE WALL TILE: CLEAN EXISTING BLUE TILE.
