## HISTORIC SITE PRESERVATION BOARD STAFF REPORT

A CERTIFICATE OF APPROVAL REQUEST BY BANK OF AMERICA FOR ADA UPGRADES AND EXTERIOR REHABILITATION AT THE

CITY NATIONAL BANK BUILDING, A CLASS 1 HISTORIC SITE LOCATED AT 588 SOUTH PALM CANYON DRIVE, ZONE C-1 (HSPB

Palm Springs Main - Exterior Repairs Schematic Design Documents Date: April 24, 2014

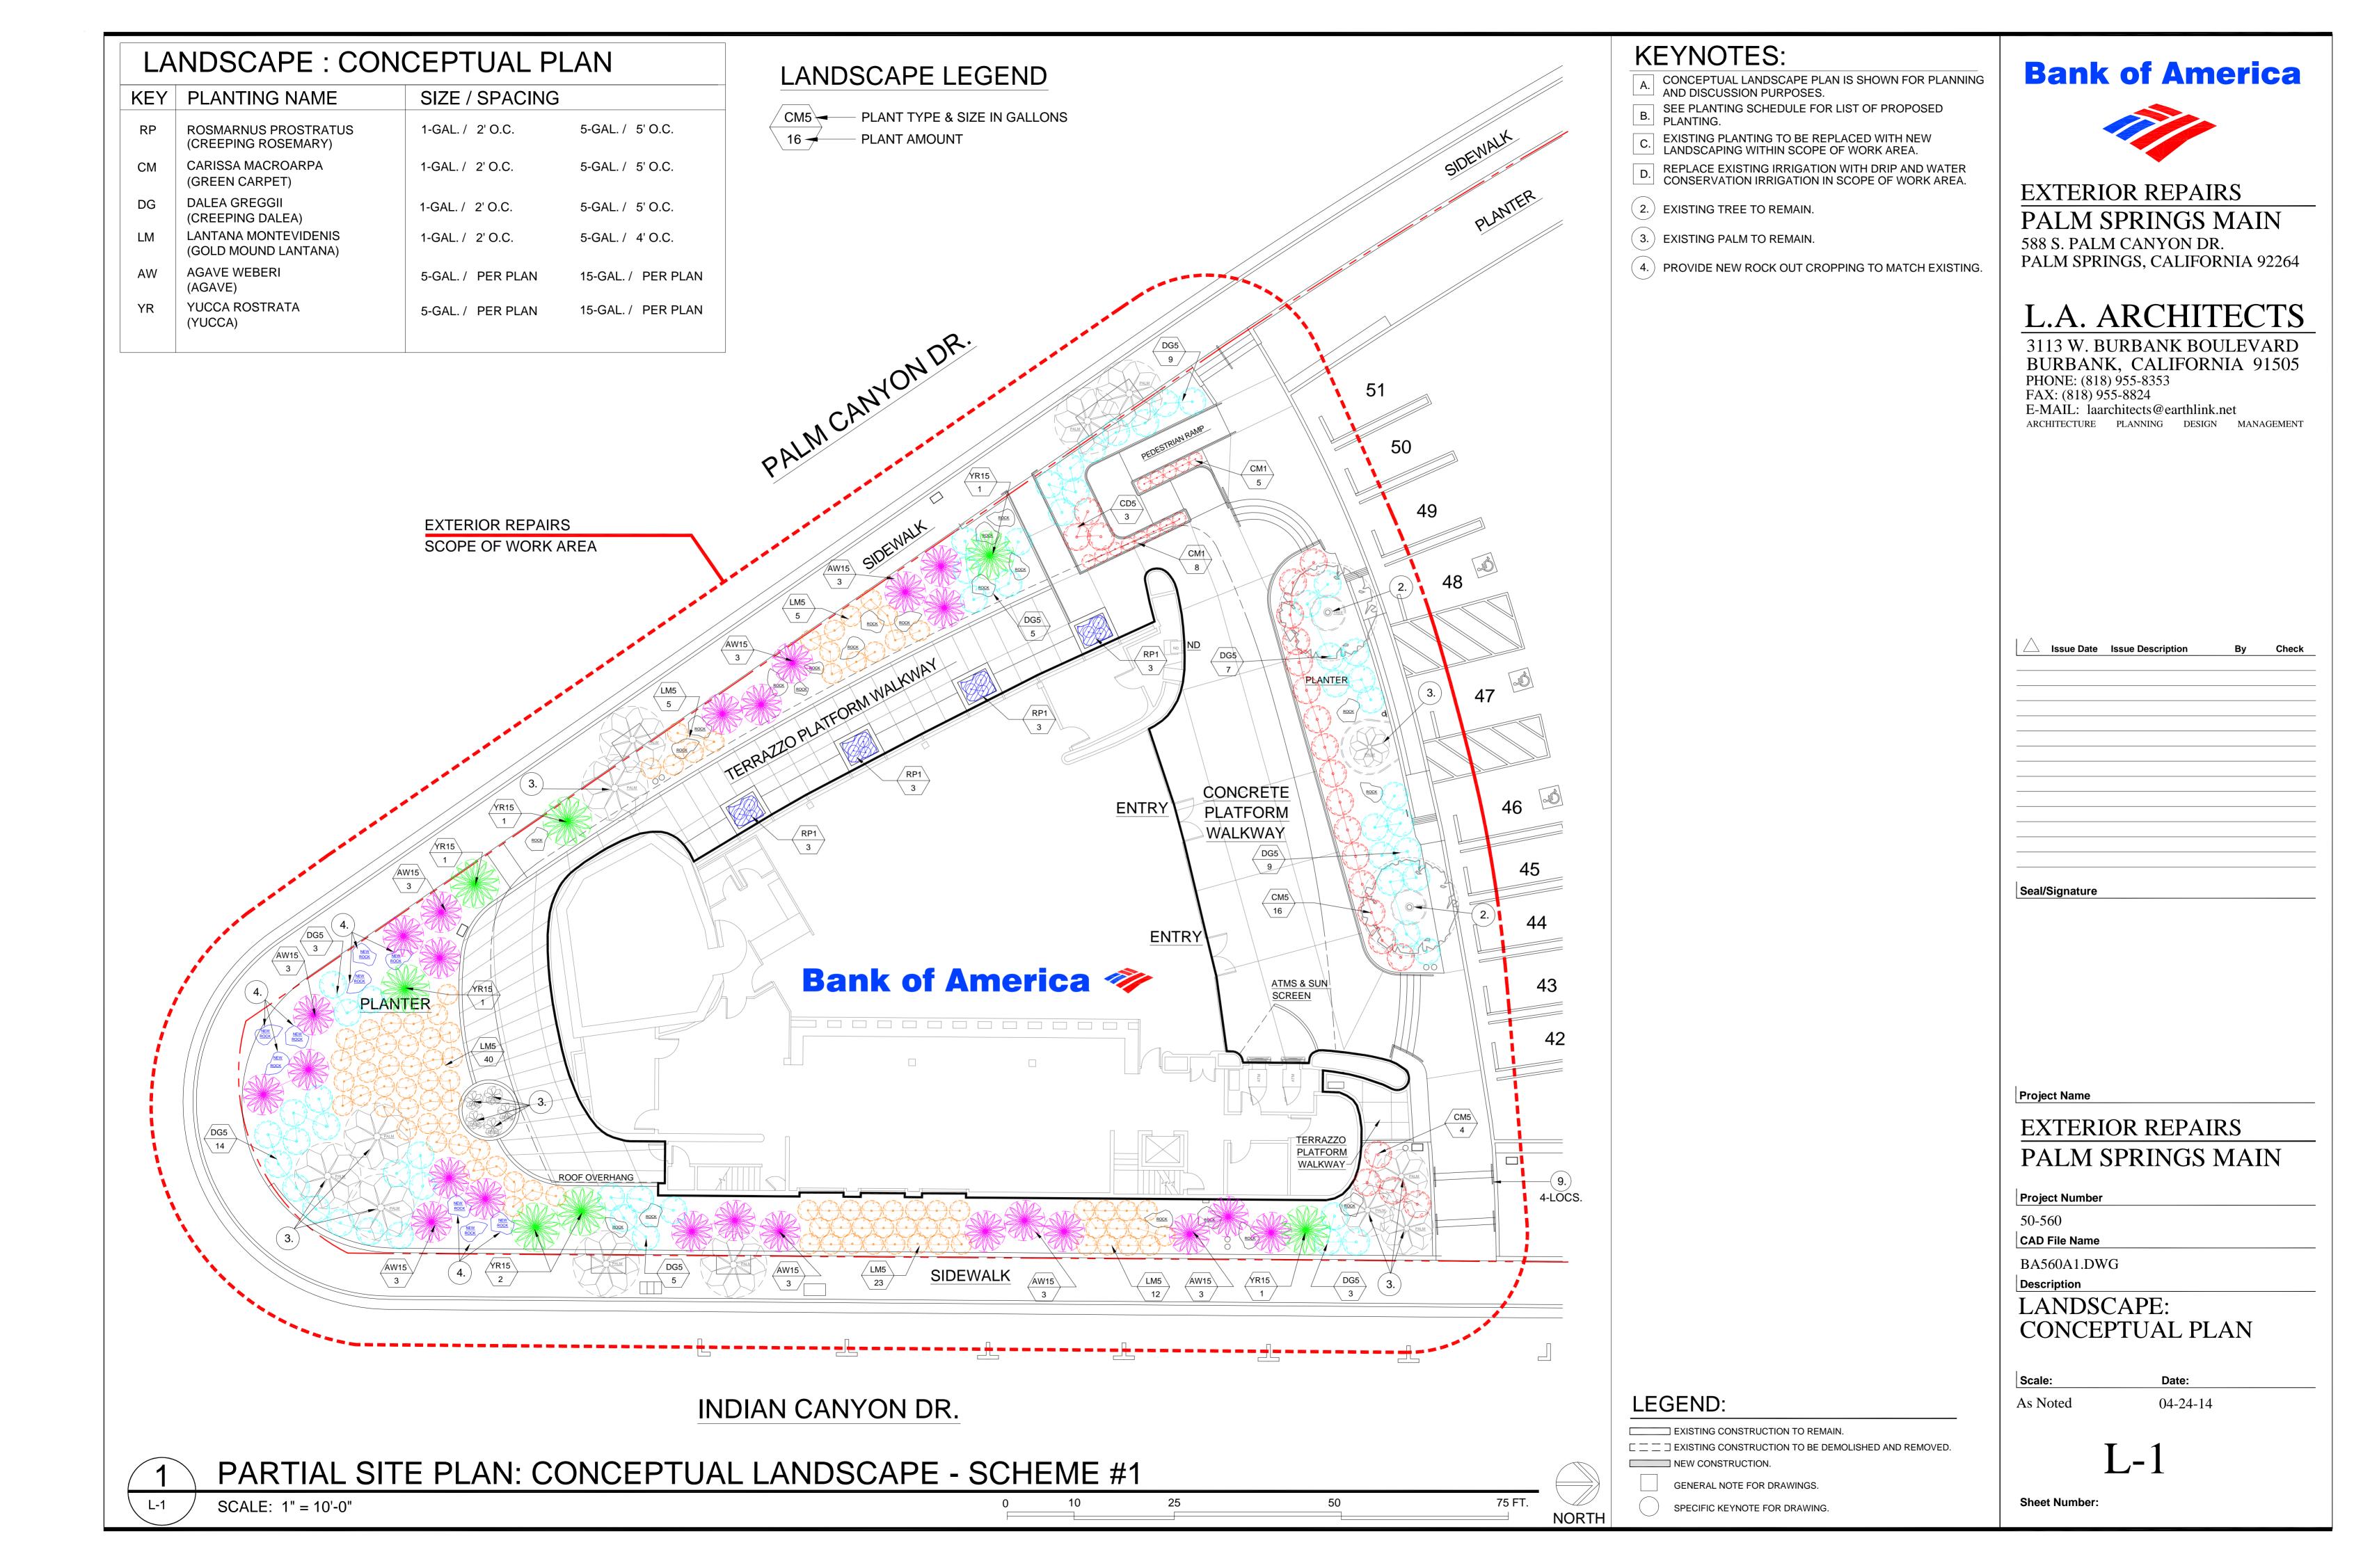
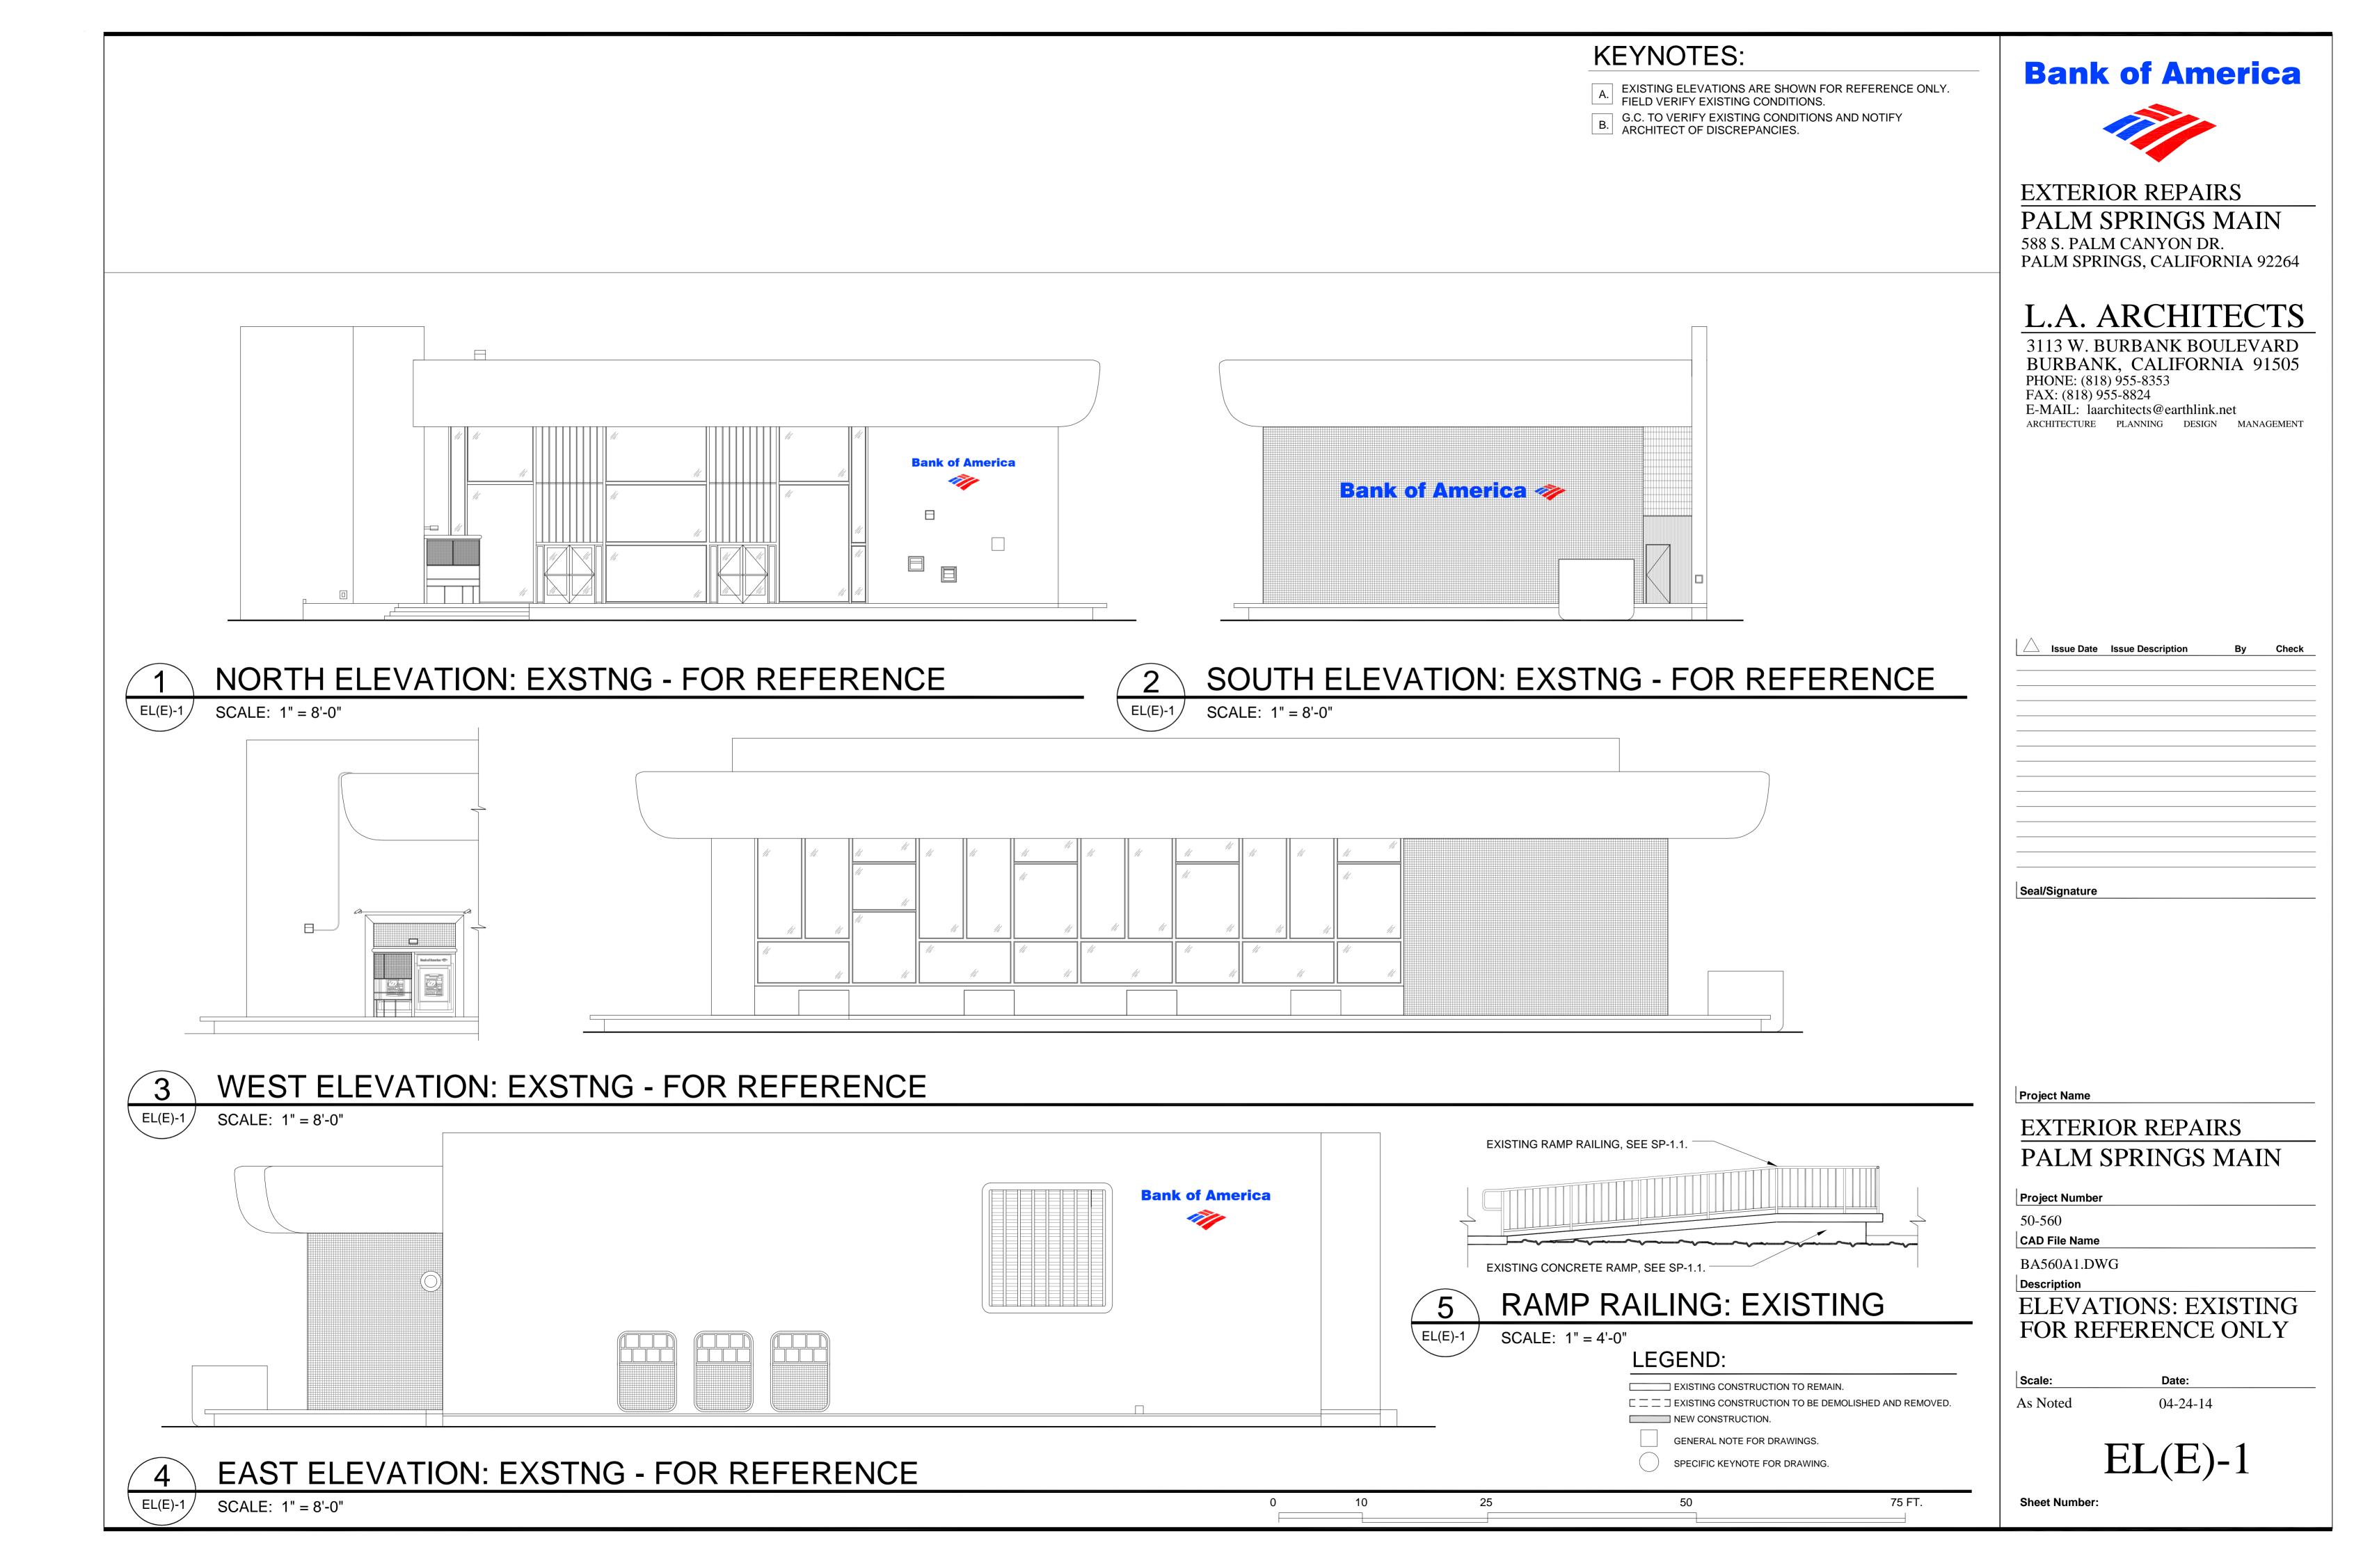
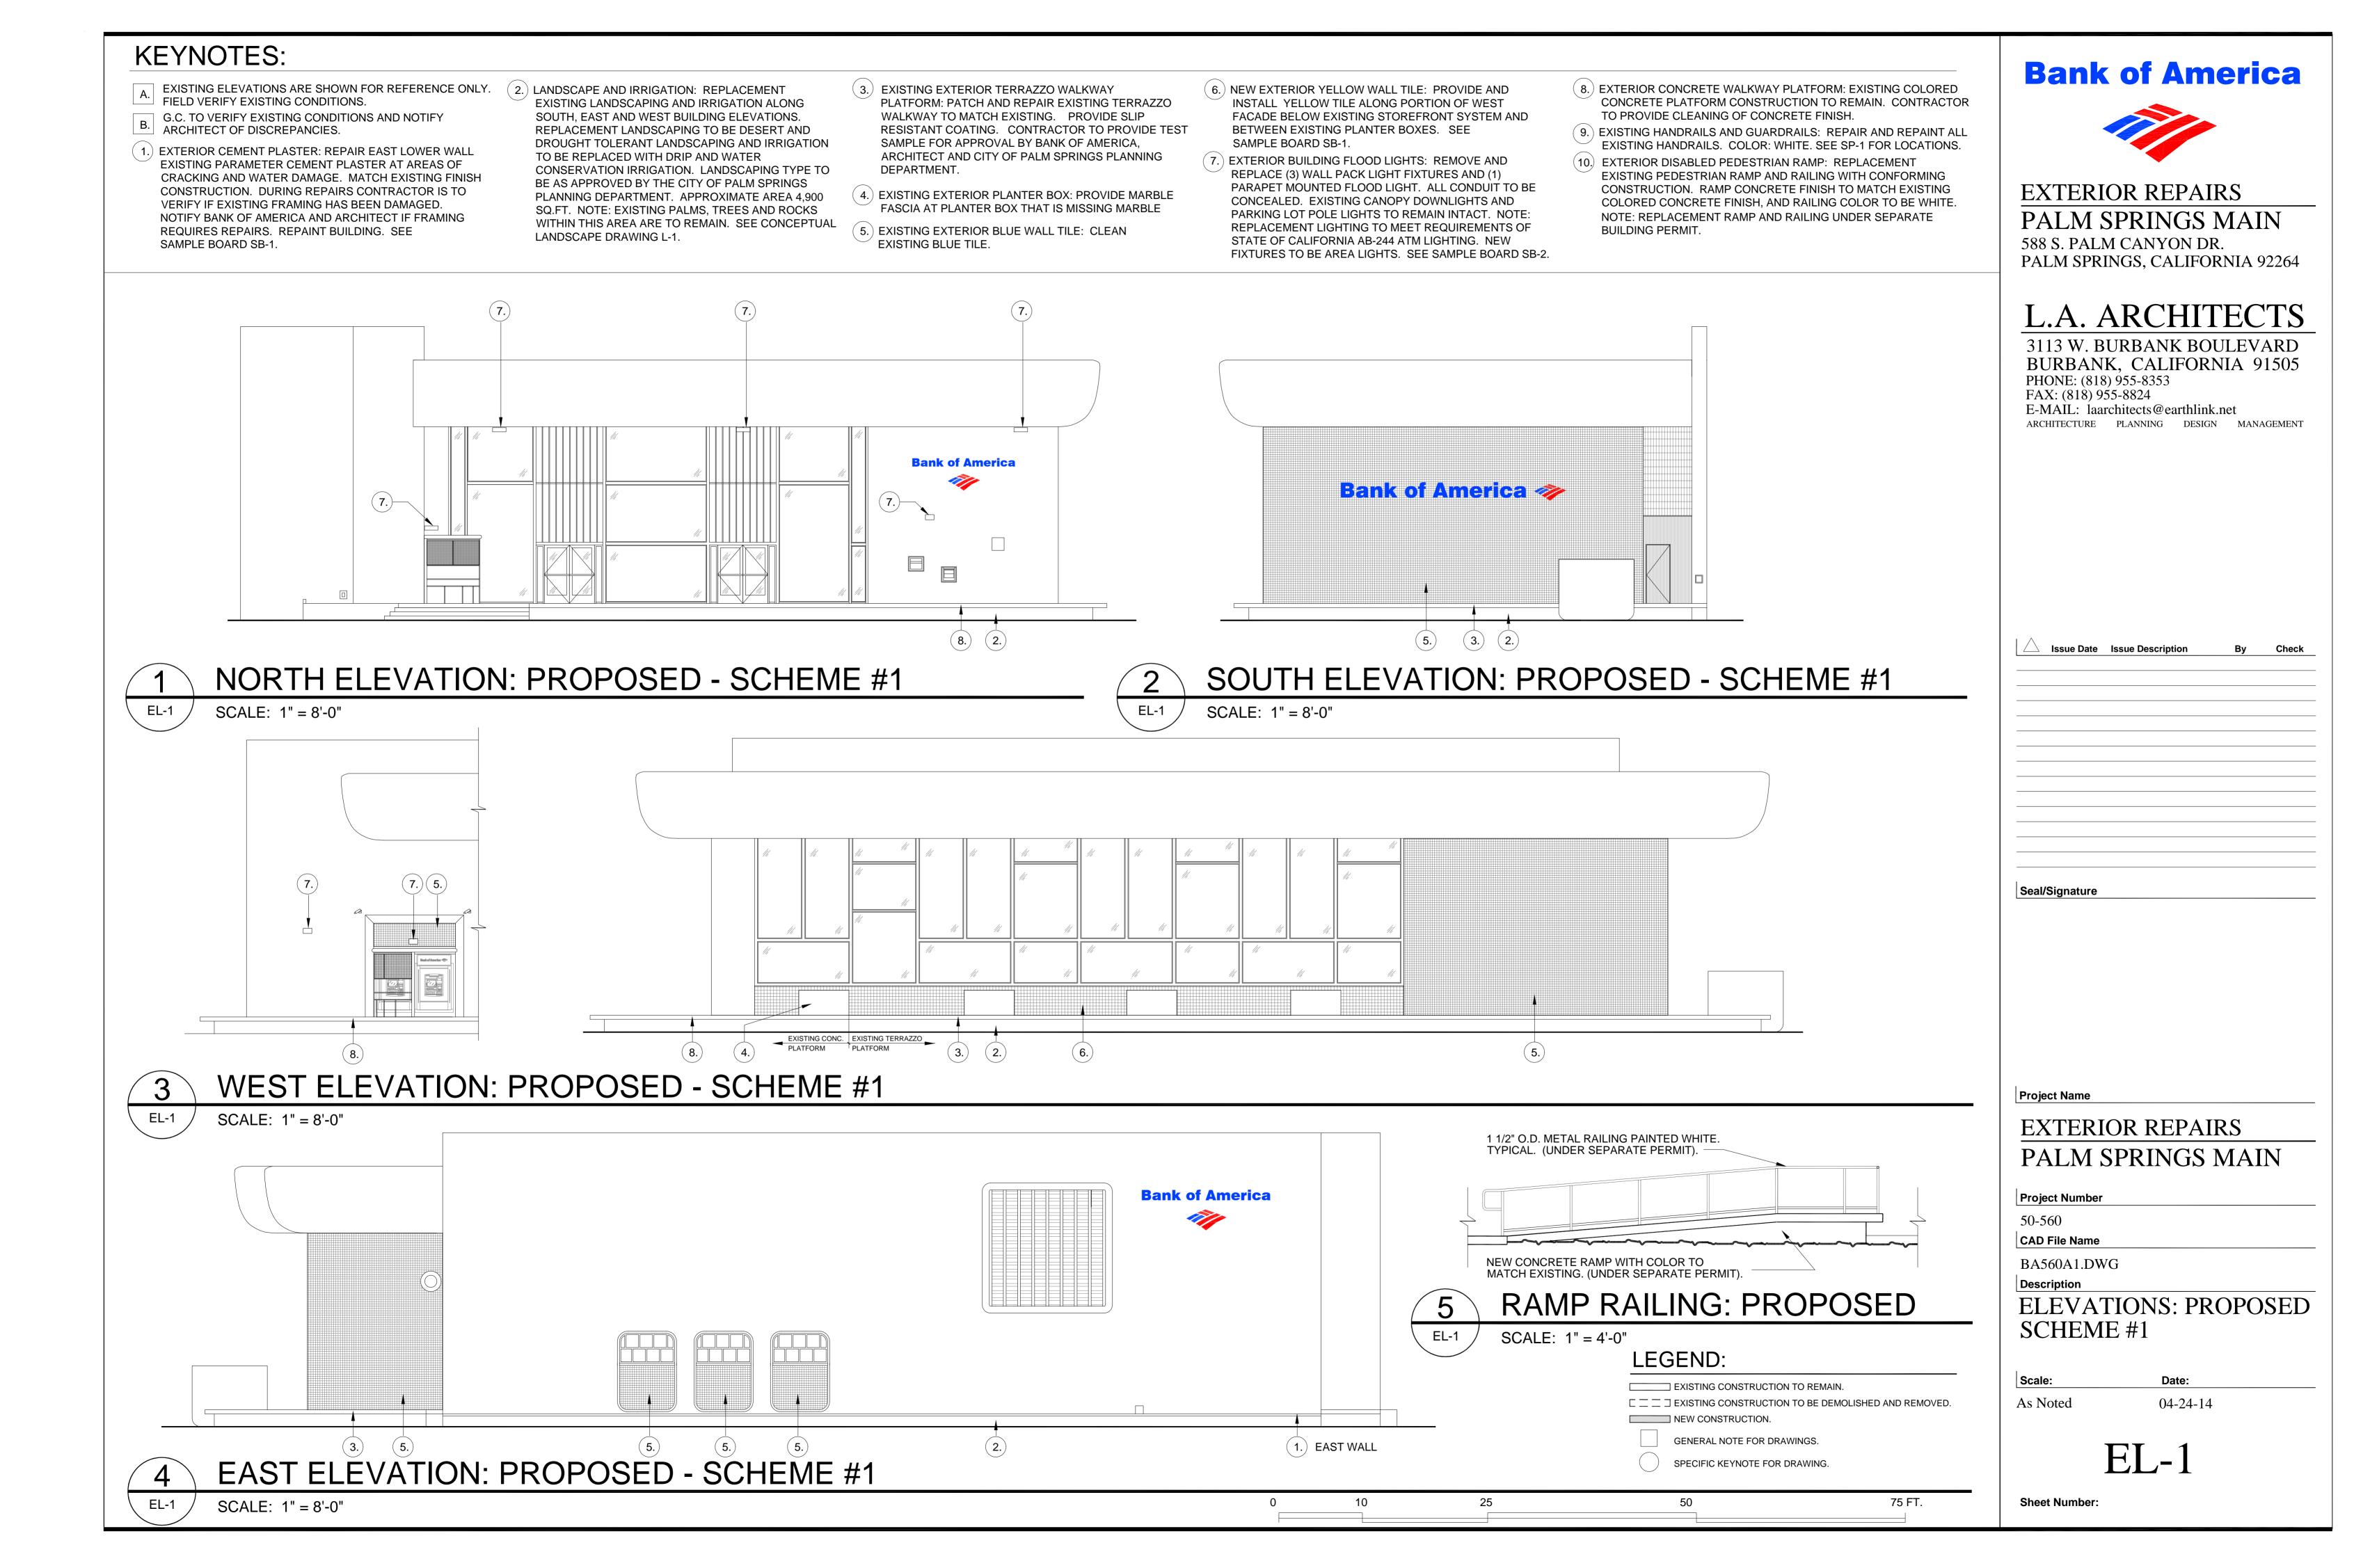
50-560 **CAD File Name** BA560A1.DWG Description PARTIAL SITE: PROPOSED SCHEME #1

- C. EXISTING DISABLED PARKING SHOWN FOR REFERENCE.
- ( 1.) EXTERIOR CEMENT PLASTER: REPAIR EAST LOWER WALL EXISTING PARAMETER CEMENT PLASTER AT AREAS OF CRACKING AND WATER DAMAGE. MATCH EXISTING FINISH CONSTRUCTION. DURING REPAIRS CONTRACTOR IS TO VERIFY IF EXISTING FRAMING HAS BEEN DAMAGED. NOTIFY BANK OF AMERICA AND ARCHITECT IF FRAMING REQUIRES REPAIRS. REPAINT BUILDING. SEE SAMPLE BOARD SB-1.

- 2.) LANDSCAPE AND IRRIGATION: REPLACEMENT EXISTING LANDSCAPING AND IRRIGATION ALONG SOUTH, EAST AND WEST BUILDING ELEVATIONS. REPLACEMENT LANDSCAPING TO BE DESERT AND DROUGHT TOLERANT LANDSCAPING AND IRRIGATION TO BE REPLACED WITH DRIP AND WATER CONSERVATION IRRIGATION. LANDSCAPING TYPE TO BE AS APPROVED BY THE CITY OF PALM SPRINGS PLANNING DEPARTMENT. APPROXIMATE AREA 4,900 SQ.FT. NOTE: EXISTING PALMS, TREES AND ROCKS WITHIN THIS AREA ARE TO REMAIN. SEE CONCEPTUAL LANDSCAPE DRAWING L-1.

- (3.) EXISTING EXTERIOR TERRAZZO WALKWAY PLATFORM: PATCH AND REPAIR EXISTING TERRAZZO WALKWAY TO MATCH EXISTING. PROVIDE SLIP RESISTANT COATING. CONTRACTOR TO PROVIDE TEST SAMPLE FOR APPROVAL BY BANK OF AMERICA, ARCHITECT AND CITY OF PALM SPRINGS PLANNING DEPARTMENT.

- (4.) EXISTING EXTERIOR PLANTER BOX: PROVIDE MARBLE FASCIA AT PLANTER BOX THAT IS MISSING MARBLE
- (5.) EXISTING EXTERIOR BLUE WALL TILE: CLEAN EXISTING BLUE TILE.

- (6.) NEW EXTERIOR YELLOW WALL TILE: PROVIDE AND INSTALL YELLOW TILE ALONG PORTION OF WEST FAÇADE BELOW EXISTING STOREFRONT SYSTEM AND BETWEEN EXISTING PLANTER BOXES. SEE SAMPLE BOARD SB-1.

- (7.) EXTERIOR BUILDING FLOOD LIGHTS: REMOVE AND REPLACE (3) WALL PACK LIGHT FIXTURES AND (1) PARAPET MOUNTED FLOOD LIGHT. ALL CONDUIT TO BE CONCEALED. EXISTING CANOPY DOWNLIGHTS AND PARKING LOT POLE LIGHTS TO REMAIN INTACT. NOTE: REPLACEMENT LIGHTING TO MEET REQUIREMENTS OF STATE OF CALIFORNIA AB-244 ATM LIGHTING. NEW FIXTURES TO BE AREA LIGHTS. SEE SAMPLE BOARD SB-2.

- (8.) EXTERIOR CONCRETE WALKWAY PLATFORM: CONSTRUCTION TO REMAIN. CONTRACTOR TO PROVIDE CLEANING OF CONCRETE FINISH.
- (9.) EXISTING HANDRAILS AND GUARDRAILS: REPAIR AND REPAINT ALL EXISTING HANDRAILS. COLOR:

- (10.) EXTERIOR DISABLED PEDESTRIAN RAMP SEPARATE BUILDING PERMIT. SEE SHEET EL-1 FOR ADDITIONAL INFOMATION.

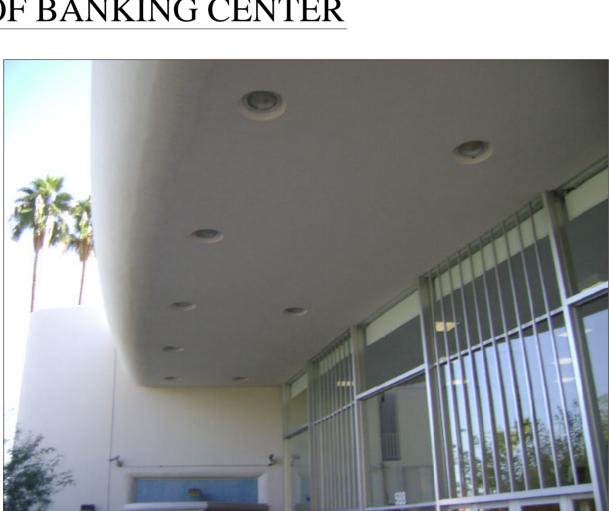
VIEW OF SOFFIT

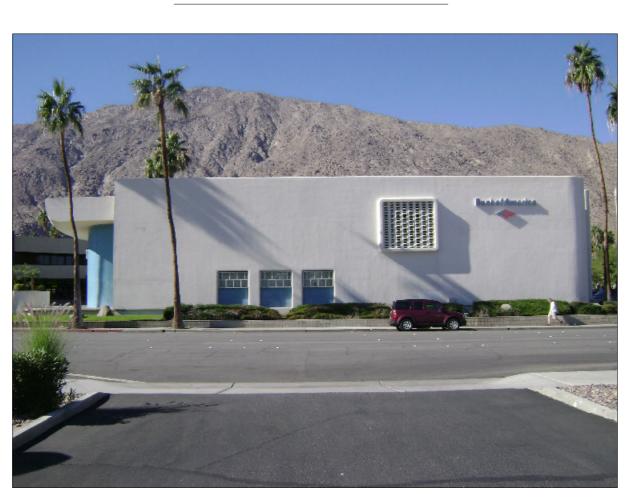
VIEW OF WEST OF BANK

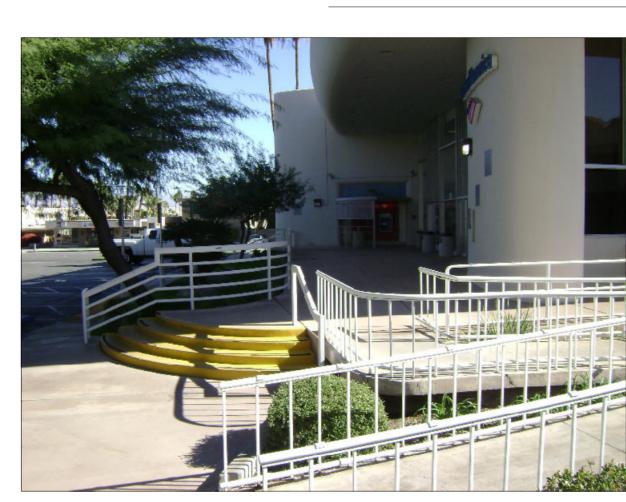
VIEW OF EXISTING RAMP

Lastly, the bank will remove and replace the existing ADA ramp at the northwest corner of the building with a new ADA ramp to comply with updated regulations. When the current ADA ramp was installed the bank replaced the terrazzo on the entry porch with pigmented concrete which is not in keeping with the original materials or appearance. Staff discussed with representatives of the bank the possible removal of pigmented concrete and restoration of the terrazzo, but at this time, it is not economically feasible and continued concerns about slipping on this surface led to the bank's decision to retain the concrete. This decision diminishes somewhat the architectural integrity of the site, however the concrete porch existed at the time of historic designation and retaining it does not diminish the integrity any further than it was at the time of designation. Staff believes this is a reasonable decision, given the circumstances.

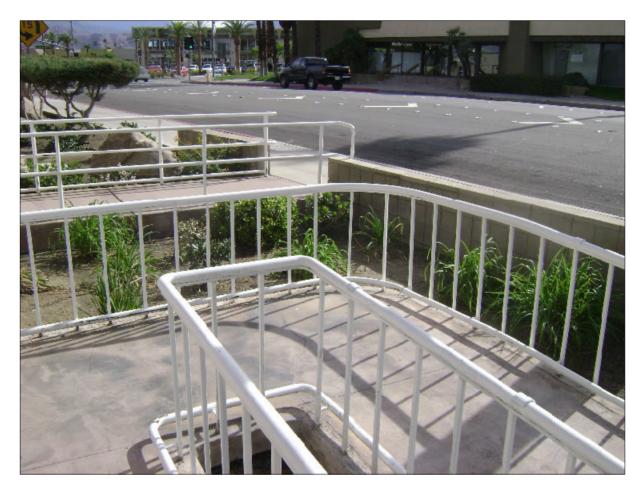
VIEW OF EXISTING RAMP

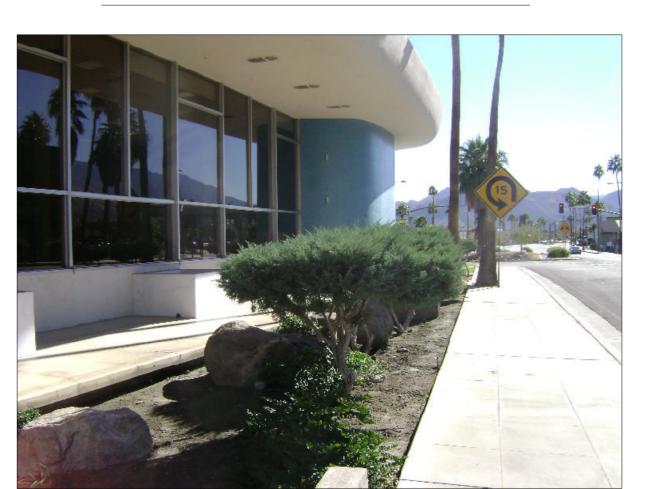
VIEW OF PLANTER BOXES

3. Deteriorated planters along the west façade; missing marble veneer, etc.)

The bank will replace the missing marble fascia on the planter box and replanted with creeping rosemary.
