HISTORIC SITE PRESERVATION BOARD STAFF REPORT

SUBJECT: A CERTIFICATE OF APPROVAL REQUEST BY THE CITY OF PALM SPRINGS FOR STABILIZATION AND REHABILITATION OF THE EXTERIOR OF THE CORNELIA WHITE HOUSE, A CLASS 1 HISTORIC SITE LOCATED AT THE VILLAGE GREEN PARK (221 SOUTH PALM CANYON DRIVE) HSPB #4, (ZONE CBD) AND A CATEGORICAL EXEMPTION PURSUANT TO CEQA.

TO Ken Lyon @ City of PS Planning
VIA email
FROM Reuel Young
PROJECT IDC No. 1311.3
SUBJECT Alternative approach to CWH

TO Ken Lyon
VIA email
FROM Reuel Young
PROJECT IDC No. 1311.4
SUBJECT Log repair

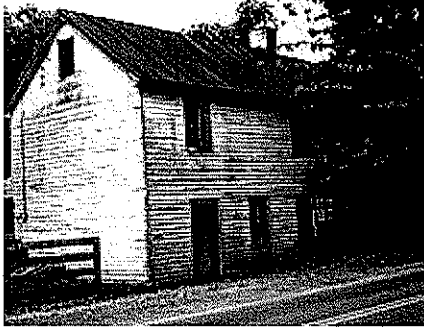
Unlike western log cabins, 18th and 19th century log houses in the eastern part of the U.S. were almost always covered with siding or stucco. Photo: NPS files.

A distinction should be drawn between the traditional meanings of "log cabin" and "log house." "Log cabin" generally denotes a simple one, or one-and-one-half story structure, somewhat impermanent, and less finished or less architecturally sophisticated. A "log cabin" was usually constructed with round rather than hewn, or hand-worked, logs, and it was the first generation homestead erected quickly for frontier shelter. "Log house" historically denotes a more permanent, hewn-log dwelling, either one or two stories, of more complex design, often built as a second generation replacement. Many of the earliest 18th and early 19th century log houses were traditionally clad, sooner or later, with wood siding or stucco.

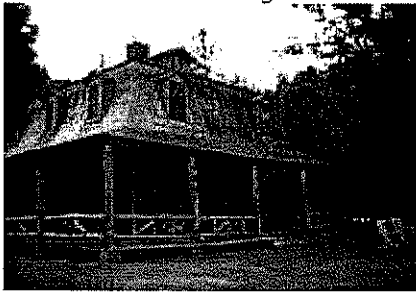
This lodge constructed of logs in the 1880s is an example of the Adirondack style of rustic camp architecture. Photo: NPS files.

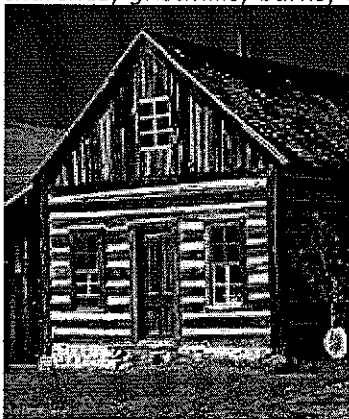
The entrance door centered in the gable end in this late-19th century log building is a typical feature of the Rocky Mountain Cabin style. Photo: NPS files.

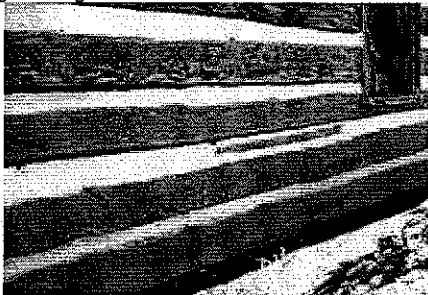
The new sill matches the original and is a compatible replacement. Photo: NPS files.

Repairing or replacing only a segment of a log is not always possible. Replacement of an entire log may be the only solution if it has been substantially lost to decay and collapsed under the weight of logs above it. Log replacement, which should be carried out only by experienced craftspersons, is begun by temporarily supporting the logs above, and then jacking them up just enough to insert the new log. Potential danger to the structure may include creating inadequate temporary bearing points, and crushing chinking and interior finishes which may have settled slowly into non-original positions that cannot withstand jacking.

To begin the process of log replacement, the entire length of the log must be inspected from the exterior and the interior of the structure to determine whether it supports any structural members or features, and how their load can be taken up by bracing during jacking and removal. On the exterior, sheathing such as weatherboard, and adjacent chinking, must be removed along the length of the log to perform this inspection. Likewise, on the interior, abutting partition walls and plaster may also need to be removed around the log to determine what, if any, features are supported by or tied into the log to be removed. A replacement log should be obtained to match the wood species of the original being removed. If it is a hewn log, then the replacement must be hewn to replicate the dimensions and tool marks of the original. If the same wood species cannot be obtained in the original dimensions, a substitute species may have to be used, and may even be preferable in some instances if a more durable wood can be found than the original wood species. It should, however, be chosen to match the visual characteristics of the original species as closely as possible.
