Accessibility Survey

City of Palm Springs Demuth Park

4365 Mesquite Avenue
Palm Springs, CA 92264

Date of Inspection
9/28/2012

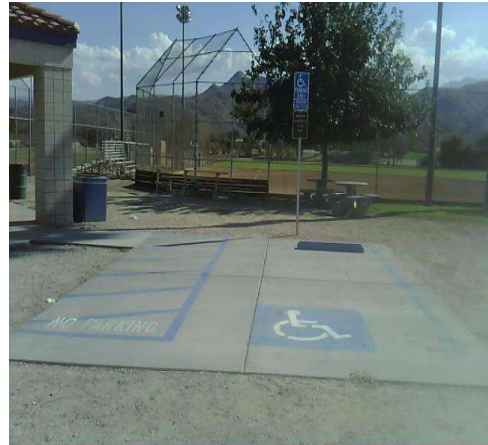
**Parking Lot Next To Baseball Fields #7 And 8
Accessible Space**

Parking Lot , Parking Space : No Van Accessible Signage

There is no additional signage marked "van accessible" at the van accessible parking space.

On-Site Finding None Found

Van accessible parking spaces shall provide additional signage that states "van accessible" .

Install post mounted sign \$250

Code Reference ADA 502, 502.6

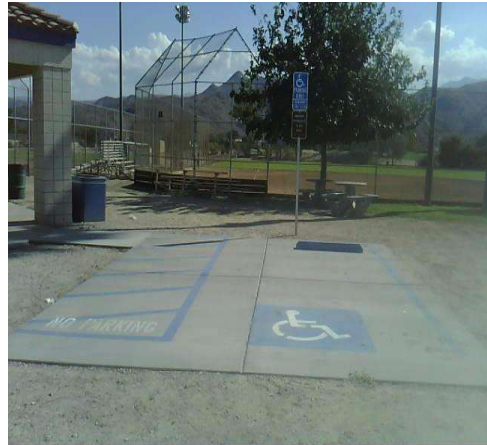
**Parking Lot Next To Baseball Fields #7 And 8
Accessible Space**

Parking Lot , Parking Space : Access Aisle Width

The access aisle does not meet the minimum required width.

On-Site Finding 57.00 inches

Recommendation At least 96.00 inches

Code Reference ADA 208, 502.2

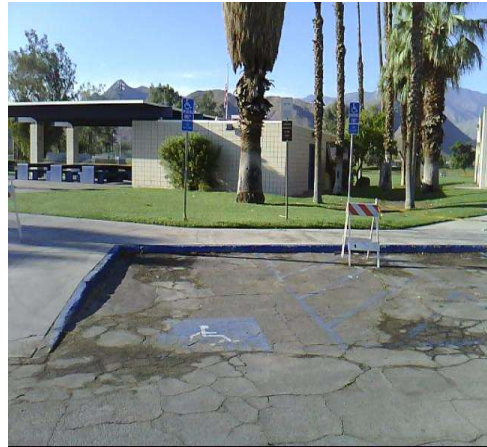
Parking Lot , Parking Space : Outline is Faded, Damaged or Missing

The accessible parking space outline is faded, damaged, missing or otherwise not viewable.

On-Site Finding Faded or Damaged

Code Reference ADA 502, 502.2,CA 11B-502.2

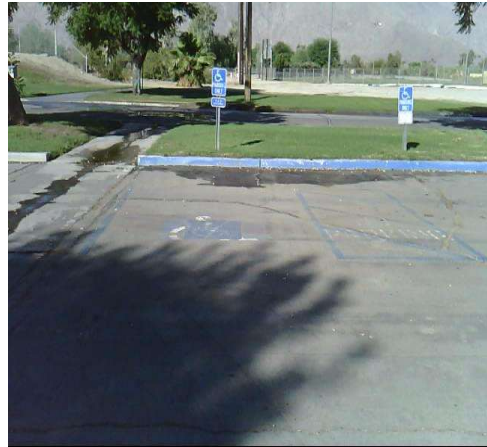
The accessible parking space outline is faded, damaged, missing or otherwise not viewable.

On-Site Finding Faded or Damaged

Stripe an access aisle at the head of the accessible parking spaces, install a wheel stop at the head of the accessible parking spaces and at the general parking spaces. Wheel stops shall be used to prevent vehicles from encroaching into access aisles or walkways, but shall not present additional encroachment into those areas.

Install crosswalk \$1,100

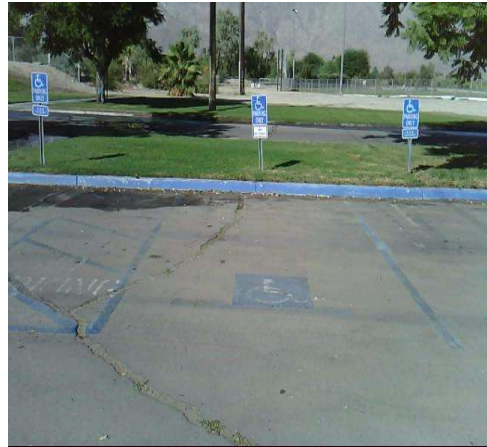
The accessible parking space outline is faded, damaged, missing or otherwise not viewable.

On-Site Finding Faded or Damaged

Stripe an access aisle at the head of the accessible parking spaces, install a wheel stop at the head of the accessible parking spaces and at the general parking spaces. Wheel stops shall be used to prevent vehicles from encroaching into access aisles or walkways, but shall not present additional encroachment into those areas.

Install crosswalk \$1,100

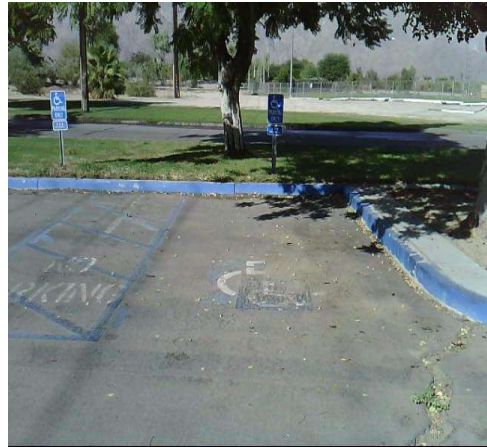
The accessible parking space outline is faded, damaged, missing or otherwise not viewable.

On-Site Finding Faded or Damaged

Stripe an access aisle at the head of the accessible parking spaces, install a wheel stop at the head of the accessible parking spaces and at the general parking spaces. Wheel stops shall be used to prevent vehicles from encroaching into access aisles or walkways, but shall not present additional encroachment into those areas.

Install crosswalk \$1,100

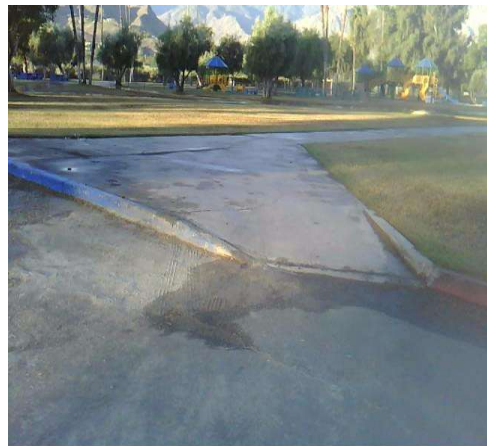
Curb Ramps - Exterior : Curb Ramp

On-Site Finding None Found

Recommendation

Recommendation See Recommendation

Code Reference CA 11B-406.5.11

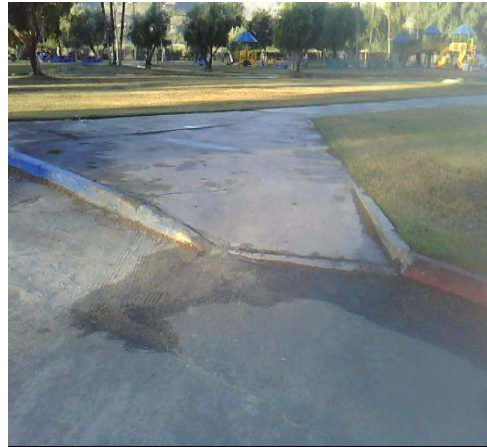
Path Of Travel From Accessible Parking To Multi-Use Fields

Path of Travel - Exterior : Path Of Travel , Walking Surfaces

On-Site Finding Curb Found

Recommendation

Recommendation See Recommendation

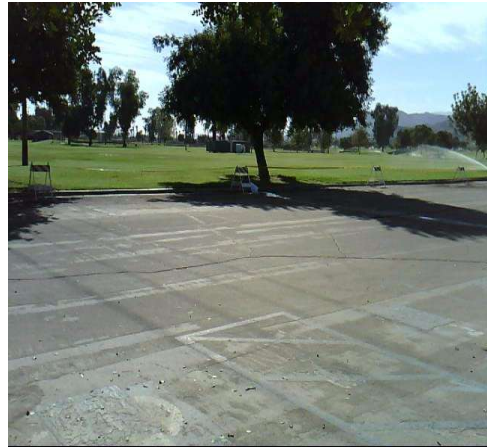
**Path Of Travel From Accessible Parking To Multi-Use Fields
Vehicular Traffic**

Path of Travel - Exterior : Path Of Travel , Vehicular Traffic

On-Site Finding None Found

Recommendation

Recommendation See Recommendation

Code Reference ADA 705, 406.5, 406.6

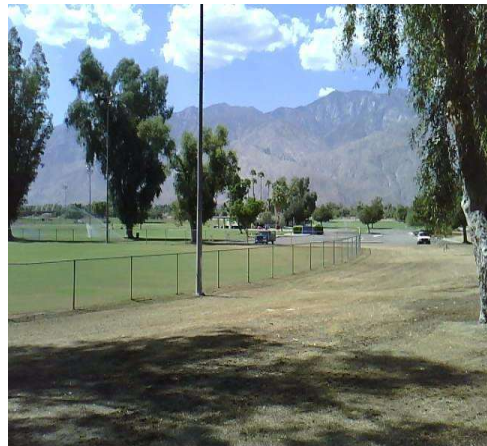
Path of Travel - Exterior : Path Of Travel , Walking Surfaces

Recommendation

Recommendation Up to 0.25 inches

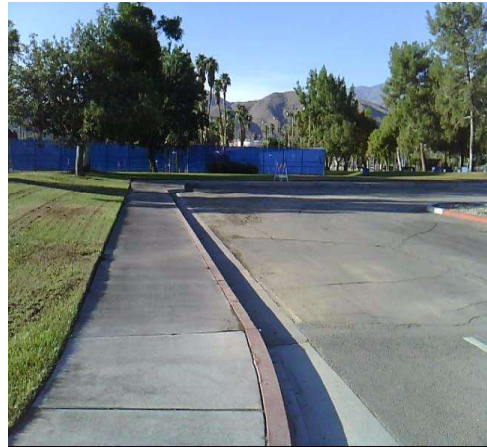
**Path Of Travel To Baseball Fields #1, 2, 3, 4
Open Area**

Path of Travel - Exterior : Path Of Travel , Walking Surfaces

Recommendation

Recommendation See Recommendation

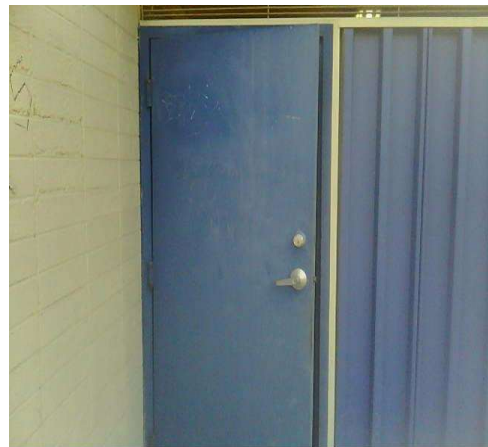
Doors - Restrooms Next To Play Area : Door , Threshold

Recommendation

Modify or replace the threshold to provide the recommended height.

Recommendation Up to 0.50 inches

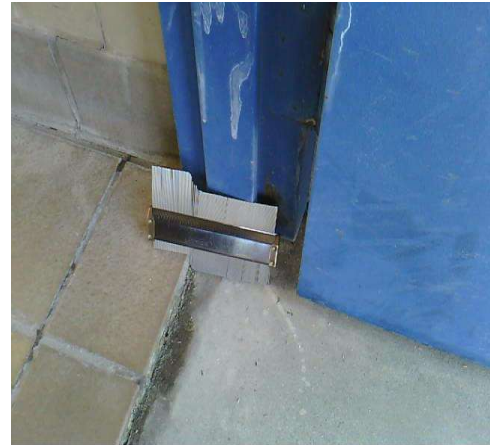
Womens Restroom Next To Play Area

Doors - Restrooms Next To Play Area : Door , Hardware Height

Recommendation

Mount the door hardware at the recommended height.

Recommendation 30.00 - 44.00 inches

Replace door hardware \$280

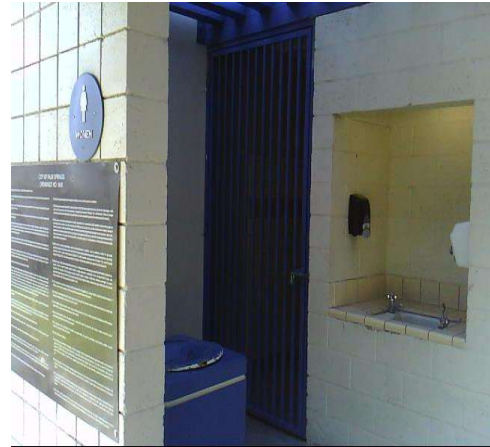
Left Mens Restroom At West Restrooms Next To Baseball Field #1

Notes : Locked at time of inspection.

Recommendation

Recommendation See Recommendation

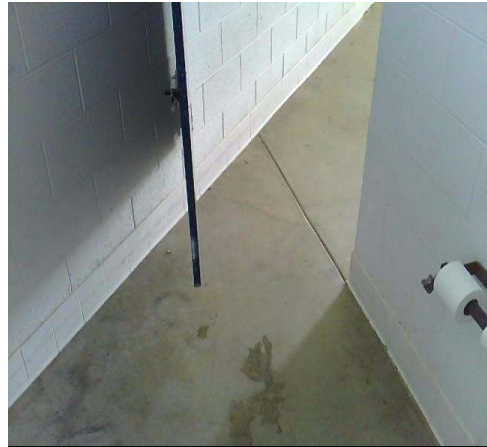
Mens Restroom Next To Baseball Field #7

On-Site Finding None Found

Recommendation

Recommendation At least 54.00 inches

Code Reference ADA 603, 609, 604.5.1,CA
11B-604.5.1,CA 11B-609

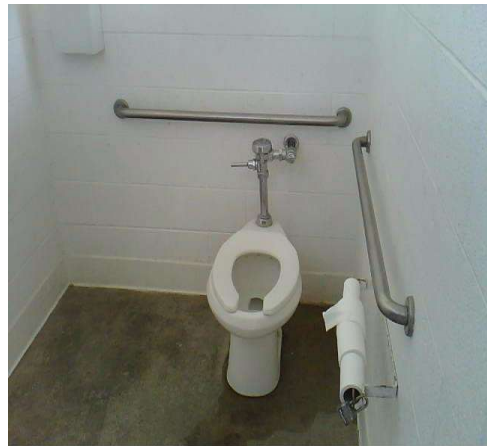
Restrooms - Restroom Building Next To Baseball Fields #7 And 8 : Restroom , Door Signage

On-Site Finding None Found

Recommendation

Recommendation See Recommendation

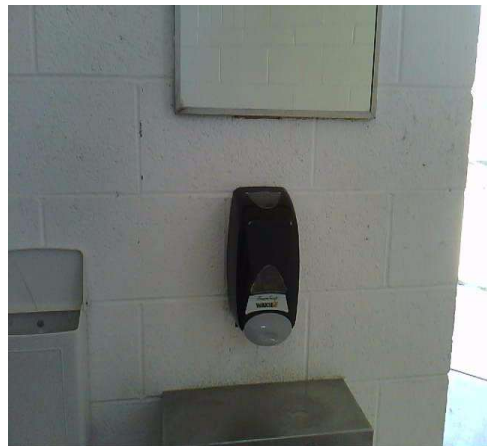
**Restrooms - Restroom Building Next To Baseball Fields #7 And 8 :
Restroom , Wall Signage**

On-Site Finding None Found

Recommendation

Recommendation See Recommendation

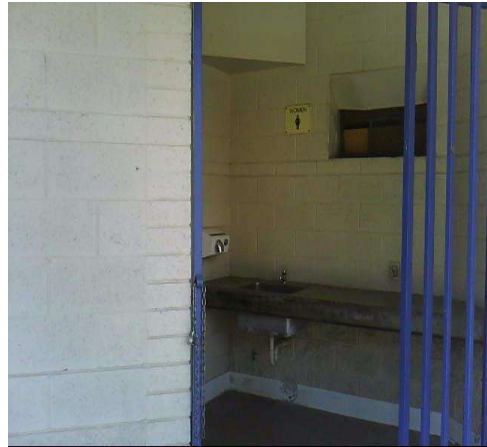
Restrooms - Restrooms Next To Play Area : Restroom , Compartment Door

On-Site Finding Missing Hardware

Recommendation

Recommendation See Recommendation

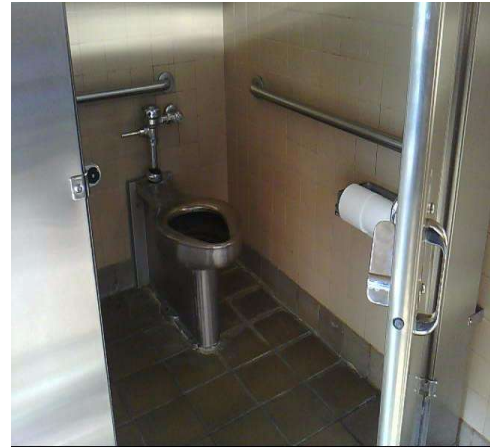
Restrooms - Restrooms Next To Play Area : Restroom

On-Site Finding None Found

Recommendation

Recommendation See Recommendation

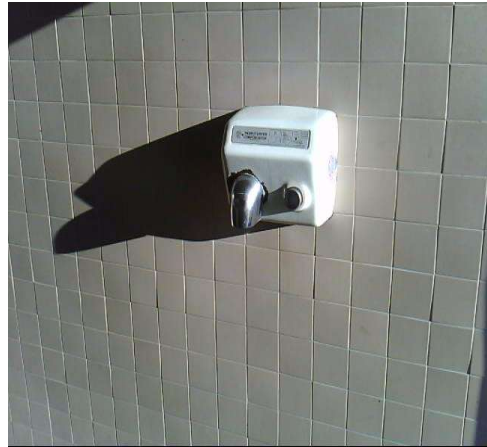
Womens Restroom Next To Play Area

On-Site Finding None Found

Recommendation

Recommendation See Recommendation

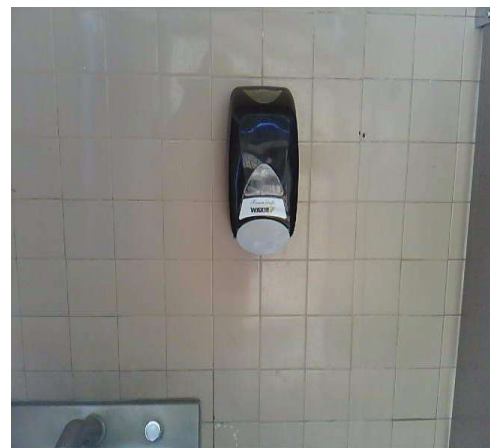
Restrooms - Restrooms Next To Play Area : Restroom , Wall Signage

On-Site Finding None Found

Recommendation

Recommendation See Recommendation

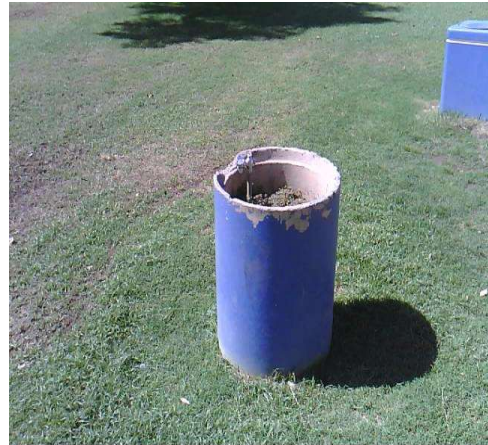
Drinking Fountain At Baseball Field #3

On-Site Finding None Found

Recommendation

Recommendation See Recommendation

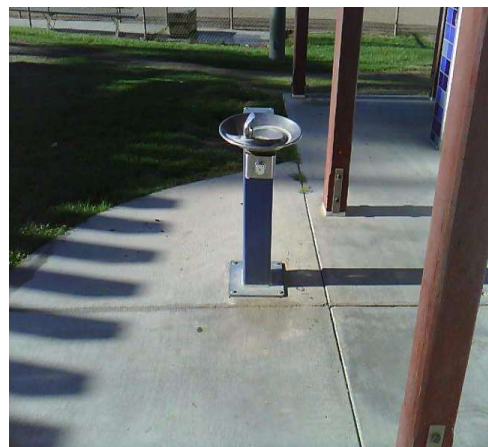
Drinking Fountains - Exterior : Drinking Fountain

On-Site Finding None Found

Recommendation

Recommendation See Recommendation

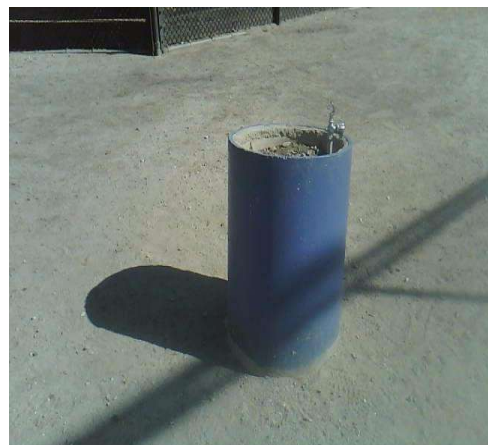
Record Number 19416

Code Reference ADA 211, 602, 602.5,CA 11B-602.5

Recommendation Up to 6.00 inches

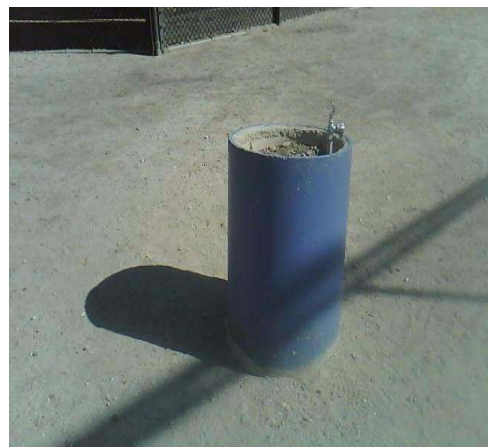
Record Number 19412

Code Reference ADA 309, 205, 211, 602, 309.4, 602.3, CA 11B-309.4, CA 11B-602.3

Replace knob faucets with paddle faucets \$392

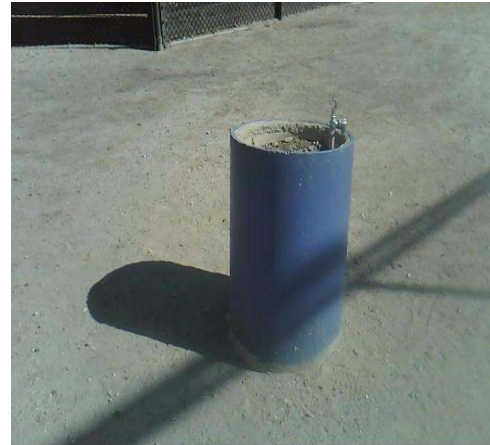
Drinking Fountain Between Baseball Fields # 7 And 8

Code Reference ADA 305, 306, 211, 602, 306.3, 602.2,CA 11B-602.2,CA 11B-305

Recommendation At least 27.00 inches

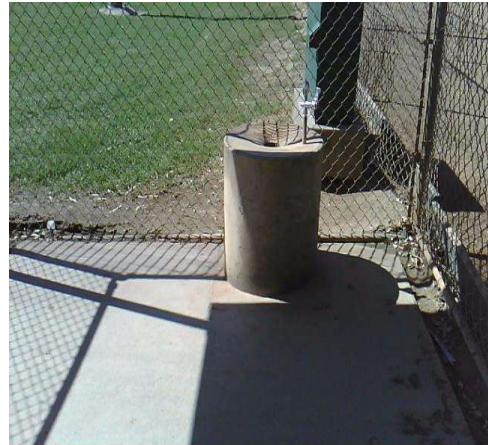
Drinking Fountain In Baseball Field #5 South Duggout

Code Reference ADA 602.6, CA 11B-602.6

Recommendation See Recommendation

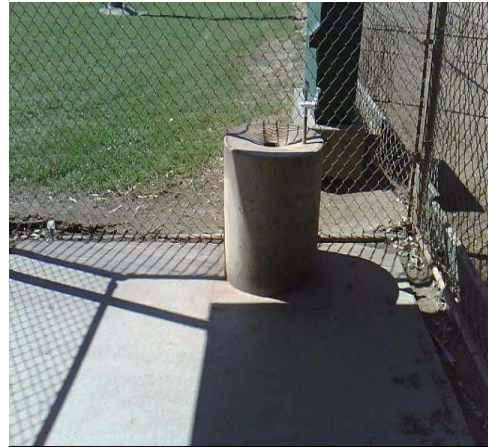
Drinking Fountain In Baseball Field #5 South Duggout

Code Reference ADA 305, 602, 211.2,CA
11B-211.2,CA 11B-602

Replace the drinking fountain with a compliant Hi-Low fountain.

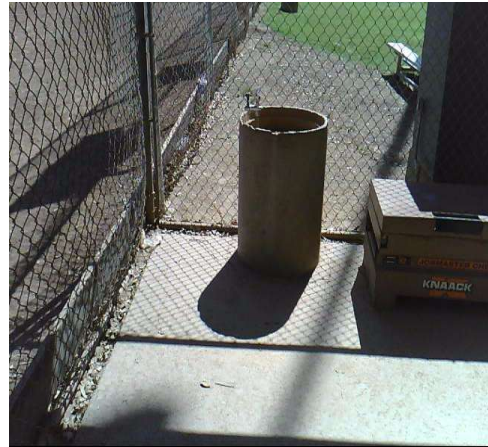
Drinking Fountain In Baseball Field #5 West Duggout

Code Reference ADA 305, 602, 211.2,CA
11B-211.2,CA 11B-602

Replace the drinking fountain with a compliant Hi-Low fountain.

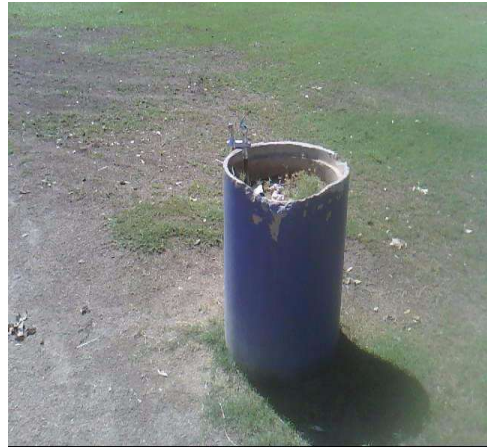
Drinking Fountain Next To Baseball Field #1

Code Reference ADA 211, 602, 602.5,CA 11B-602.5

Recommendation Up to 6.00 inches

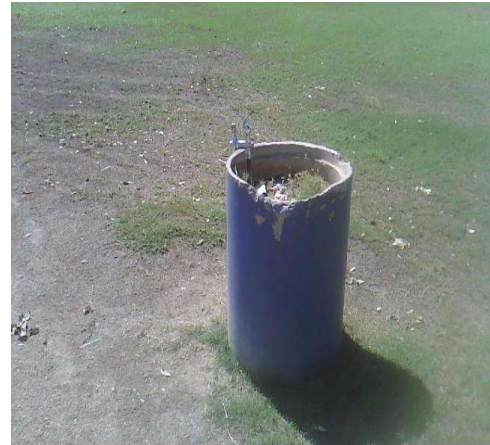
Drinking Fountain Next To Baseball Field #1

Code Reference ADA 309, 205, 211, 602, 309.4, 602.3, CA 11B-309.4, CA 11B-602.3

Replace knob faucets with paddle faucets \$392

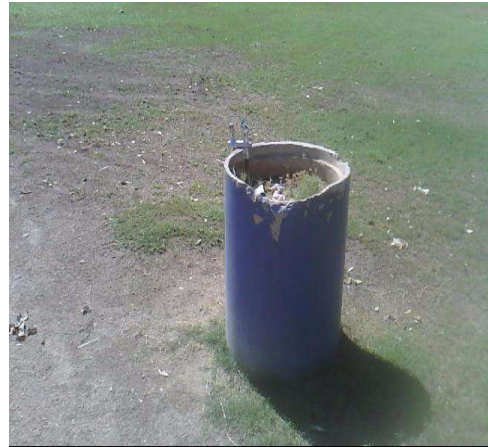
Drinking Fountain Next To Baseball Field #2 South Duggout

Code Reference ADA 305, 306, 211, 602, 306.2, 602.2, CA 11B-602.2, CA 11B-305

Recommendation At least 9.00 inches

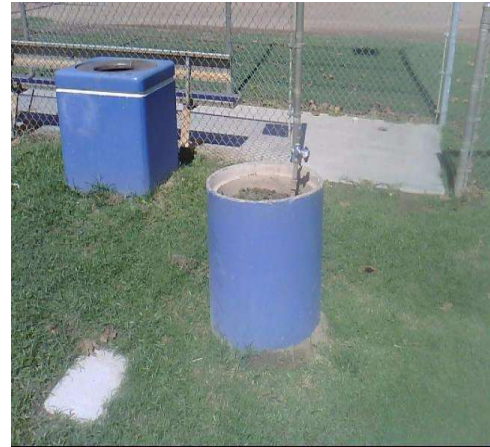
Drinking Fountain Next To Baseball Field #2 South Duggout

Code Reference ADA 211, 602, 602.5,CA 11B-602.5

Recommendation Up to 6.00 inches

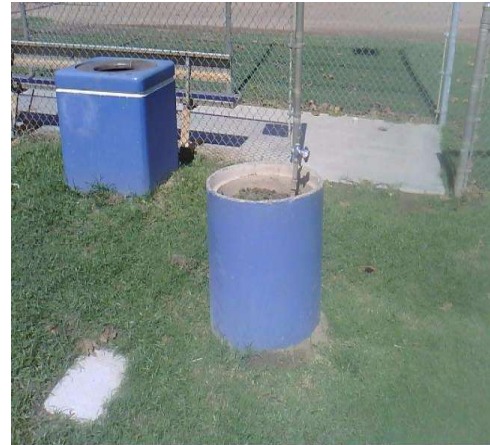
Drinking Fountain Next To Baseball Field #2 South Duggout

Code Reference ADA 309, 205, 211, 602, 309.4, 602.3, CA 11B-309.4, CA 11B-602.3

Replace knob faucets with paddle faucets \$392

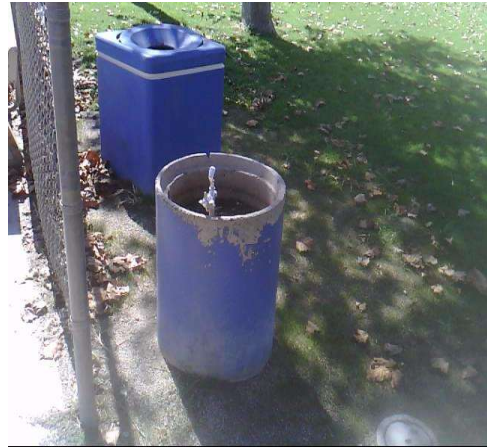
Drinking Fountain Next To Baseball Field #2 West Duggout

Code Reference ADA 305, 306, 211, 602, 306.3, 602.2,CA 11B-602.2,CA 11B-305

Recommendation At least 27.00 inches

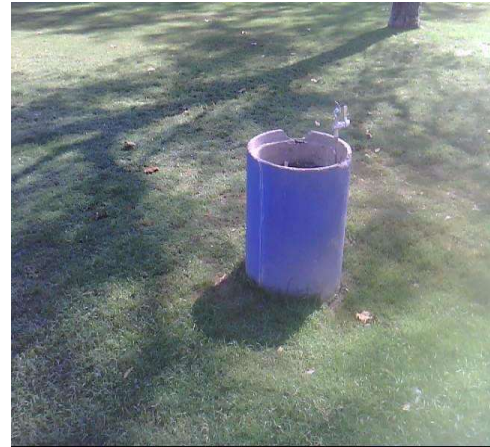
Drinking Fountain Next To Baseball Field #4 East Duggout

Code Reference ADA 305, 306, 211, 602, 306.3, 602.2,CA 11B-602.2,CA 11B-305

Recommendation At least 27.00 inches

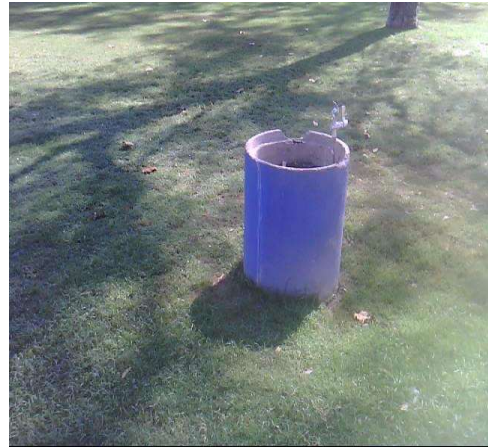
Drinking Fountain Next To Baseball Field #4 East Duggout

Code Reference ADA 305, 602, 211.2,CA
11B-211.2,CA 11B-602

Replace the drinking fountain with a compliant Hi-Low fountain.

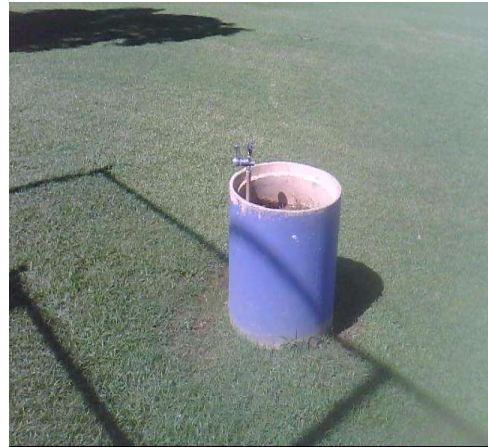
Drinking Fountain Next To Baseball Field #4 North Duggout

Code Reference ADA 305, 306, 211, 602, 402.1, 602.1

Recommendation See Recommendation

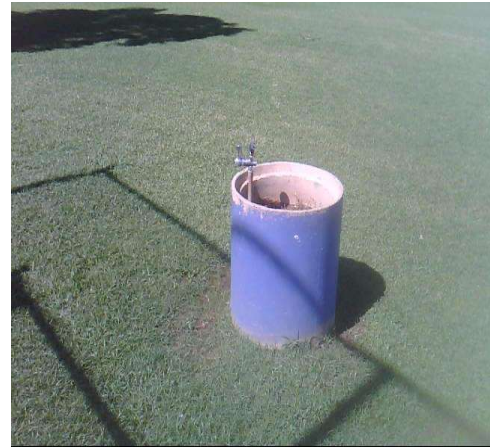
Drinking Fountain Next To Baseball Field #4 North Duggout

Code Reference ADA 305, 602, 211.2,CA
11B-211.2,CA 11B-602

Replace the drinking fountain with a compliant Hi-Low fountain.

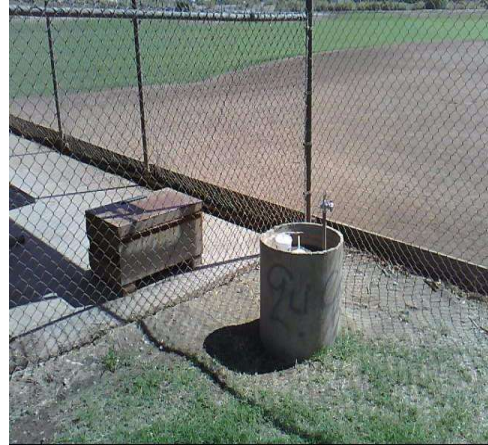
Drinking Fountain Next To Baseball Field #6 North Duggout

Code Reference ADA 305, 306, 211, 602, 306.2, 602.2, CA 11B-602.2, CA 11B-305

Recommendation At least 9.00 inches

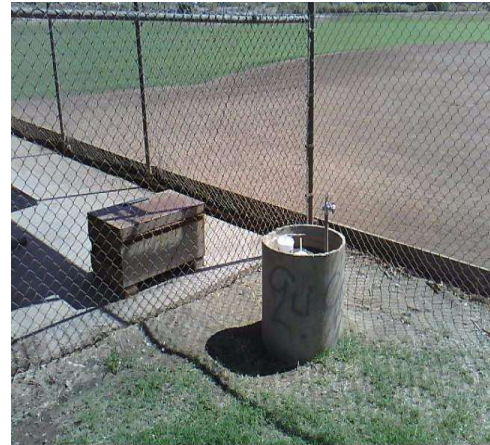
Drinking Fountain Next To Baseball Field #6 North Duggout

Code Reference ADA 309, 205, 211, 602, 309.4, 602.3, CA 11B-309.4, CA 11B-602.3

Replace knob faucets with paddle faucets \$392

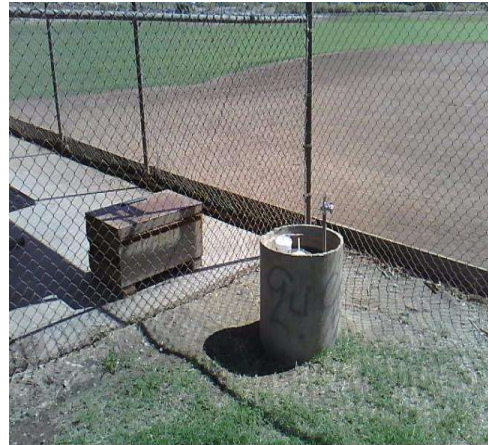
Drinking Fountain Next To Baseball Field #6 North Duggout

Code Reference ADA 211, 602, 602.5, CA 11B-602.5

Recommendation Up to 6.00 inches

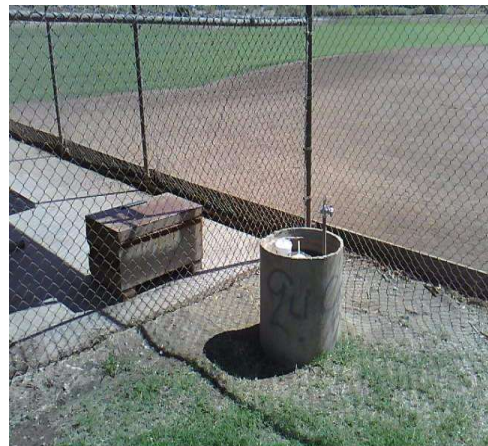
Record Number 19350

Code Reference ADA 305, 306, 211, 602, 402.1, 602.1

Recommendation See Recommendation

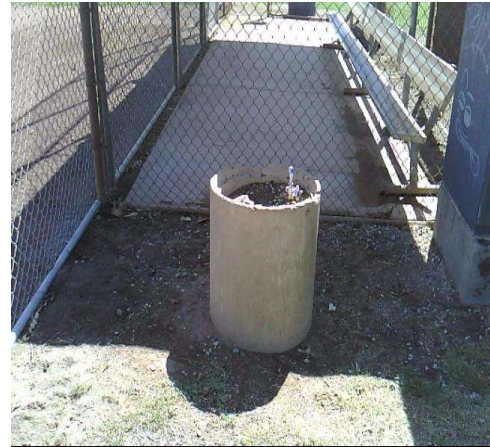
Record Number 19392

Drinking Fountains - Exterior : Drinking Fountain

Code Reference ADA 305, 306, 211, 602, 306.2, 602.2, CA 11B-602.2, CA 11B-305

Recommendation At least 9.00 inches

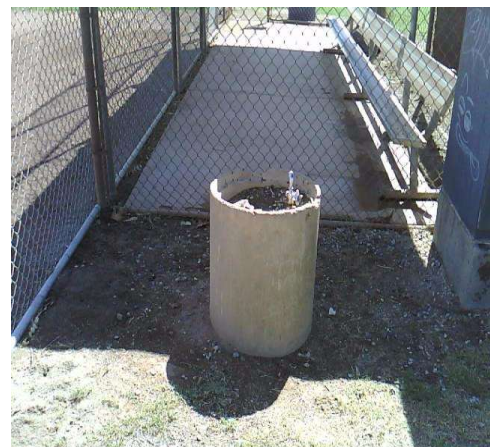
Record Number 19394

Drinking Fountain Next To Baseball Field #6 West Duggout

Code Reference ADA 305, 306, 211, 602, 306.3, 602.2, CA 11B-602.2, CA 11B-305

Recommendation At least 27.00 inches

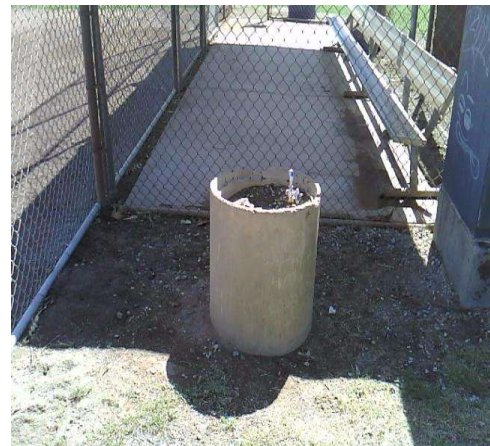
Record Number 19390

Code Reference ADA 305, 602, 211.2, CA 11B-211.2, CA 11B-602

Replace the drinking fountain with a compliant Hi-Low fountain.

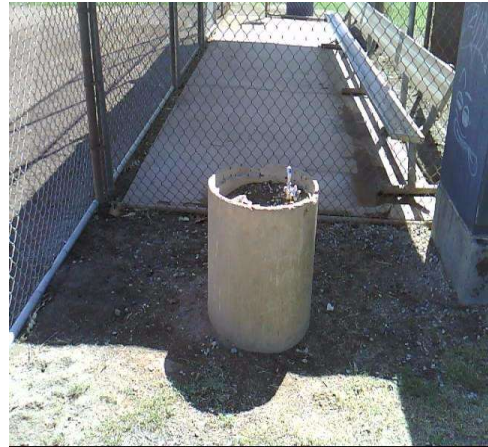
Record Number 19393

Code Reference ADA 305, 306, 211, 602, 402.1, 602.1

Recommendation See Recommendation

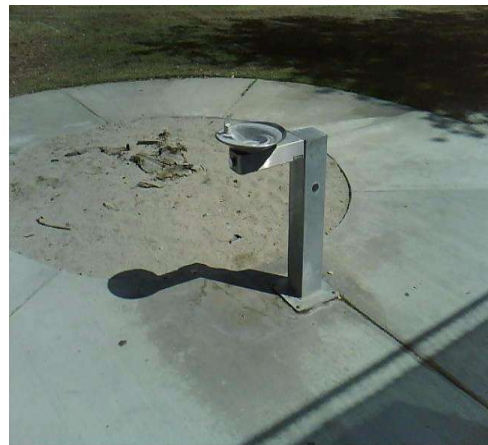
Record Number 19409

Drinking Fountain Next To Tennis Courts

Code Reference ADA 305, 602, 211.2,CA 11B-211.2,CA 11B-602

Replace the drinking fountain with a compliant Hi-Low fountain.

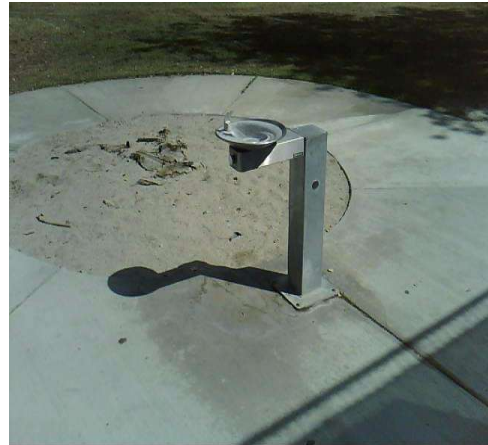
Record Number 19410

Drinking Fountains - Exterior : Drinking Fountains

Code Reference ADA 305, 306, 211, 602, 307.2,CA
11B-602,CA 11B-307.2

Recommendation See Recommendation

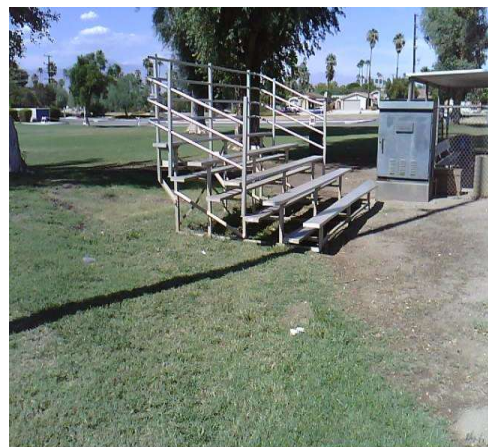
Record Number 16907

Baseball Field #5

Code Reference ADA 221.2, 802.1,CA 11B-221.2,CA
11B-802.1

Recommendation At least 2.00 seats

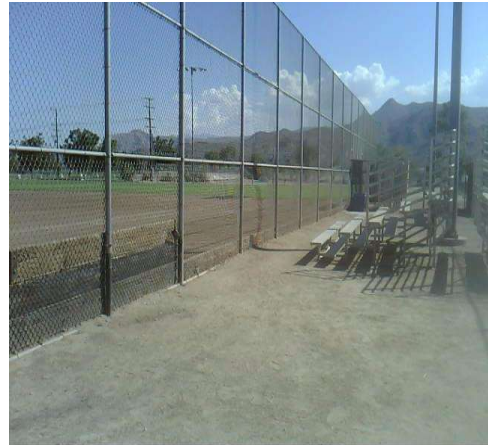
Record Number 16896

Code Reference ADA 221.2, 802.1, CA 11B-221.2, CA 11B-802.1

Recommendation At least 4.00 seats

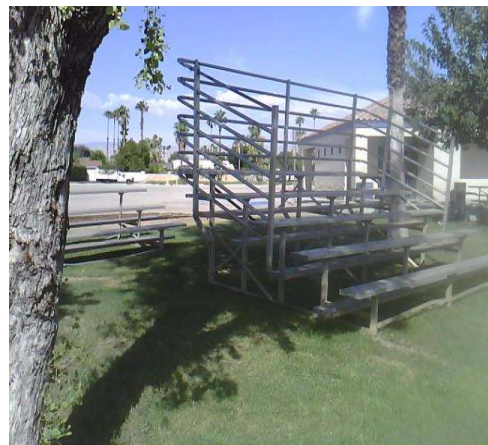
Record Number 16897

Baseball Field #8

Code Reference ADA 221.2, 802.1, CA 11B-221.2, CA 11B-802.1

Recommendation At least 4.00 seats

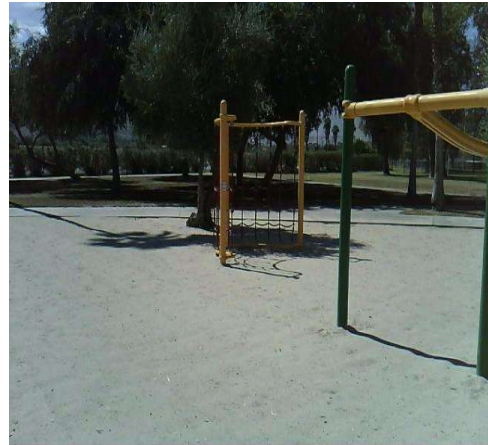
Record Number 19504

Play Area - Exterior : Play Area

Code Reference ADA 1008, 240, 1008.2, 1008.2.6

Recommendation See Recommendation

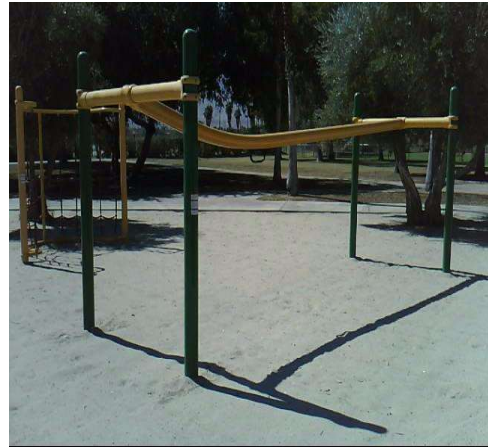
Record Number 19507

Play Area - Exterior : Play Area

Code Reference ADA 1008, 240, 1008.2, 1008.2.6

Recommendation See Recommendation

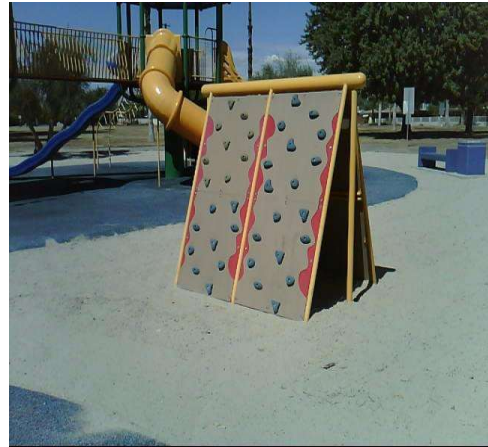
Record Number 19509

Play Area - Exterior : Play Area

Code Reference ADA 1008, 240, 1008.2, 1008.2.6

Recommendation See Recommendation

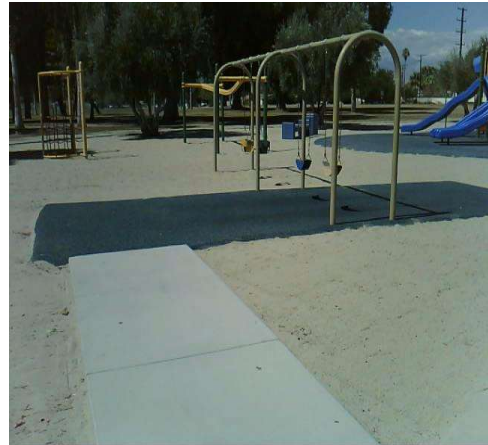
Record Number 19506

Play Area - Exterior : Play Area

Notes : Path of travel to the swings is concrete.

Recommendation See Recommendation

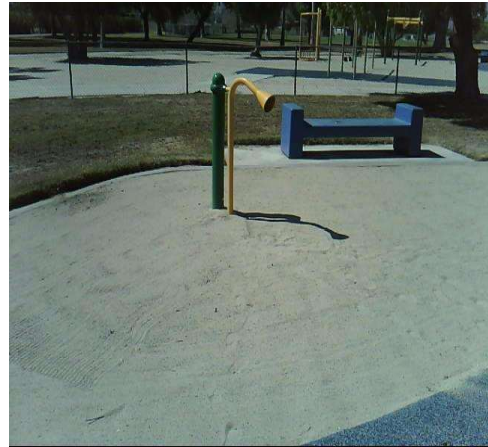
Record Number 19513

Play Area - Exterior : Play Area

Code Reference ADA 1008, 240, 1008.2, 1008.2.6

Recommendation See Recommendation

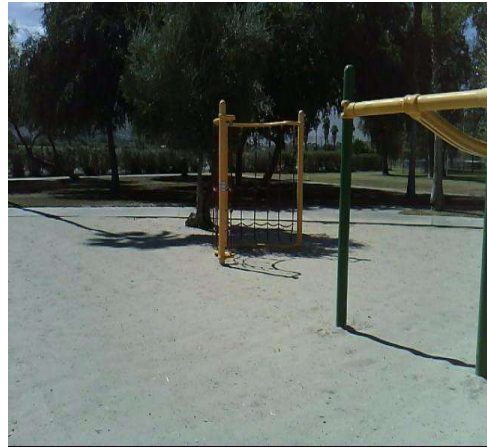
Record Number 19505

Play Areas - Exterior : Play Area , Ground level Equipment

Code Reference ADA 1008, 305, 305.2, 302.1, 1008.4.2

Recommendation See Recommendation

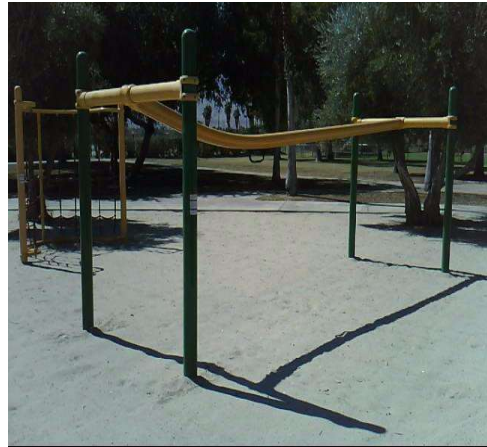
Record Number 19508

Play Areas - Exterior : Play Area , Ground level Equipment

Code Reference ADA 1008, 305, 305.2, 302.1, 1008.4.2

Recommendation See Recommendation

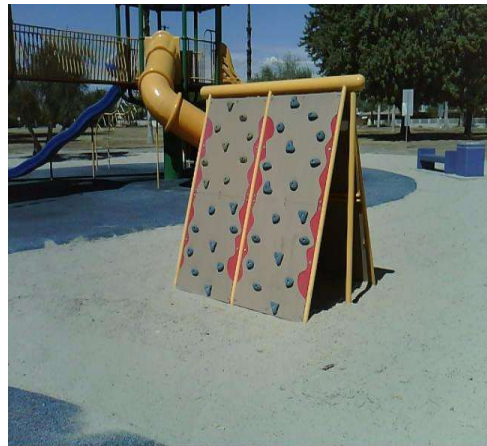
Record Number 19510

Play Area (Ages 5-12)

Code Reference ADA 1008, 305, 305.2, 302.1, 1008.4.2

Recommendation See Recommendation

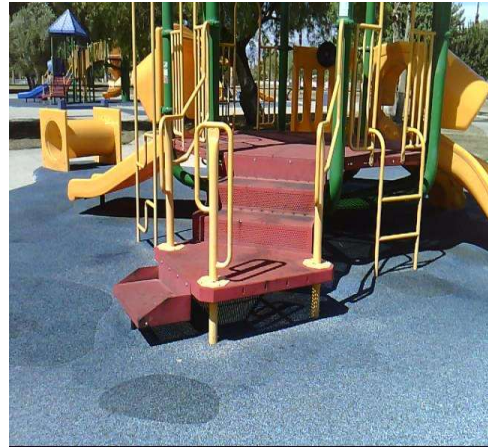
Record Number 19511

Play Areas - Exterior : Play Area , Equipment

Code Reference ADA 1008, 1008.3.2.1

Recommendation At least 14.00 inches

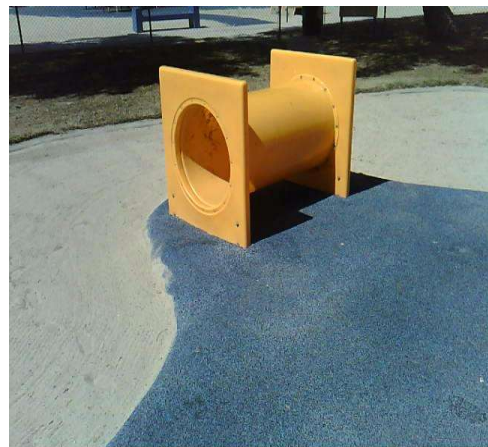
Record Number 19512

Toddler Play Area (Ages 2-5)

Code Reference ADA 1008, 305, 305.3, 1008.4.2

Recommendation At least 48.00 inches

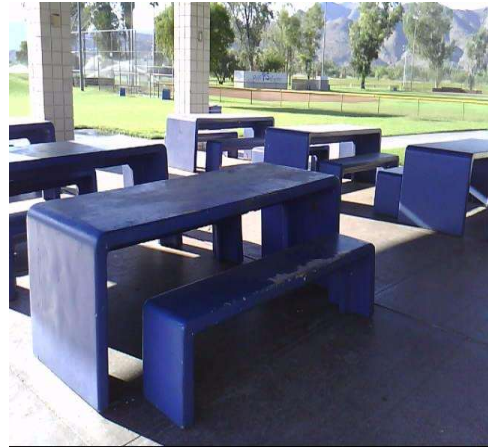
Record Number 16991

Picnic Areas - Exterior : Picnic Tables

Code Reference ADA 309, 305, 205, 306, 308, 902, 228, 226.1

Recommendation At least 1.00 tables

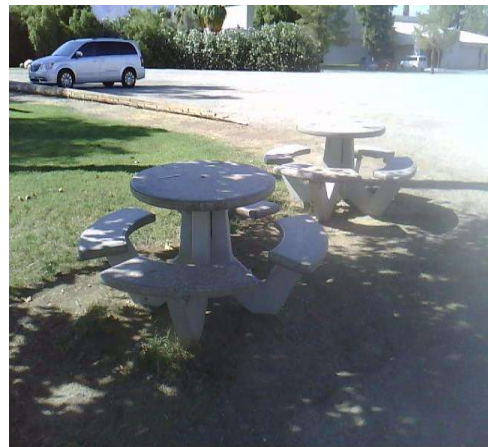
Record Number 16944

Picnic Tables Next To Baseball Fields # 7 And 8

Code Reference ADA 309, 305, 205, 306, 308, 902, 228, 226.1

Recommendation At least 1.00 tables

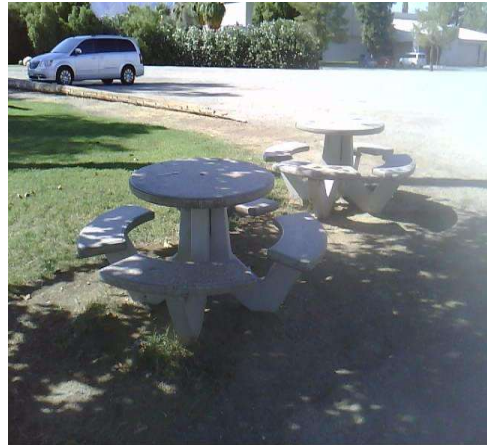
Record Number 16943

Picnic Areas - Exterior : Picnic Tables

Code Reference ADA 402, 403, 309, 205, 308, 226, 228,CA 11B-246.5,CA 11B-902

Recommendation See Recommendation

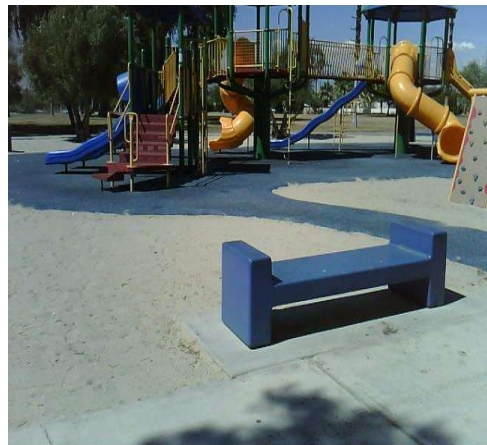
Record Number 16895

Benches At Play Area

Code Reference ADA 305, 903.2,CA 11B-903.2,CA 11B-305

Recommendation See Recommendation

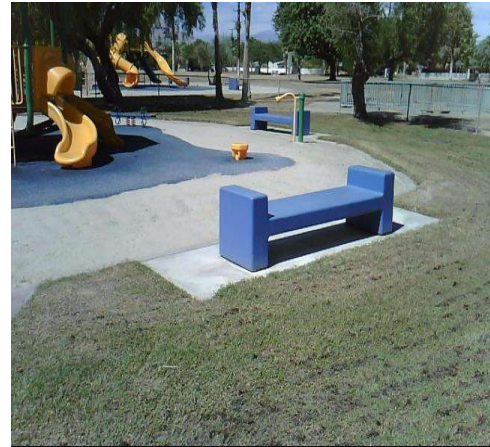
Record Number 16927

Benches - Exterior : Bench

Code Reference ADA 309, 903, 305, 205, 308, 228

Recommendation See Recommendation
