## City Council Staff Report

SUBJECT: APPROVAL OF AMENDMENT NO. 2 IN THE AMOUNT OF \$70,000 TO THE PROFESSIONAL SERVICES AGREEMENT WITH ARCHITECTURAL RESOURCES GROUP, INC., (A6791) FOR THE CORNELIA WHITE HOUSE EXTERIOR REPAIRS, CITY PROJECT NO. 15-16

## Existing Conditions Assessment

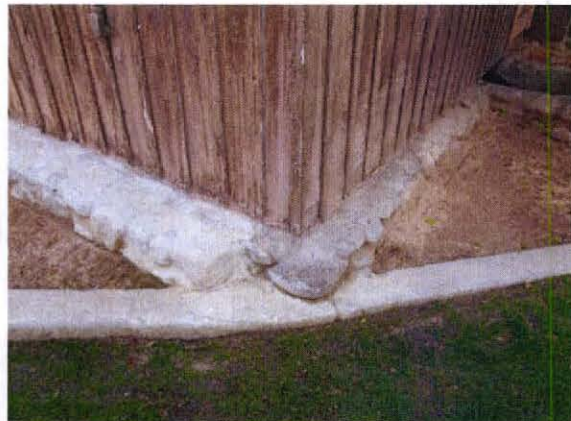
Foundation wall stone detail at southeast corner.

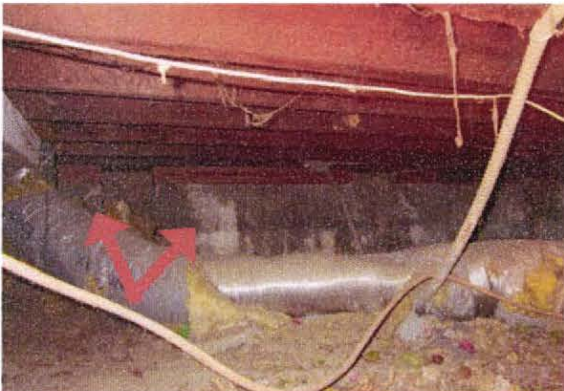
*View inside crawlspace to west foundation wall below Kitchen.  
Note engaged piers and blocking with stone between.*

The crawl space was accessed at the time of our survey. The entrance is at the enclosed porch area (Second Room) at the east elevation. It is framed below-grade with concrete and stone walls, and has a locking metal grille cover. The opening is tight and difficult for maintenance staff to access. The foundation wall appears to be non-continuous. There are breaks where the wall forms engaged piers, and the back of stone can be seen between. Floor joists appear to be a mixture of old and new lumber, roughly 2x10 in size. They are supported at the foundation wall engaged piers by wood blocking, and within the crawlspace by larger timber beams. The timber beams are also a mix of different generations of material. In many cases, the ends of the beams at the foundation walls are decayed. The beams have been secondarily supported throughout their lengths with various items, including short posts on wood blocking and cmu blocks, and metal tripod-type supports. Finish flooring appears to be secured directly to the floor joists; no sub-floor was observed. The crawlspace itself is fairly open; there is some minor debris accumulation throughout. Insulated ductwork rest on the ground. All wood elements are generally raised from the ground. There were no observed signs of recent insect attack, such as mud tubes, wood tunneling or boring, flight holes, or frass noted.

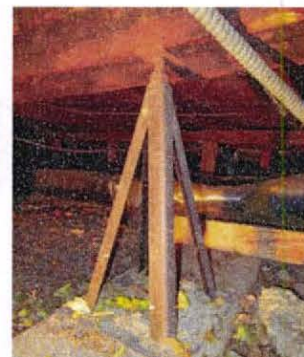
*Metal tripod support at crawlspace.*

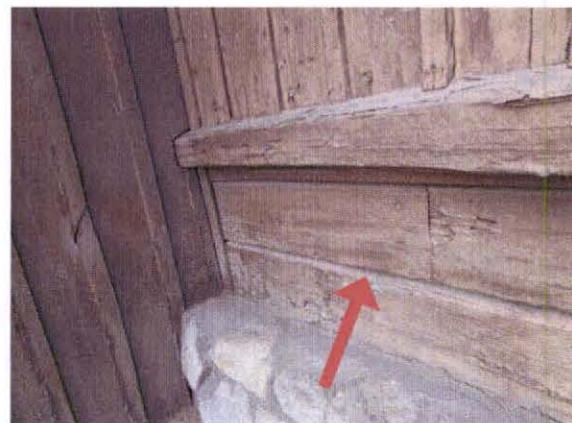
Chamfered edge detailing still visible at cross ties at east elevation.

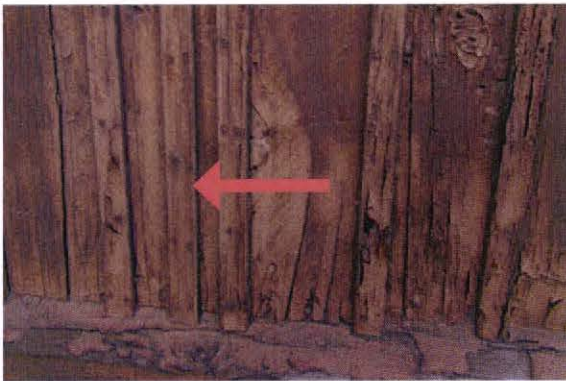
Cross ties and battens at east elevation. Note additional batten at left of image

The vertical cross ties are nominally 6-inches wide by 4-inches thick, and positioned adjacent to each other in the wall (sandwiched together with no space between). Battens are used to cover vertical joints between members. The cross ties are in fair to poor condition. There is advanced wood decay at the base where they meet with the belt course element. This is particularly noticeable at the northeast corner of the east elevation and along the west elevation where there are full thickness voids. Sealants have been used in the past to seal this horizontal joint with the belt course which has trapped moisture in the wood, exacerbating the decay. Vertical checking and splitting was noted throughout, in some cases running the full height of the cross tie members. At a few wide splits, additional battens have been installed. Other surface features included gouges, round indentations (possibly from hammers), mortised ends, wrought iron forged spikes and nails, and holes from missing nails and anchors.

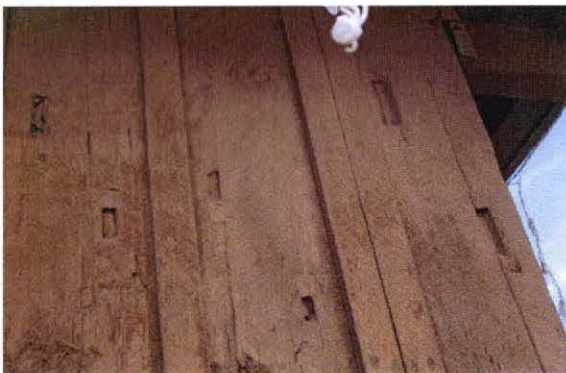
Cross ties at east elevation. Note mortises and other surface features.

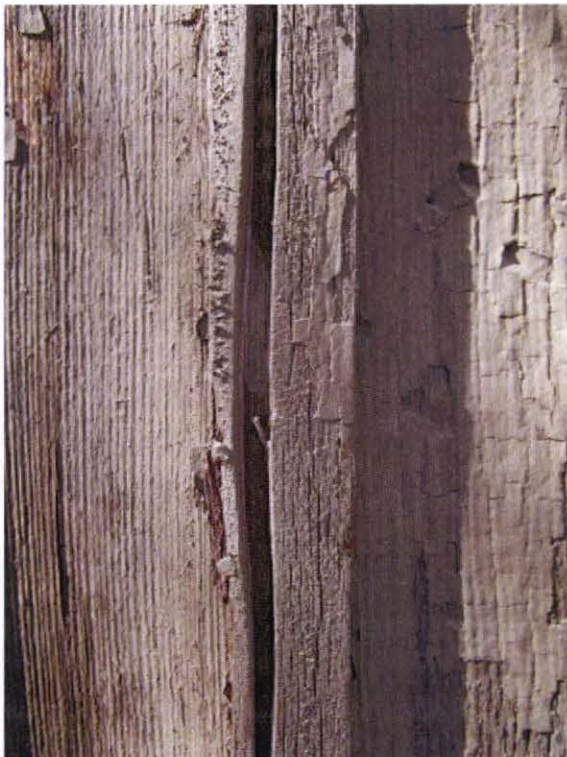
The vertical battens are 1-1/2 inches wide by 1/4-inch thick. They are face-nailed to the cross ties and siding boards with ferrous fasteners, and have angled cuts at the base to fit snugly against the sloped top surface of the belt course. Battens are in fair condition overall. There are numerous splits, particularly adjacent to corroded fasteners. There are also warped and bowed battens, some no longer covering vertical joints, and a few missing battens. And as mentioned above, a few battens have been added to cover larger splits in siding or vertical cross ties.

*Split batten at east elevation.*

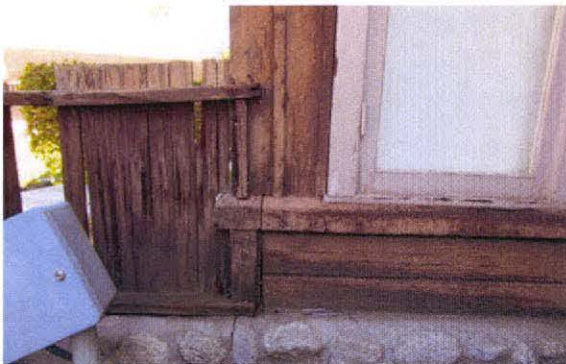
*Fence at north end of mechanical area. Note connection to southwest corner of Dining Room.*

The mechanical area (west of the Kitchen) contains a concrete floor slab which supports the HVAC equipment. The area is surrounded by low concrete and stone walls and a wood-framed fence. There is a gate at the south end. The fence is composed of vertical posts, horizontal top and bottom rails and vertical boards to the outside. It is attached to the building at the north end with pieces of wood scabbed onto the building corner. The fence is generally in poor condition, with large gaps, missing boards, and loose components.

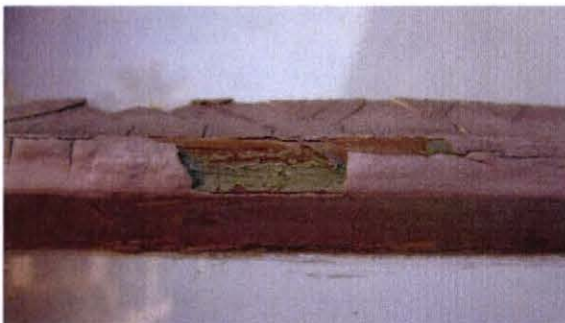
*Detail view of window muntin at west elevation. Note mint green paint.*

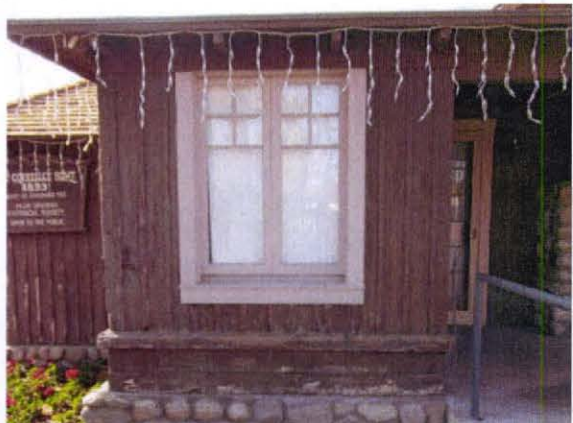
*Replaced window at north elevation of Bathroom.*

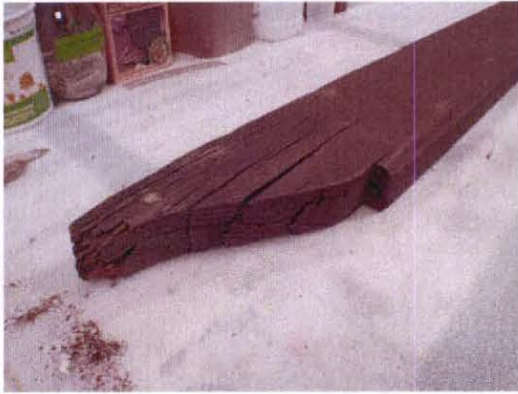
1. Rafter prior to treatment.

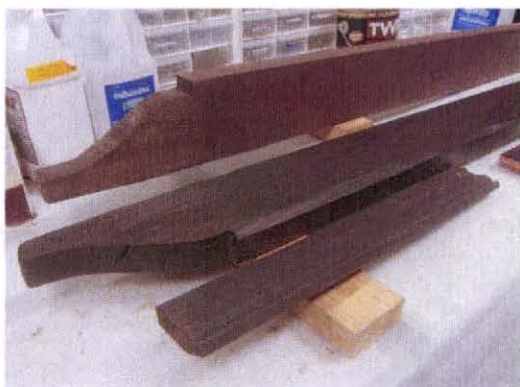
19. Completed rafter repair.

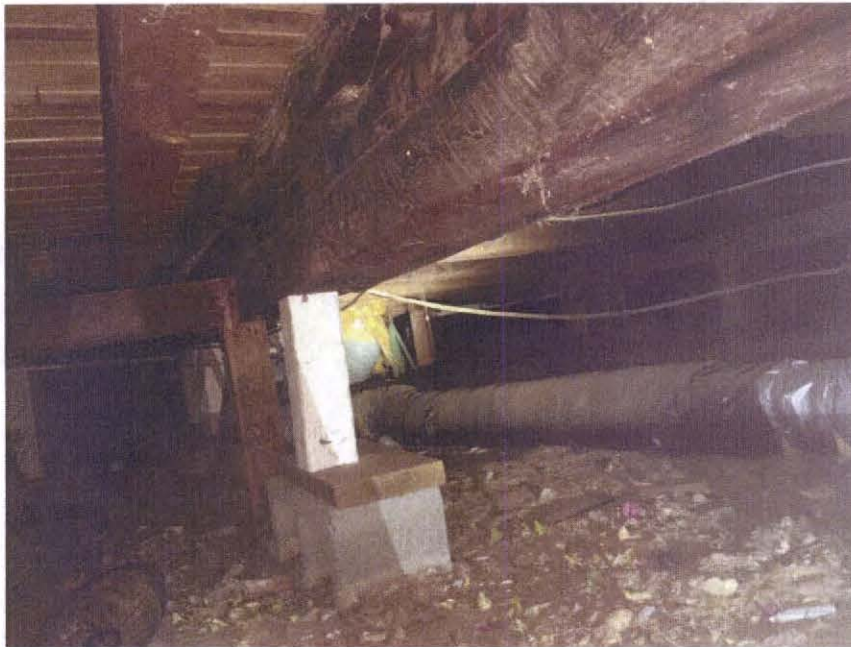
- The foundations of the building are not adequate to provide competent support for the structure and do not meet the current International Building Code requirements, or the lower requirements of the California Historical Building Code. Presumably, the foundations were constructed as part of the 1979 relocation of the building, but they do not appear to meet the building code in affect at that time. The perimeter foundations are mostly continuous, but the reinforcing is unknown, and no anchors between the framing and the foundation wall was observed. The interior framing bears on several different conditions, but none appear to have been engineered or meet any minimal code requirements.

Figure 2: Existing crawlspace, interior support

2.	The foundations should be either replaced or retrofitted to provide a more stable base for the structure. The existing perimeter concrete foundations can probably be salvaged, but the walls above need to be anchored positively to the stem walls using a <i>Universal Foundation Plate</i> by Simpson Strong-Tie, or similar. (A photo is provided in the appendix to this report.) The interior foundations need to be completely replaced with new precast concrete pads and adequately anchored to the floor framing.

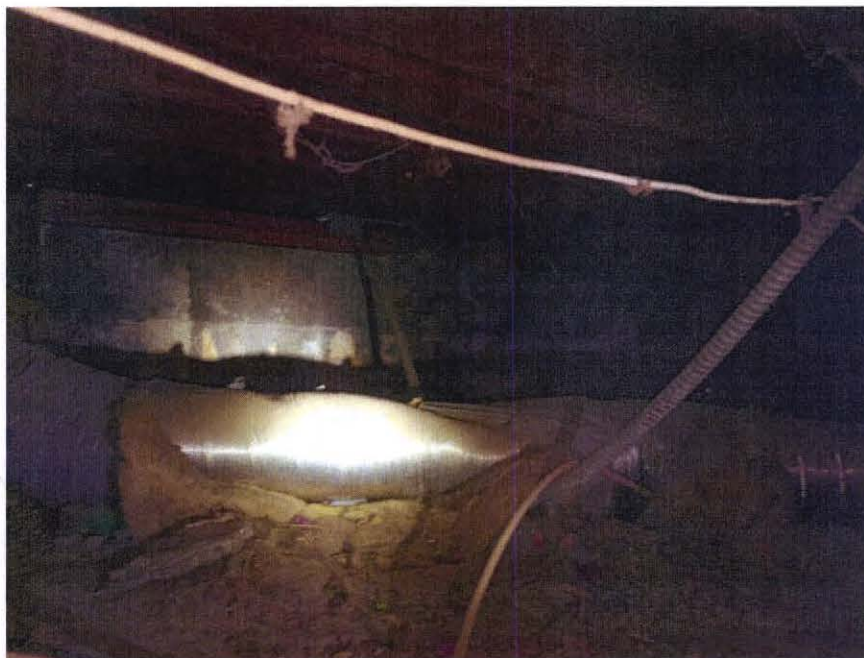
Figure 3: Existing crawlspace, perimeter concrete footing

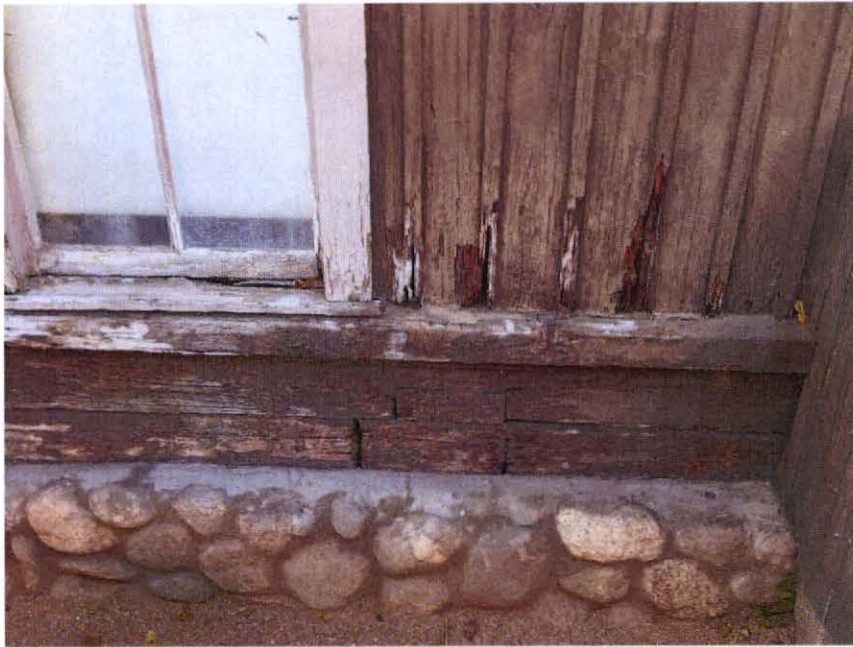
Figure 6: Existing Type A wall constructed of railroad ties

6.	The original exterior walls constructed of railroad ties (Type A) require repairs and some bracing. The horizontal joint at the bottom of the vertical members is a hinge point for that wall and it can rotate out-of-plane at that location. Some continuous vertical strengthening is needed to run from the foundation level up to the top plate level at the roof line. Some ideas for retrofitting include what would be the equivalent to "center-coring" in the retrofit of an unreinforced masonry wall. This is accomplished by boring a hole from the top of the wall all the way down to the base, and inserting a continuous vertical rod and epoxy. Another option would be to remove interior finishes of the wall and inserting continuous vertical members in a vertical chase cut in the railroad ties from the inside. In both options, these new vertical members might be spaced 2 to 3 feet apart. Some improvements for waterproofing at the base of the walls where in contact with the foundation wall are recommended.

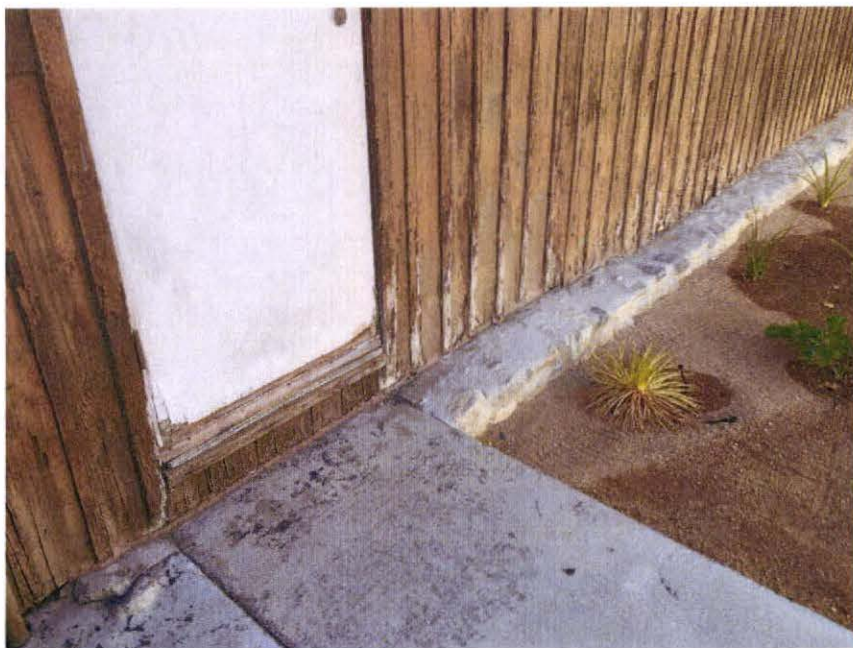
- The Type B and Type C walls are stud framed walls covered in vertical board-and-batten siding. In general, the siding is in very poor condition. It is likely that the wood studs behind the siding is in fair to poor condition. There is obvious decay at the base of the walls where in contact with the top of the foundation wall.

Figure 7: Existing wall with board-and-batten siding

7.	The Type B and Type C walls should be closely inspected and repaired in kind. The siding could be reinstalled if in acceptable condition, or replaced with new siding that could also be designed to resist lateral loads. Some improvements for waterproofing at the base of the walls where in contact with the foundation wall are recommended.
