PALMS SPRINGS RACQUET CLUB

HISTORIC REPORT

2743 N. INDIAN CANYON DRIVE

J A G ARCHITECTS

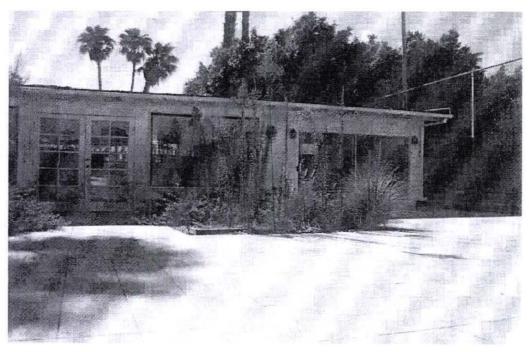
Figure A.1 Building "A"- Lobby/ Office Building

After successive alterations and additions, the original building was replaced with a deeper one and a return section of building was added on the main entry wall (Fig. A.1). The planter was also removed and a covered walkway was added to lead to the Bamboo Lounge (Fig. A.2). In addition, an entrance canopy was added to the front in 1965 (which was later replaced with the current one) (Fig. A.3, A.4) and in 1972, additional offices (Fig. A.5, Plan 11.1-A) were added north of the original brick wall enclosure along the edge of tennis courts 1 and 2. It currently houses the entry lobby (Fig. A.9), the hotel's lobby reception area (Fig. A.7), hotel management offices (Fig. A.11) and a tennis pro office (Fig. A.I, right side).

View of Rear of Entrance lobby

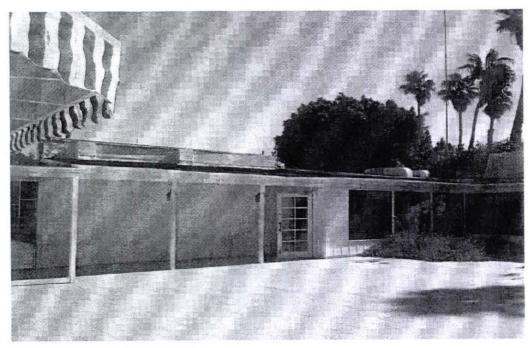
Figure A.11 Building "A"- Lobby/ Office Building

Exterior View of Hotel Reception Desk Area
