LETTER OF TRANSMITTAL

DATE: 3-2-98	JOB NO: 05-001350
RE: Desert Fashion Plaza	
Asbestos Survey	
Palm Springs, CA

EXECUTIVE SUMMARY

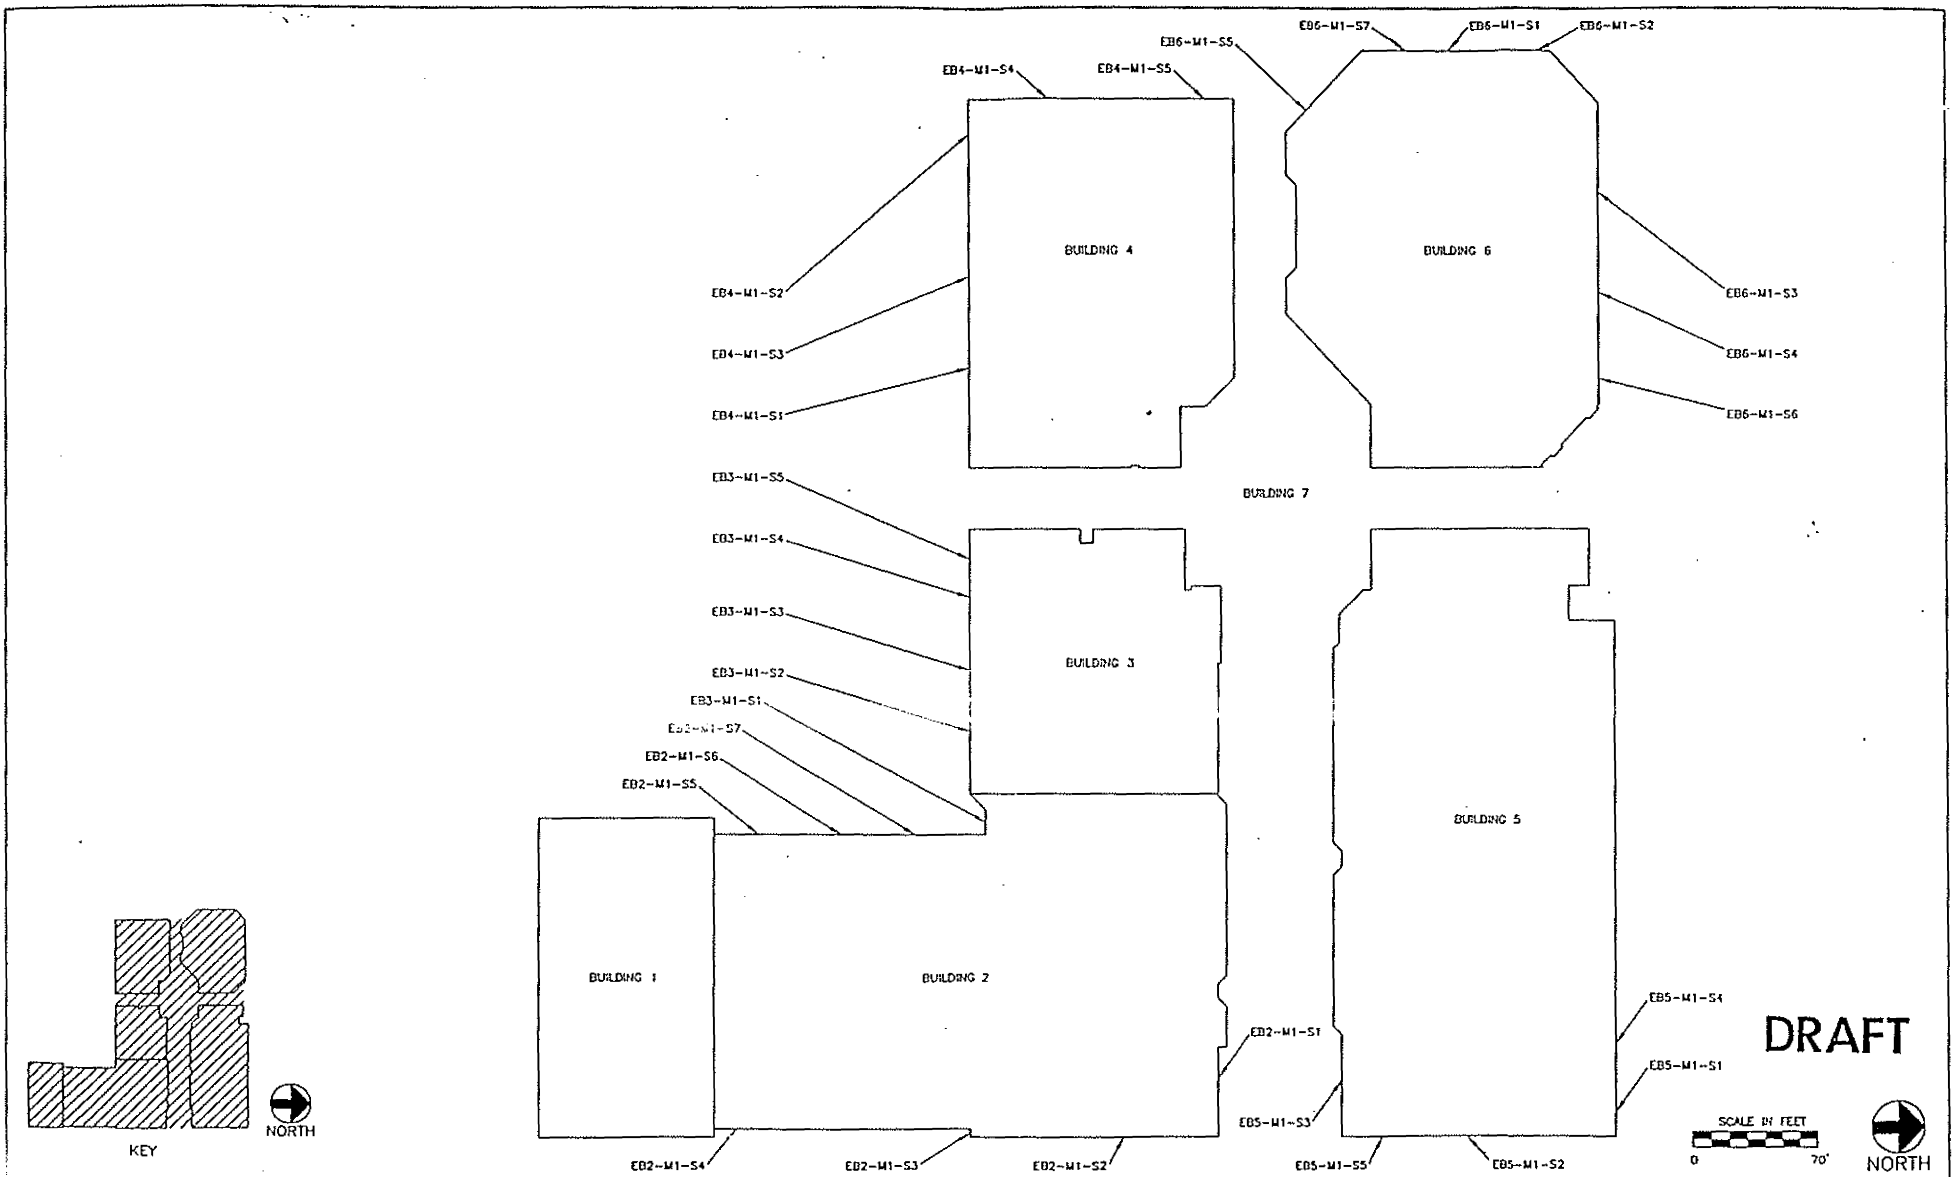
NORTHWEST ENVIROCON, INC. 1828 TRIBUTE ROAD, SUITE A, SACRAMENTO, CA 95815 (916) 649-3570 FAX: (916) 649-3819	APPROVED: DRAWN: CEB	SITE: DESERT FASHION PLAZA 124 PALM CANYON PALM SPRINGS CALIFORNIA	CLIENT: DRAWING TITLE: EXTERIOR WALL PLAN	DATE: FEBRUARY 1998 SCALE: 1" = 70'	PROJECT#: 05-001350 DRAWING#:	REVISIONS:
---	-------------------------	---	--	--	----------------------------------	------------

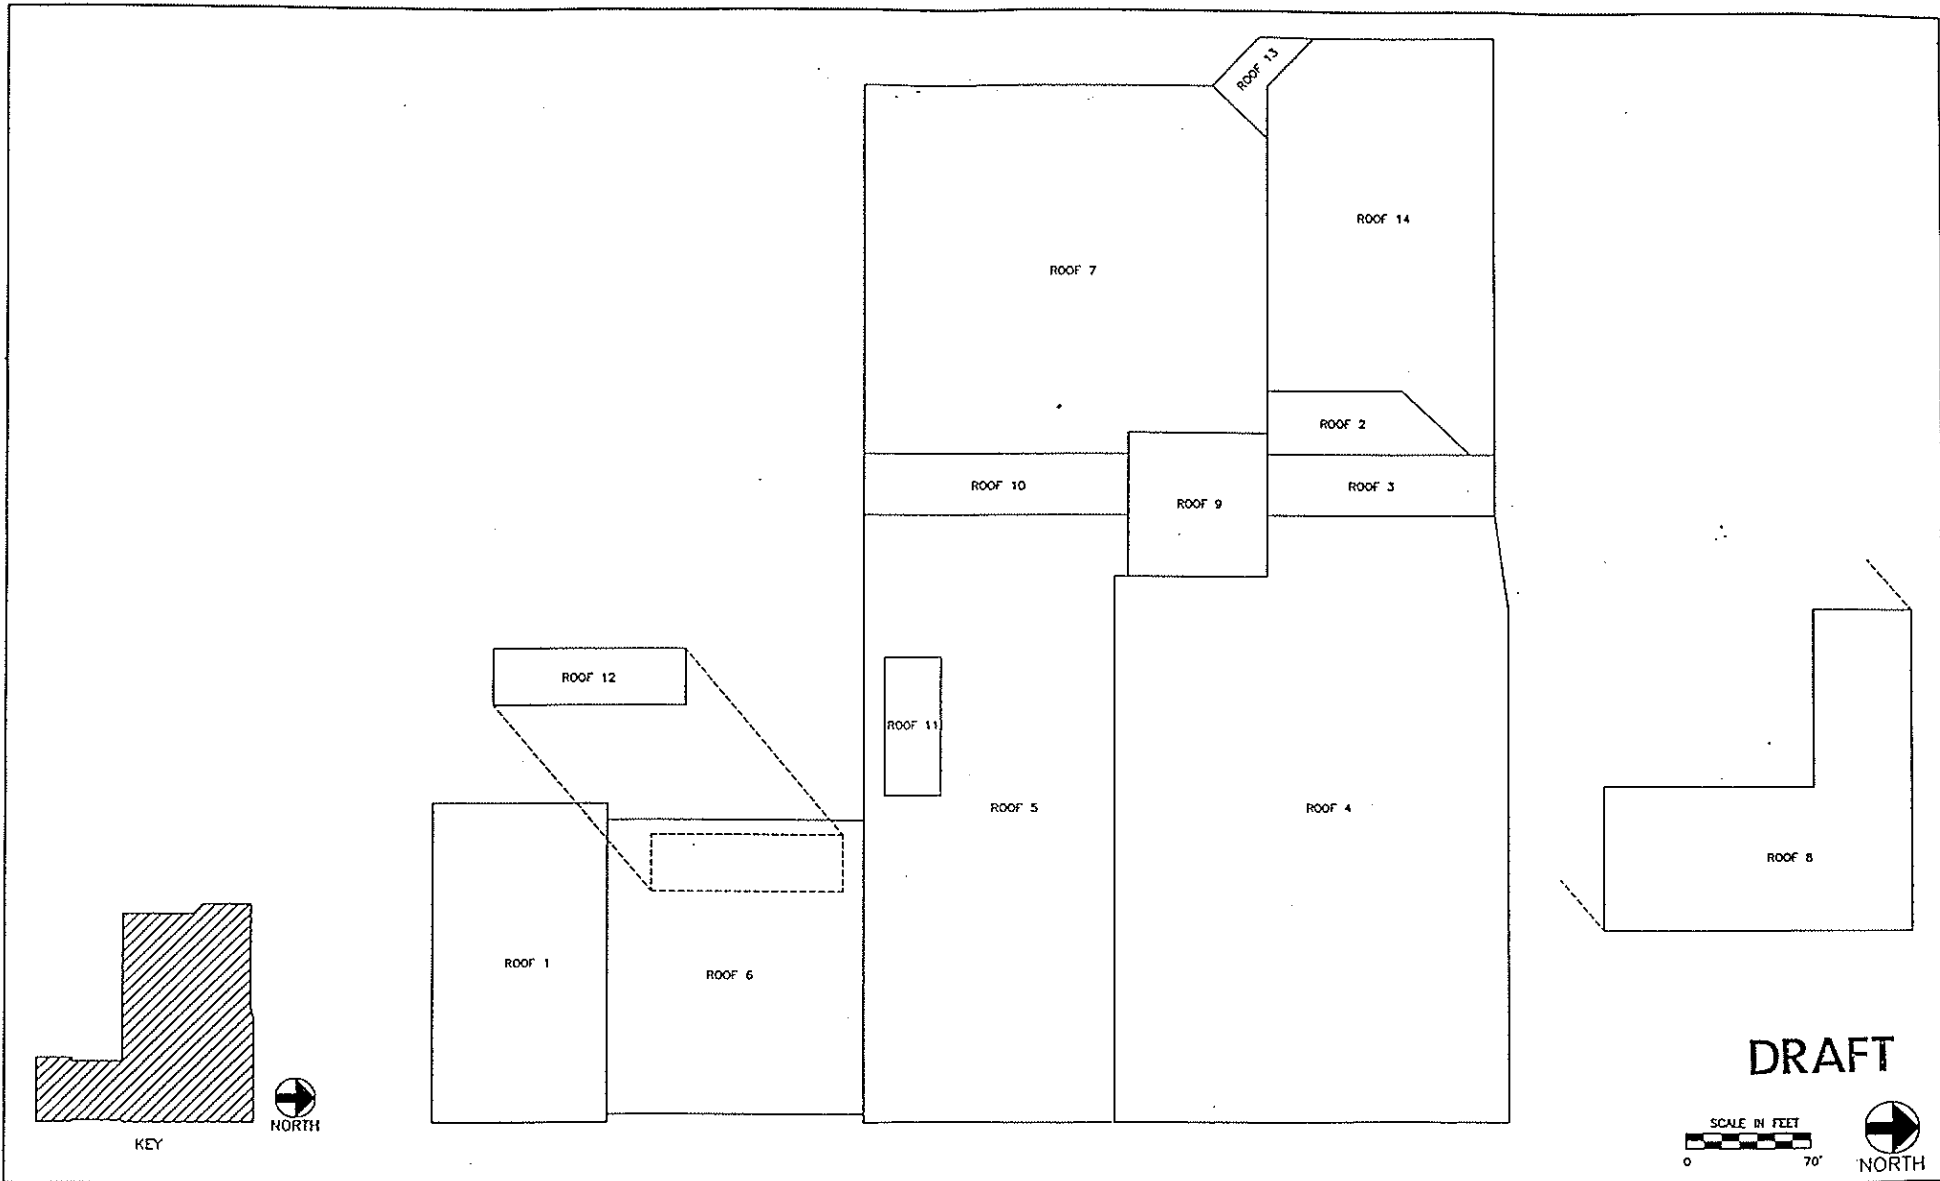
NORTHWEST ENVIROCON, INC. 1828 TRIBUTE ROAD, SUITE A, SACRAMENTO, CA. 95815 (916) 649-3570 FAX: (916) 649-3819	APPROVED: _____ DRAWN: CEB	SITE: DESERT FASHION PLAZA 124 PALM CANYON PALM SPRINGS CALIFORNIA	CLIENT: _____ DRAWING TITLE: SITE ROOF PLAN	DATE: FEBRUARY 1998 SCALE: 1" = 70'	PROJECT#: 05-001350 DRAWING#: _____	REVISIONS: _____ _____ _____

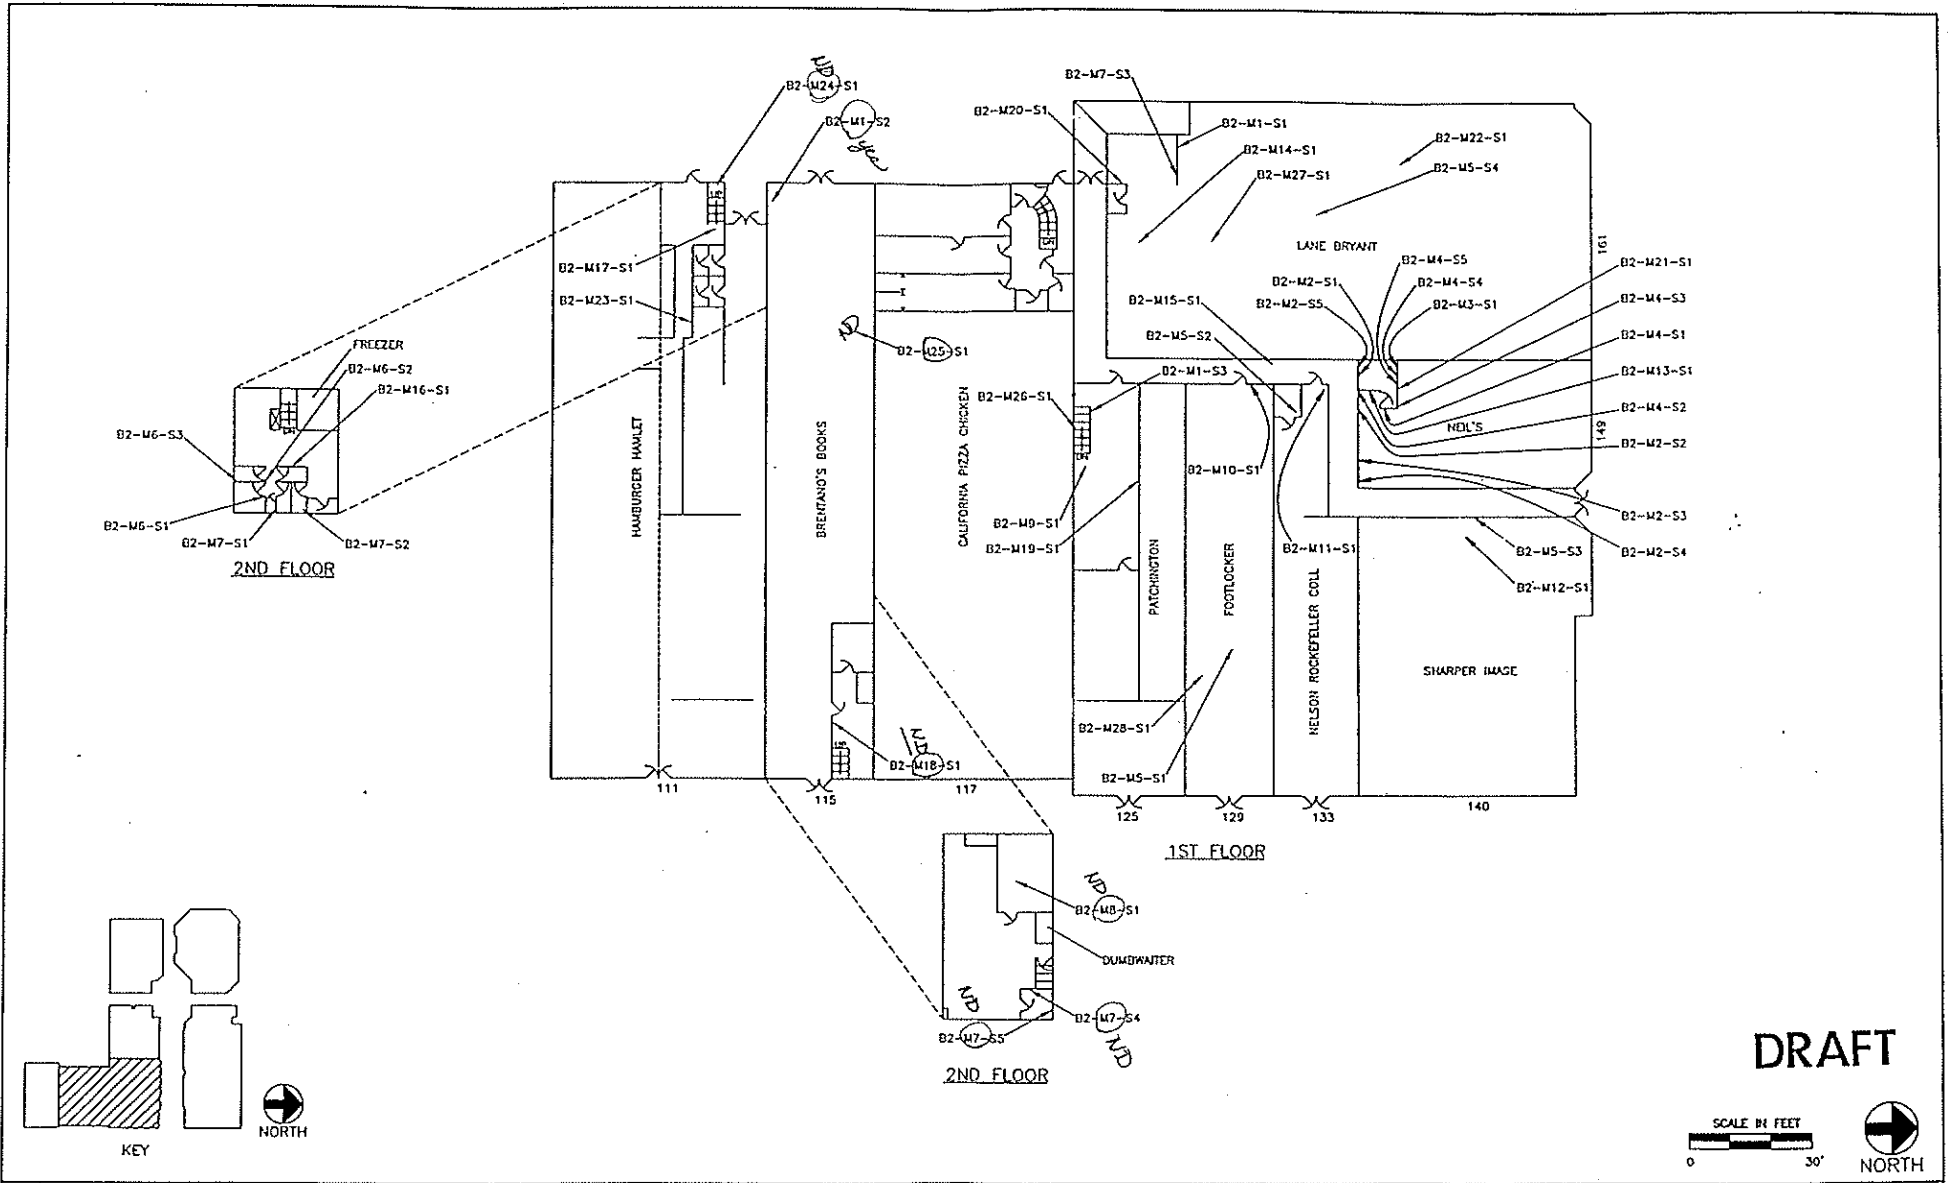
<p>NORTHWEST ENVIROCON, INC. 1828 TRIBUTE ROAD, SUITE A, SACRAMENTO, CA 95815 (916) 649-3570 FAX: (916) 649-3819</p>	<p>APPROVED: DRAWN: CEB</p>	<p>SITE: DESERT FASHION PLAZA 124 PALM CANYON PALM SPRINGS CALIFORNIA</p>	<p>CLIENT: DRAWING TITLE: BUILDING #2</p>	<p>DATE: FEBRUARY 1998 SCALE: 1" = 30'</p>	<p>PROJECT: 05-001350 DRAWING:</p>	<p>REVISIONS</p>
---	--	--	--	---	--	------------------

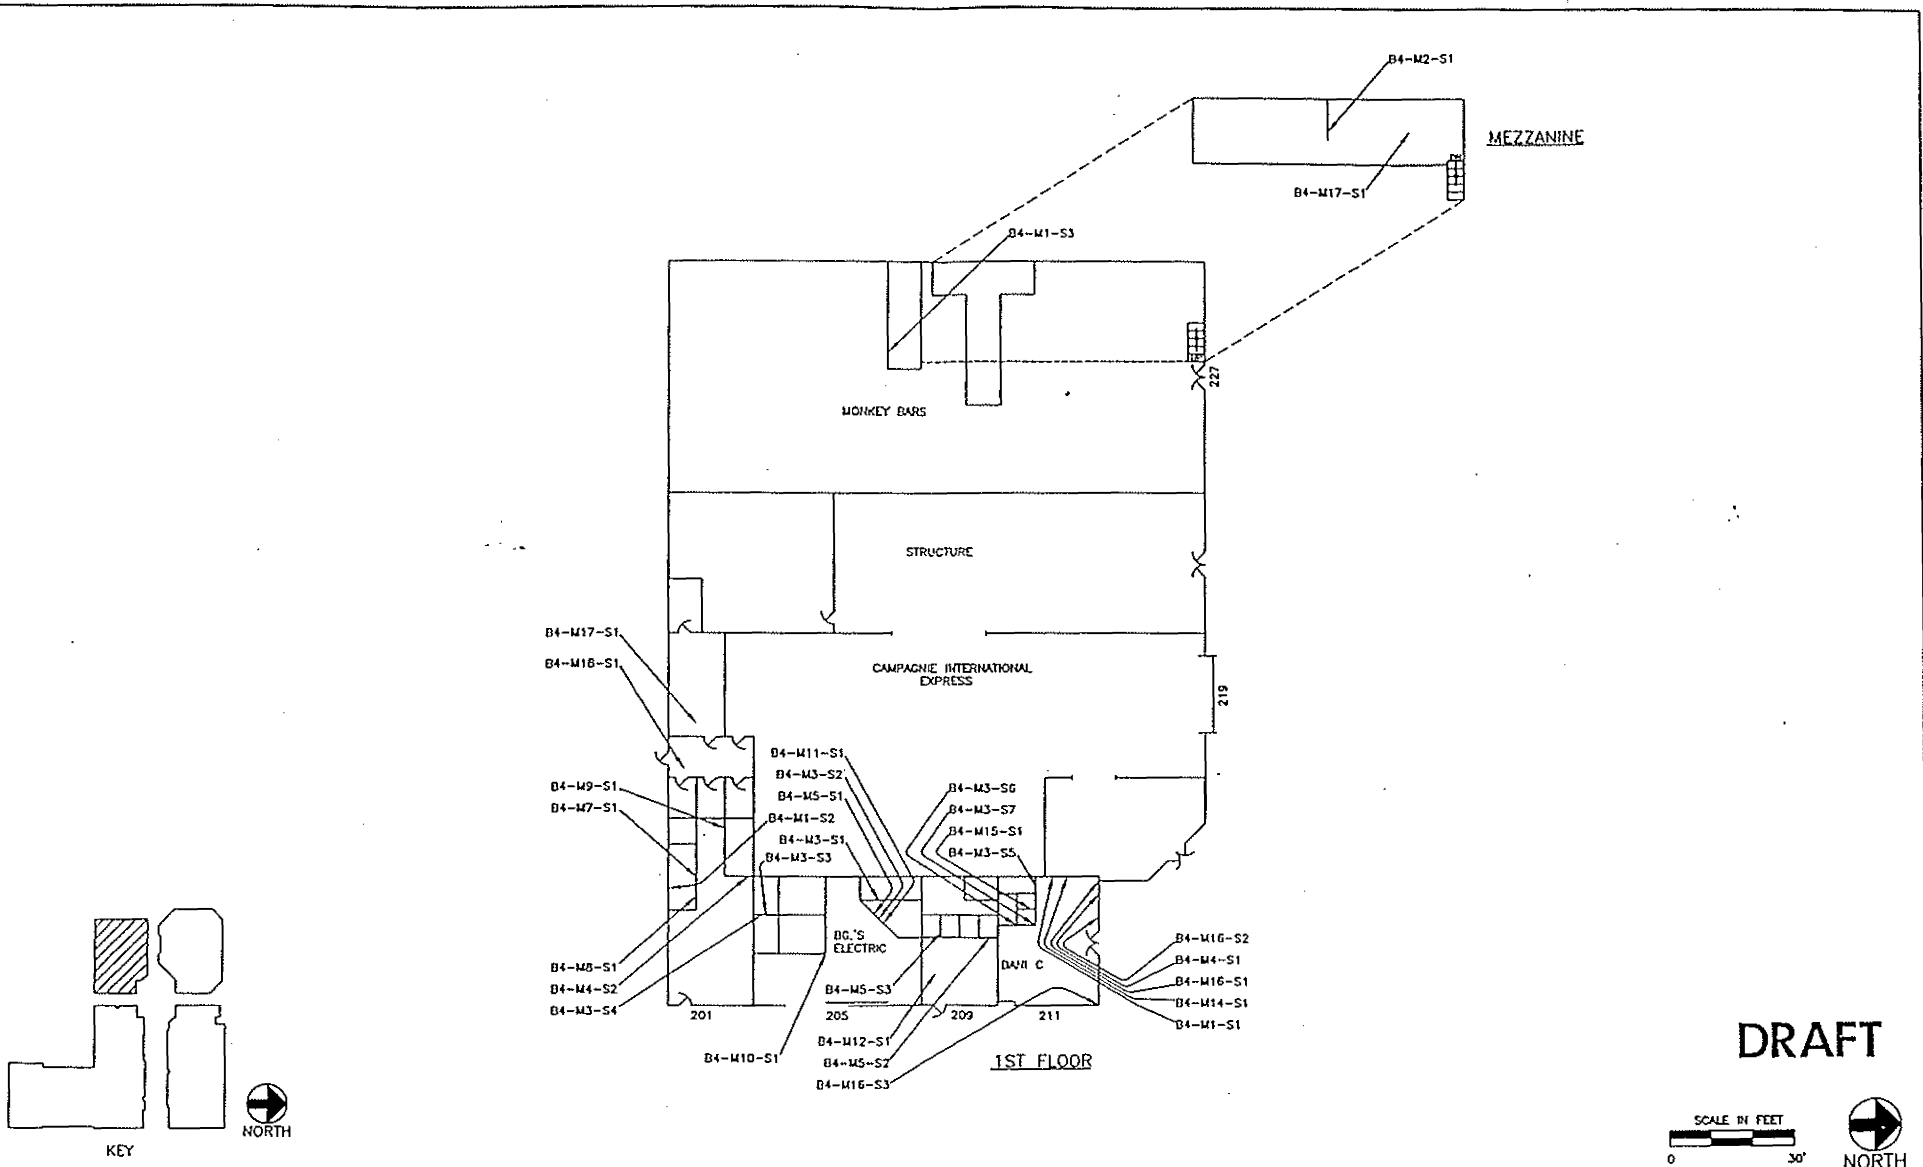
NORTHWEST ENVIROCON, INC. 1828 TRIBUTE ROAD, SUITE A, SACRAMENTO, CA. 95815 (916) 649-3570 FAX: (916) 649-3819	APPROVED:	SITE: DESERT FASHION PLAZA 124 PALM CANYON PALM SPRINGS CALIFORNIA	CLIENT:	DATE: FEBRUARY 1998	PROJECT#: 05-001350	REVISIONS:
	DRAWN: CEB	DRAWING TITLE: BUILDING #4	SCALE: 1" = 30'	DRAWING#:

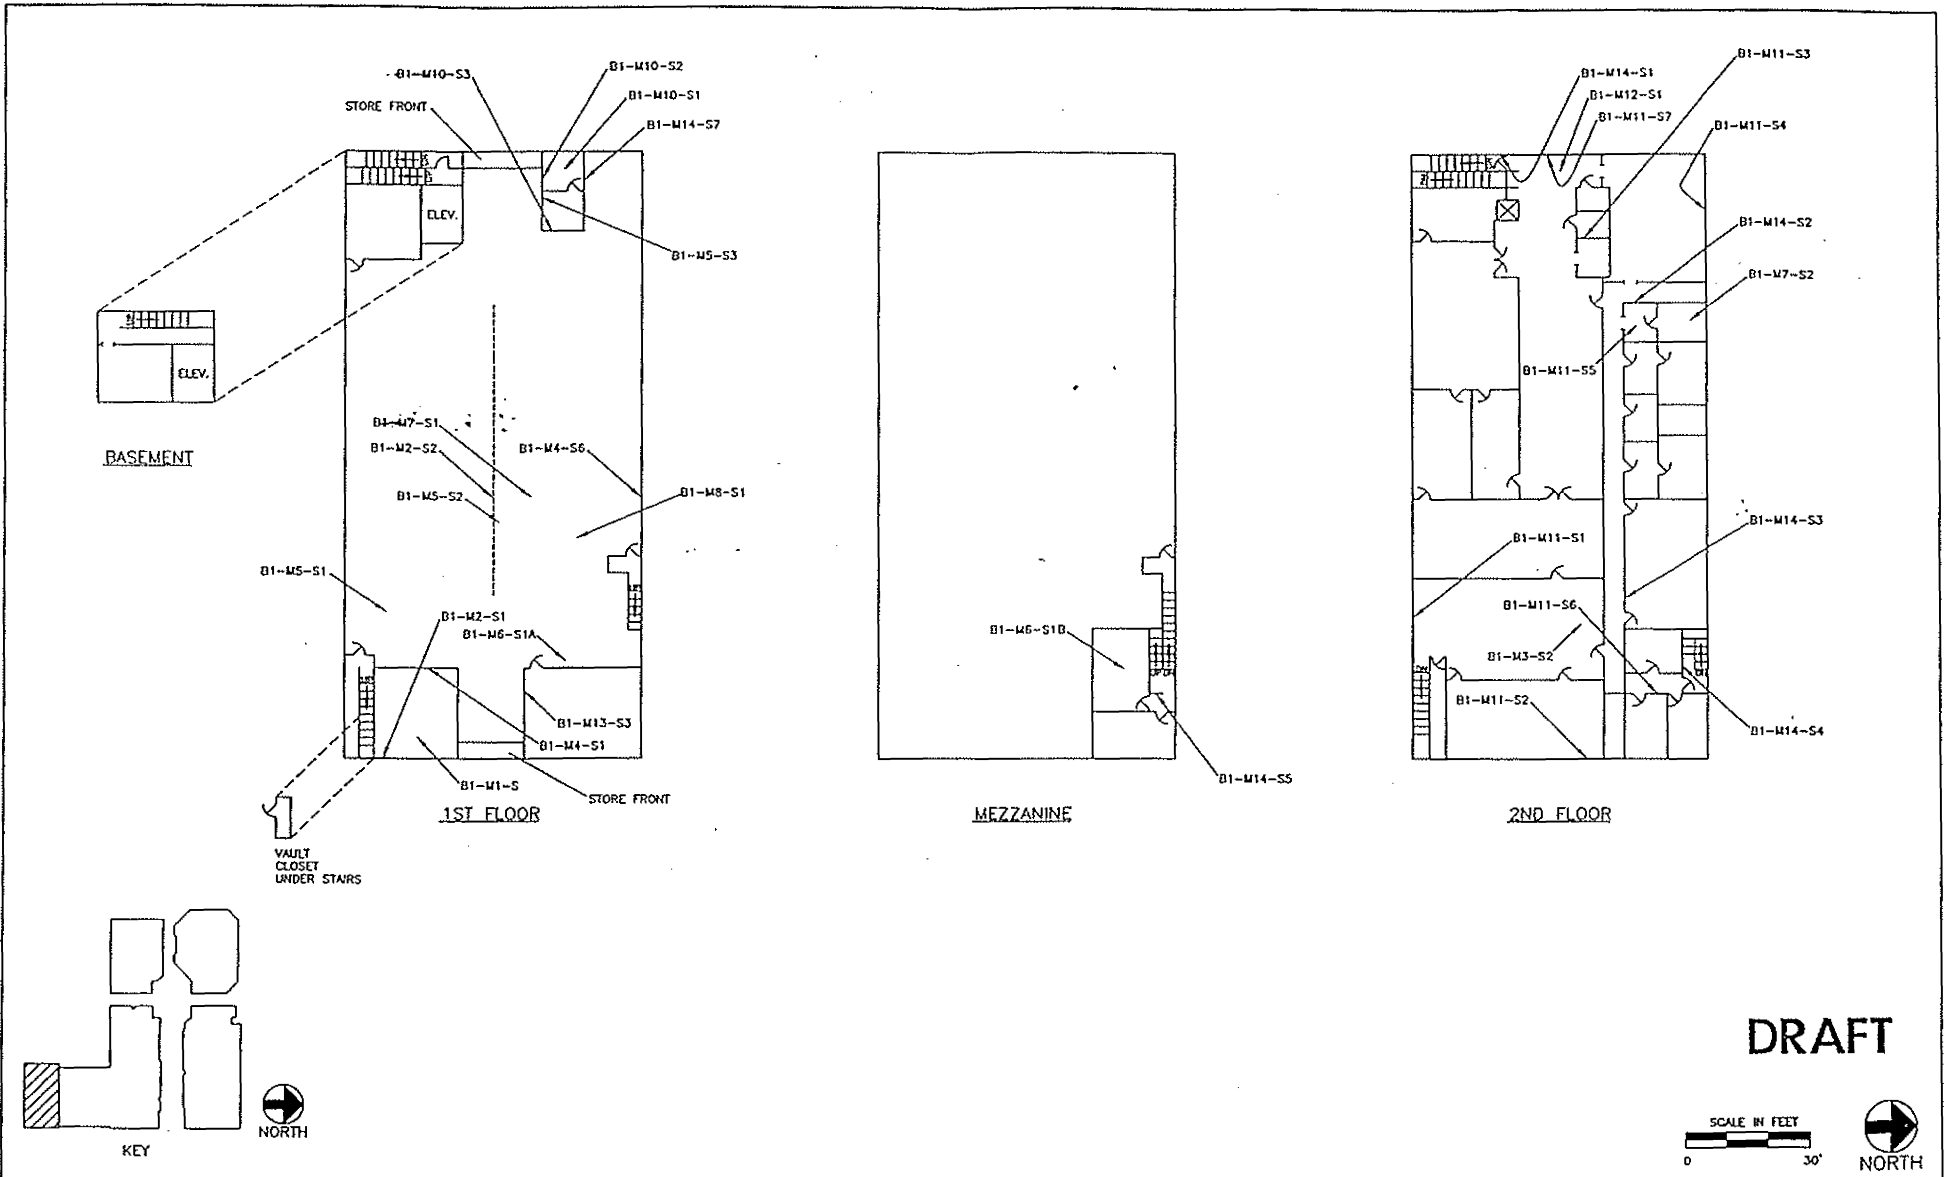
NORTHWEST ENVIROCON, INC. 1828 TRIBUTE ROAD, SUITE A, SACRAMENTO, CA. 95815 (916) 649-3570 FAX: (916) 649-3819	APPROVED: DRAWN: CEB	SITE: DESERT FASHION PLAZA 124 PALM CANYON PALM SPRINGS CALIFORNIA	CLIENT: DRAWING TITLE: BUILDING #1	DATE: FEBRUARY 1998 SCALE: 1" = 30'	PROJECT: 05-001350 DRAWING:	REVISIONS:
--	-------------------------	---	---------------------------------------	--	--------------------------------	------------

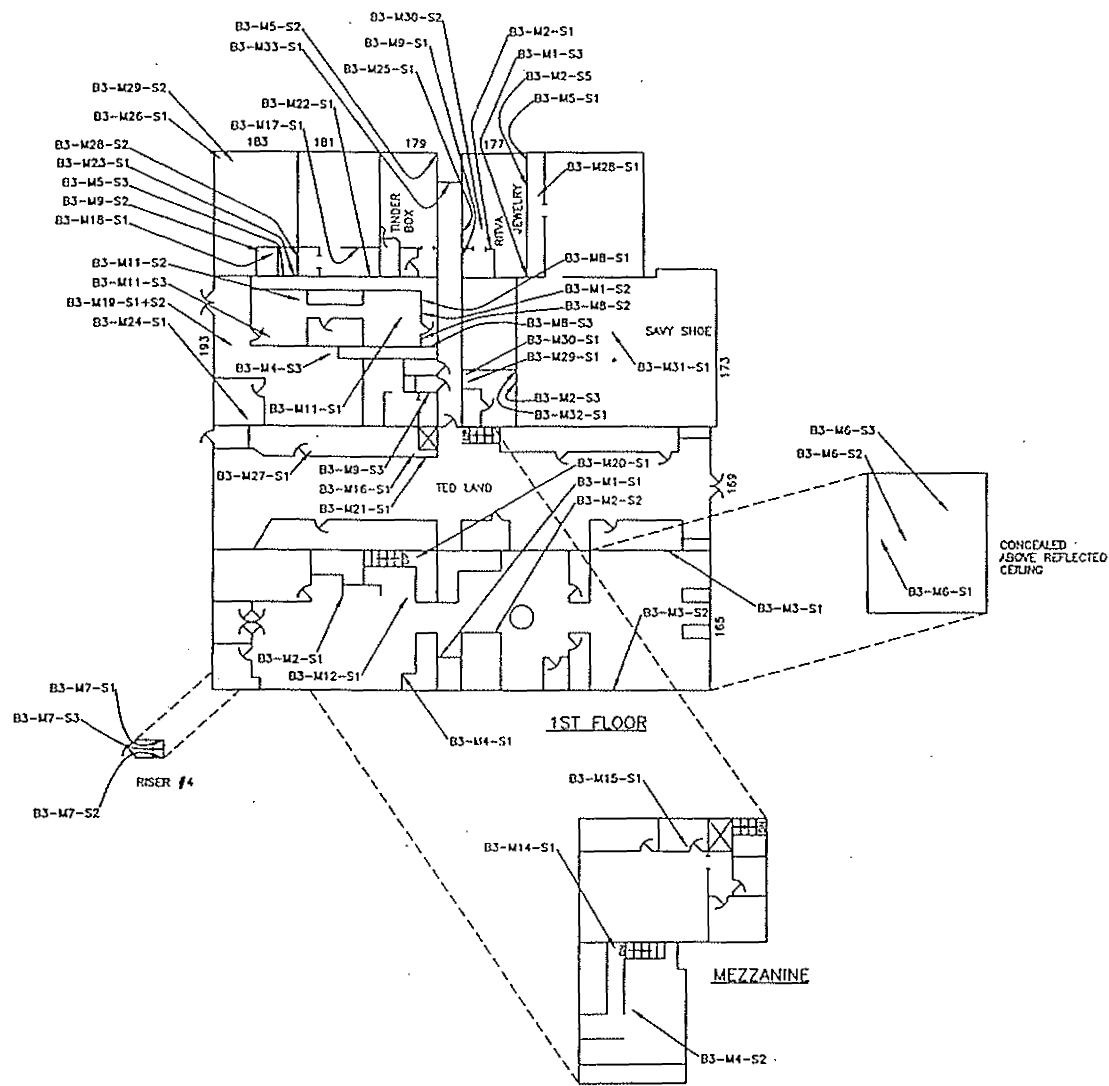
NORTHWEST ENVIROCON, INC. 1828 TRIBUTE ROAD, SUITE A, SACRAMENTO, CA. 95815 (916) 649-3570 FAX: (916) 649-3819	APPROVED:	SITE: DESERT FASHION PLAZA 124 PALM CANYON PALM SPRINGS CALIFORNIA	CLIENT:	DATE: FEBRUARY 1998	PROJECT#: 05-001350	REVISIONS
	DRAWN: CEB	DRAWING TITLE: BUILDING #3	SCALE: 1" = 30'	DRAWING#:

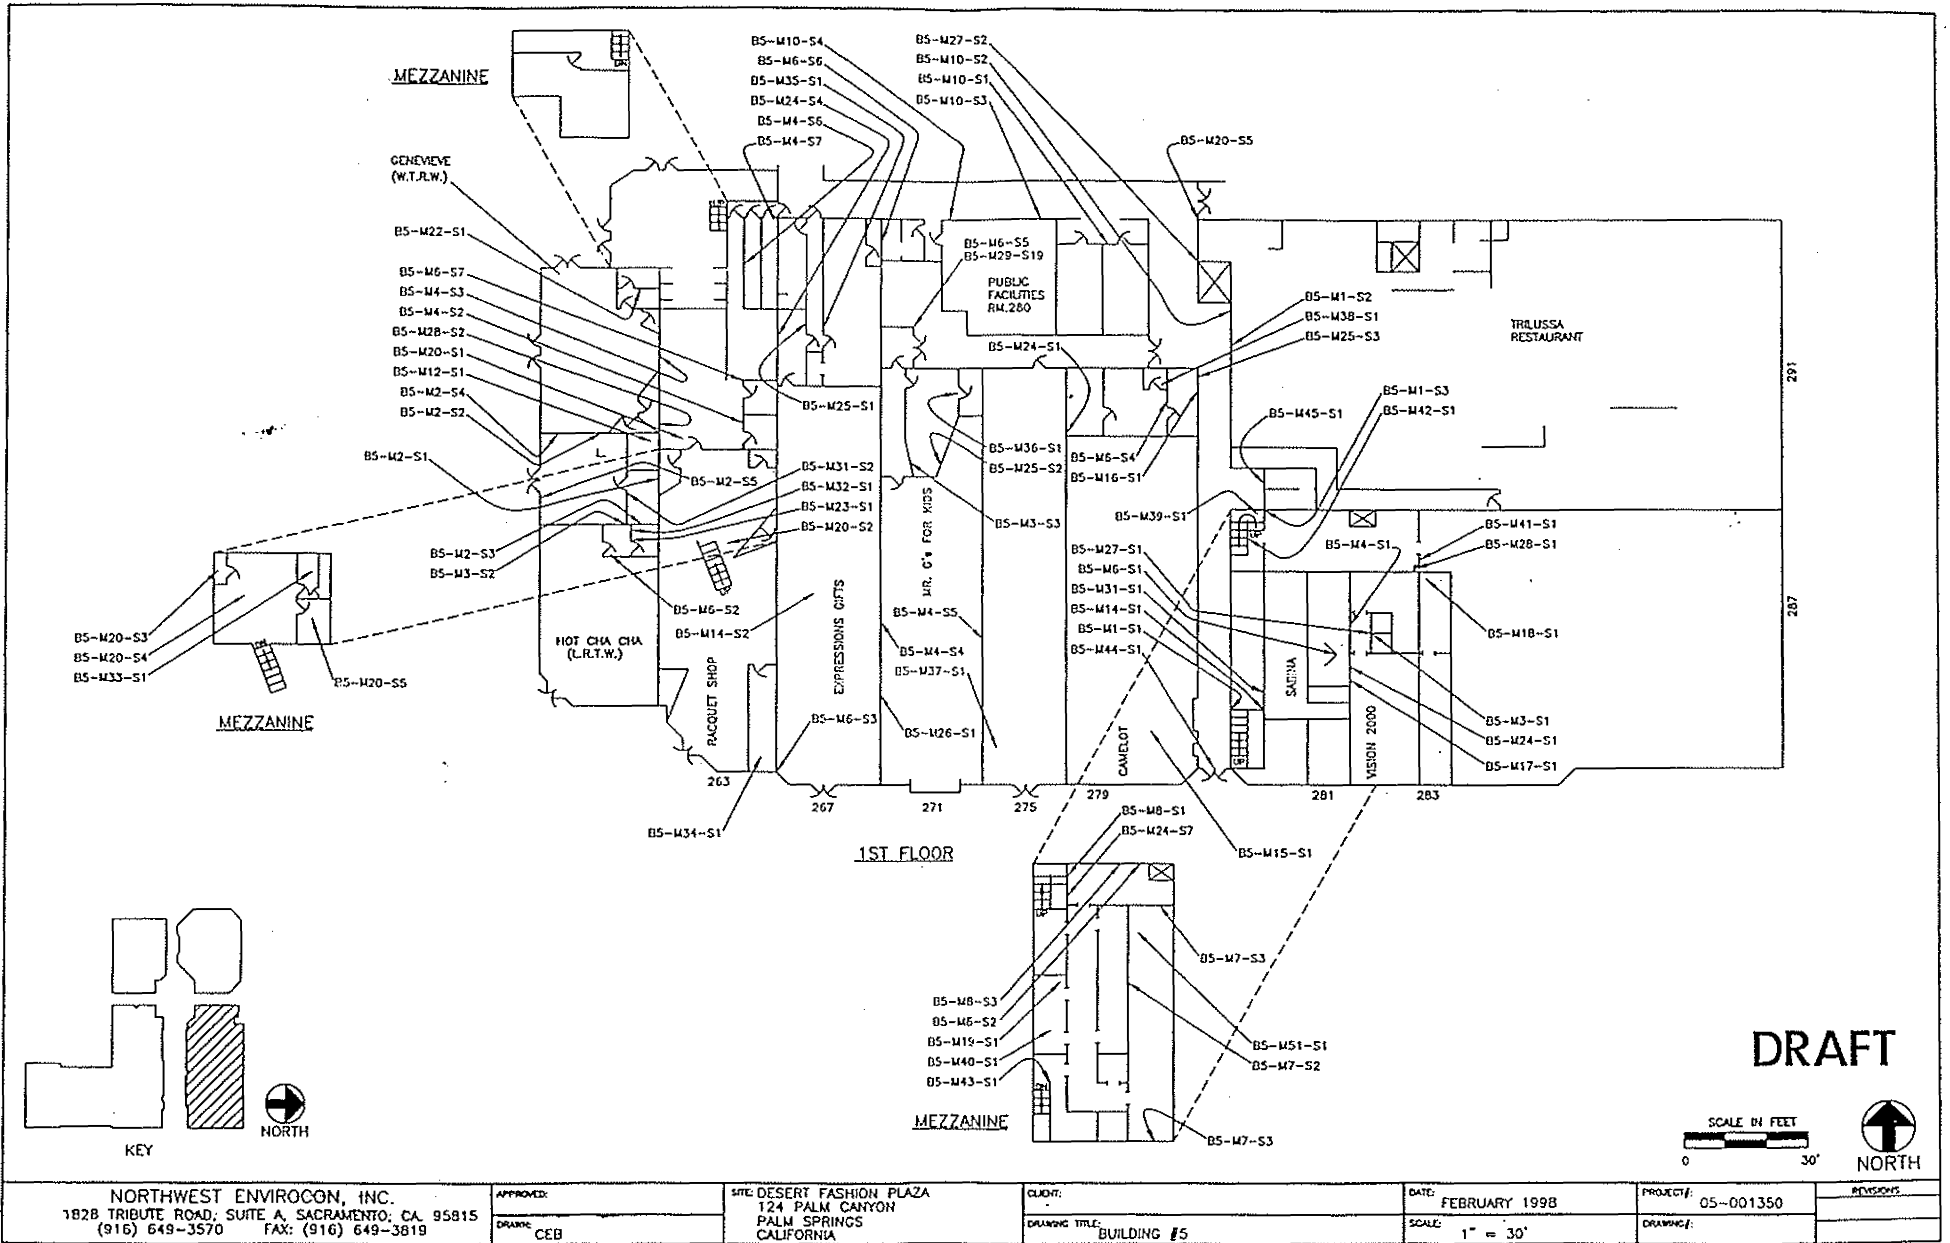
NORTHWEST ENVIROCON, INC. 1828 TRIBUTE ROAD, SUITE A, SACRAMENTO, CA 95815 (916) 649-3570 FAX: (916) 649-3819	APPROVED: _____ DRAWN: CEB	SITE: DESERT FASHION PLAZA 124 PALM CANYON PALM SPRINGS CALIFORNIA	CLIENT: _____ DRAWING TITLE: BUILDING #5	DATE: FEBRUARY 1998 SCALE: 1" = 30'	PROJECT#: 05-001350 DRAWING#: _____	REVISIONS: _____
