BENCH MARK

SECTION 20

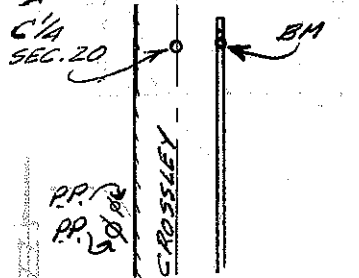
<p>2" C.P.S. Bronze disc stamped " A-7 1973 " set in top of curb, East side of Crossley Dr. at the end of curb app. center of section 20.</p>	<p>351.196</p>	<p>A-7</p>

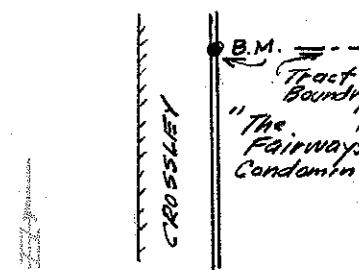
<p>2" C.P.S. bronze disc stamped "C.P.S. B.M. 20-18 1975" set in top of curb on east side of Crossley Road approx. 327' north of Fairway Circle or 1/4 mile N. of Ave. 34</p> <p>F.B. #75, PG. 133 5-18-75</p>	<p>344.675</p>	<p>20-18</p>

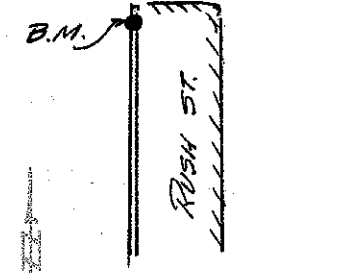
<p>2" C.P.S. bronze disc stamped "C.P.S. B.M. 20-19 1975" set in top of curb on west side of Rush St. 1/4 mile north of Ave. 34</p> <p>F.B. #75, PG. 133 5-18-75</p>	<p>340.083</p>	<p>20-19</p>

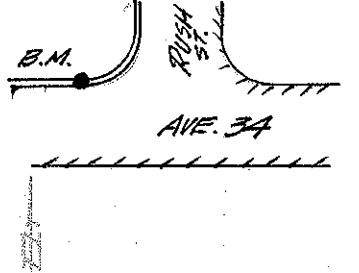
<p>2" C.P.S. bronze disc stamped "C.P.S. B.M. 29-4 1975" set in top of curb at W.N.W. curb return of intersection of Avenue 34 and Rush Street.</p> <p>F.B. #75, PG. 133 5-18-75</p>	<p>334.757</p>	<p>29-4</p>
