## SECTION 26

ELEVATION	BENCHMARK

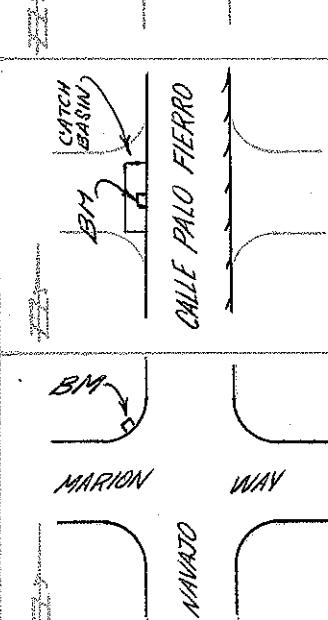
Chisled box on centerline of concrete frame for catch basin on the West side of Calle Palo Fierro at Tiki Drive	444.558	26-7

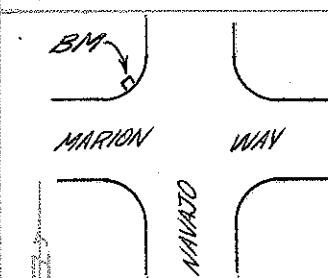
Chisled box on the M.O.C. of the N.W. curb at the intersection of Marion Way and Navajo Drive	445.078	26-8

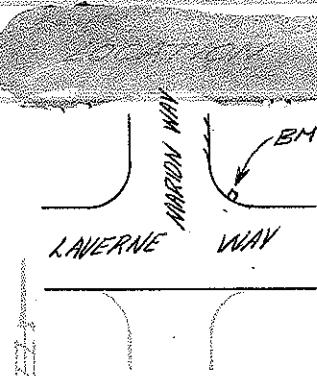
443.985	26-9
